Geotechnical Assessment

Project: New Residence
189 Riverview Road, Avalon Beach NSW.

REF: AG 20235
21 February 2022

189 Riverview Road, Avalon Beach NSW

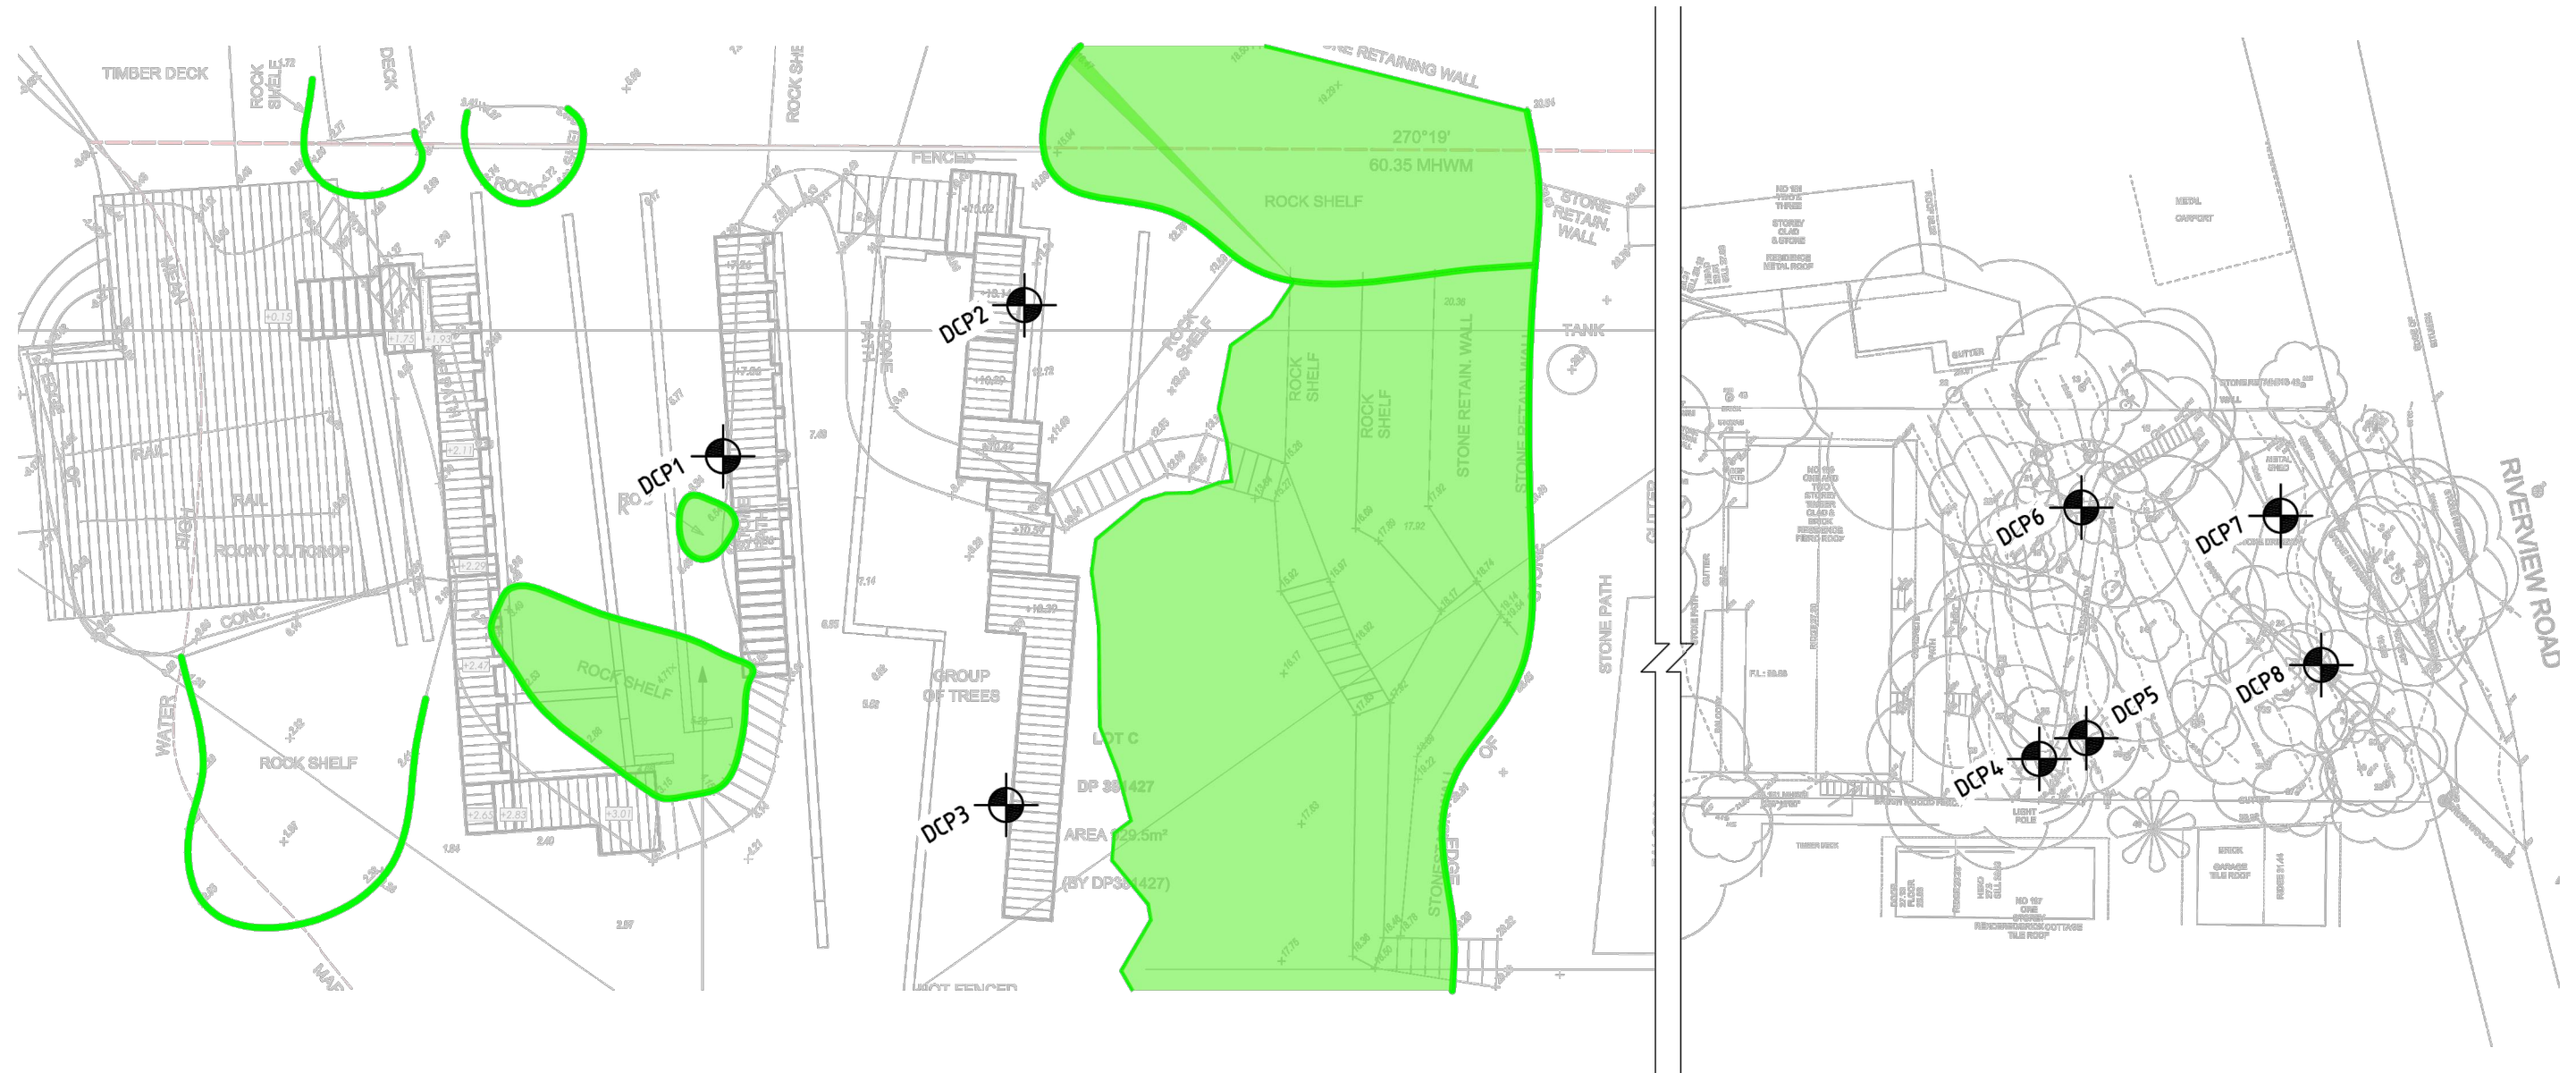
SITE PLAN/GROUND TEST LOCATIONS
SCALE NTS

EXPOSED SANDSTONE
BEDROCK/LARGE
DETACHED FLOATERS

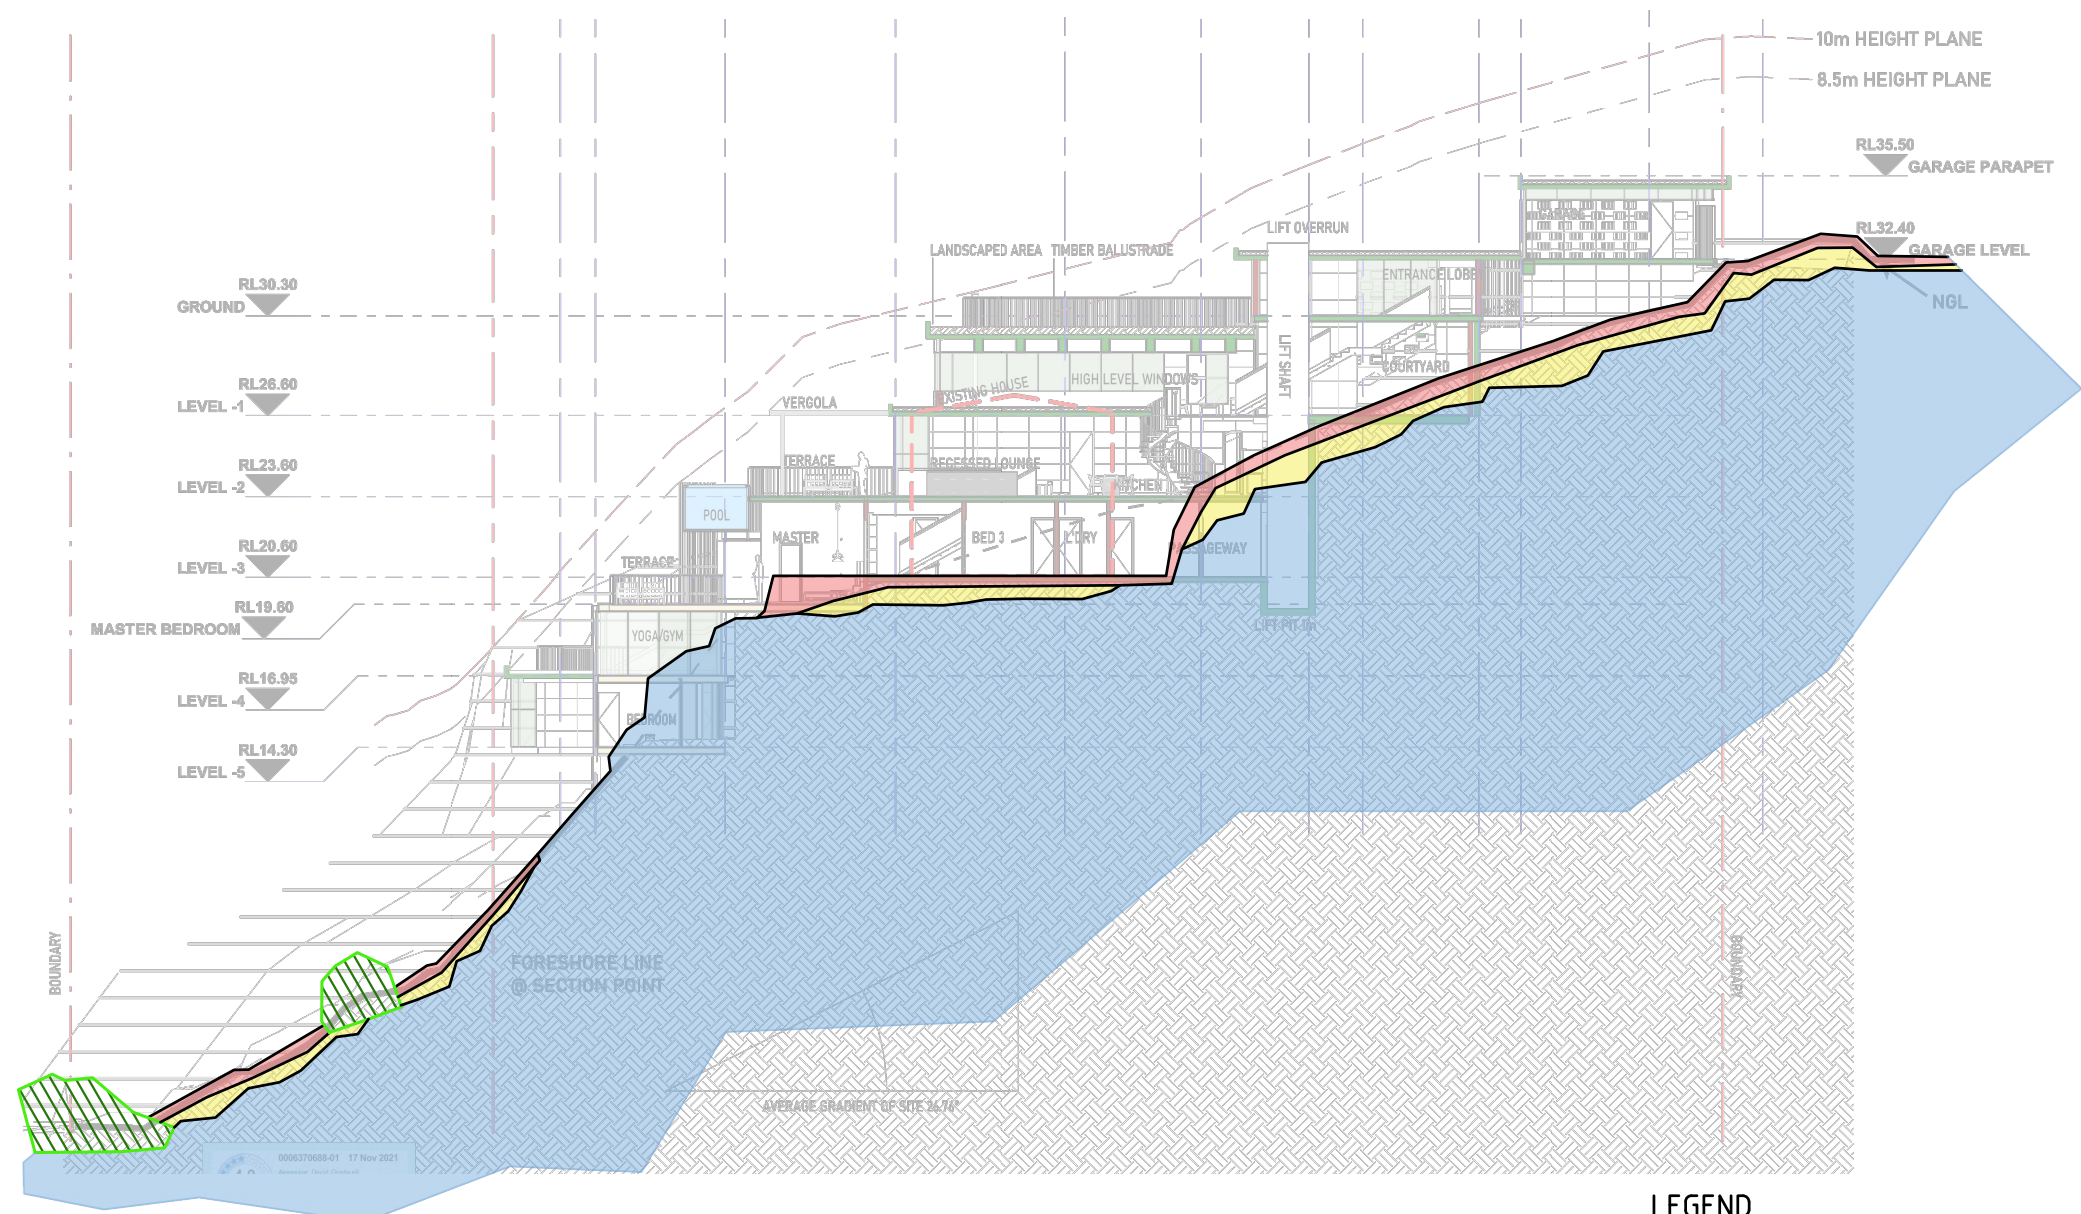
INFERRED GEOLOGICAL SECTION
SCALE NTS

INTERPRETED SUBSURFACE SECTION ONLY.
ACTUAL GROUND CONDITIONS MAY VARY.
