arboricultural impact assessment report

AIA-01

Revision A, Issued for Development Application
13 June, 2018

Allambie Heights Village - Project 2

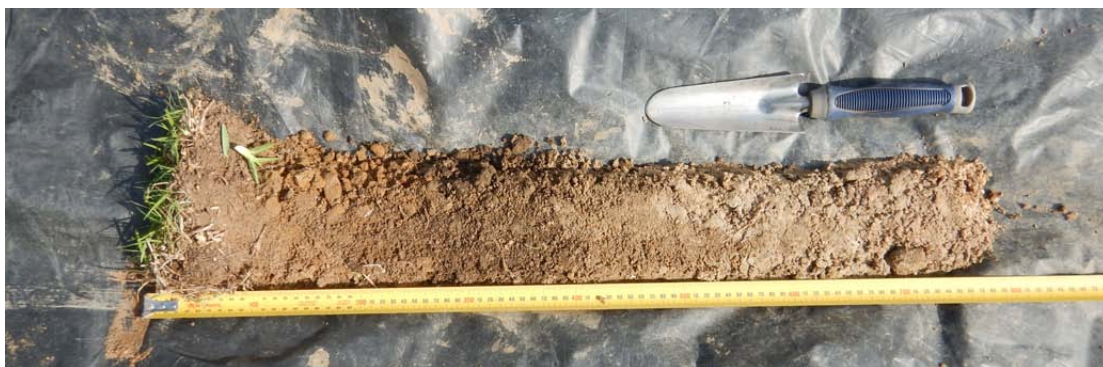
pH - 6.0 – moderately acidic

Texture - Sandy loam with a high percentage of sand.

Figure 4 – Typical Soil Profile to a depth of 700mm – the auger was rejected at this depth. (Photo: Arterra)

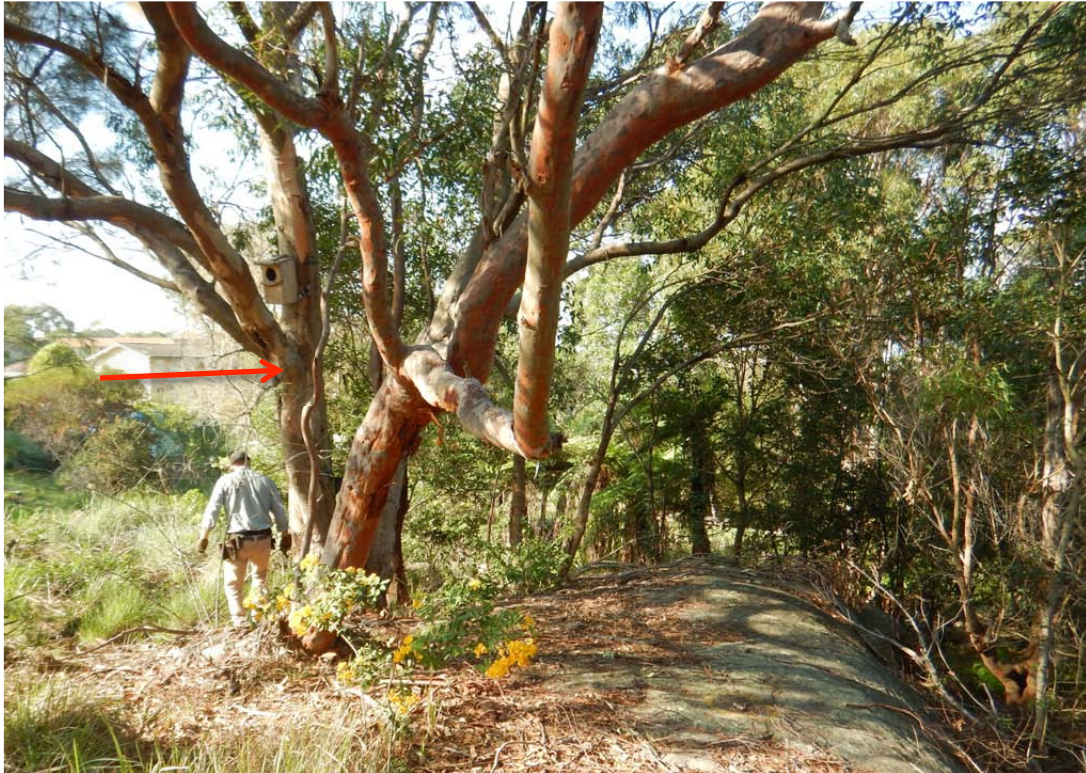
This tree has a TPZ radius of 8.2m and is located adjacent to a prominent sandstone outcrop on the edge of the bushland, adjacent to the intermittent creek line in the south western corner of the development area. **T23** is one of four trees (**T22-T25**) that are in a stand growing around this sandstone outcrop. **T23** is only in fair condition overall, displaying a variety of structural defects including co-dominant stems, major decay, minor deadwood, branch tear-outs and a major lean. This stand of trees however forms a prominent landscape feature in this portion of the site and provides screening to the proposed new building when viewed from the south west. This is also an endemic species and will provide important habitat services.

T23 will experience a minor incursion as defined by AS 4970, of approximately 10.0%, as a result of excavations required for the construction of the pool building and a pedestrian access pathway through the north-eastern portion of its nominal TPZ. The other trees within the stand are unlikely to experience any impact as a result of the proposed works. Based on the minor nature of the likely incursion it is the author’s opinion that **T23** may be successfully retained and protected throughout the course of the project.

Figure 7 – T22 in foreground, T23 immediately behind with the nest box installed. Note the sandstone outcrop at right. (Photo: Arterra 21/4/18)

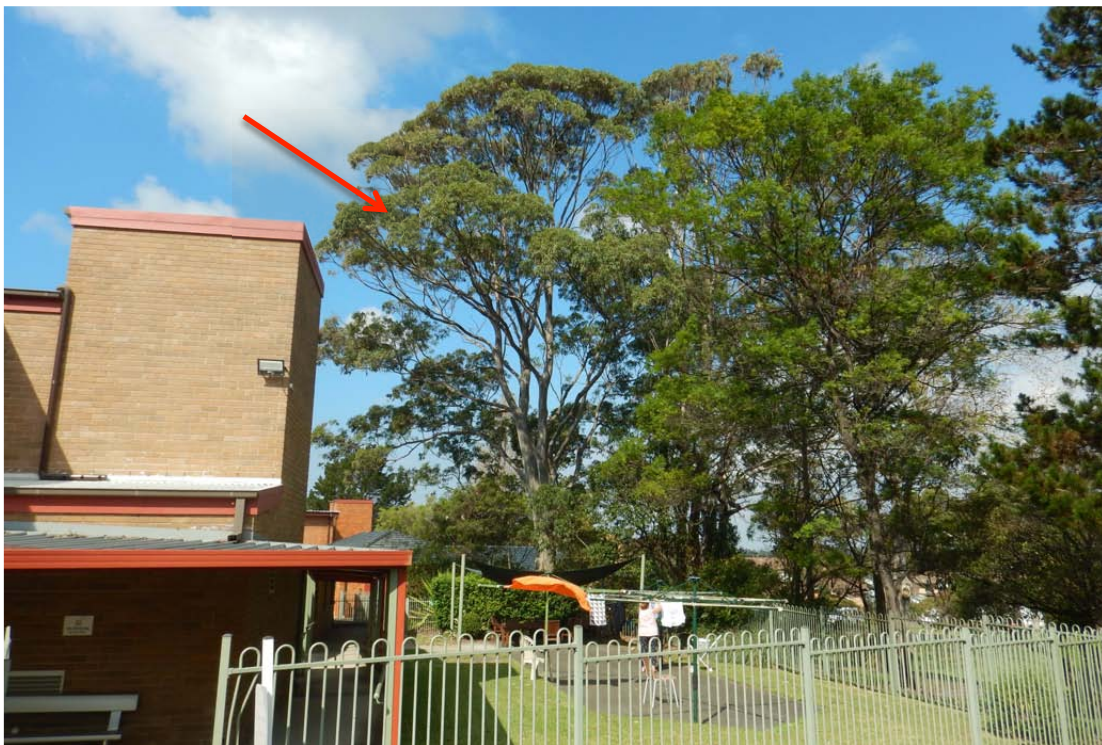
The largest and most prominent tree on the site is a large Sydney Blue Gum (*Eucalyptus saligna*) (T55). It is clearly visible from Allambie Road and other public areas. A similar tree to its west is in poor health and condition and should be removed. Tree T55 should be the focus of efforts to retain. It is not 'naturally' occurring in this particular site but it will create a valuable landscape asset and will help screen and separate the new development from the existing William Charlton Village. It is visually prominent and in good health.

Figure 8 – T55 a tree native to the Sydney basin, is large and very visually prominent with no notable defects. The retention of this tree should form a priority. (Photo: Arterra 21/4/18)

This tree has a TPZ radius of 13.56m and is located in a garden bed in a steep bank between the access road and utilities area to the rear of William Charlton Village and the cleared, grassed area in the north-eastern corner of the project site. There will be what we consider a minor incursion, as defined by AS 4970, of approximately 10.6% in the south-western portion of this tree's nominal TPZ. The incursion will result from the excavations for the adjacent building's basement floor level, which will sit approximately 400 – 500mm below the current ground level. The existing ground levels and surface conditions around this tree, within the TPZ and beyond, (with the exception of the noted incursion), will be maintained at existing levels. A low retaining wall/ kerb will be constructed along the eastern side of the basement to prevent the need for any further battering. A new pedestrian pathway proposed to run through the south-eastern portion of the TPZ shall be installed as a suspended structure above the existing ground levels requiring no significant excavation, and minimising any likely root impacts in this area.

Given that the incursion occurs to a relatively small south-western portion of the TPZ and the remainder of the TPZ will experience no significant disturbance including the areas contiguous and beyond the TPZ to the north, east and south it is the author's opinion that this impact is acceptable and is likely to have little impact to the overall condition of the tree. It will be vital however to protect the remaining TPZ thoroughly, during construction. The implementation of temporary irrigation during the construction phase will be extremely beneficial and help maintain the health and vitality of the tree and is recommended.

Located immediately to the west of **T55**, is **T54** which is a similar tree, however, it is in much poorer health and condition with significant borer blazes to the north and south sides of trunk. **T56-T60** are smaller trees in poor condition and weeds that are growing around the base of **T55**. It is recommended that **T54** & **T56-T60** be removed for the betterment of **T55**.

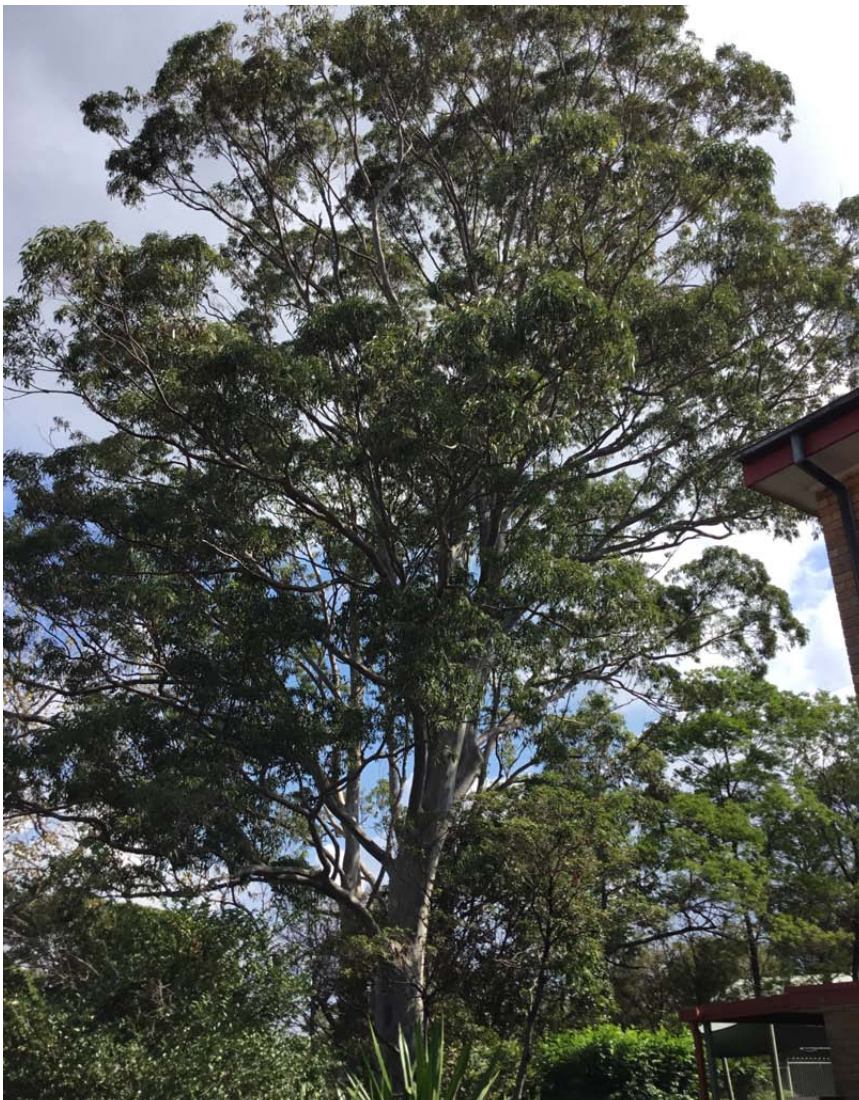
Figure 9 – T55- view north west from rear of William Charlton Village towards tree. (Photo: Arterra 21/4/18)

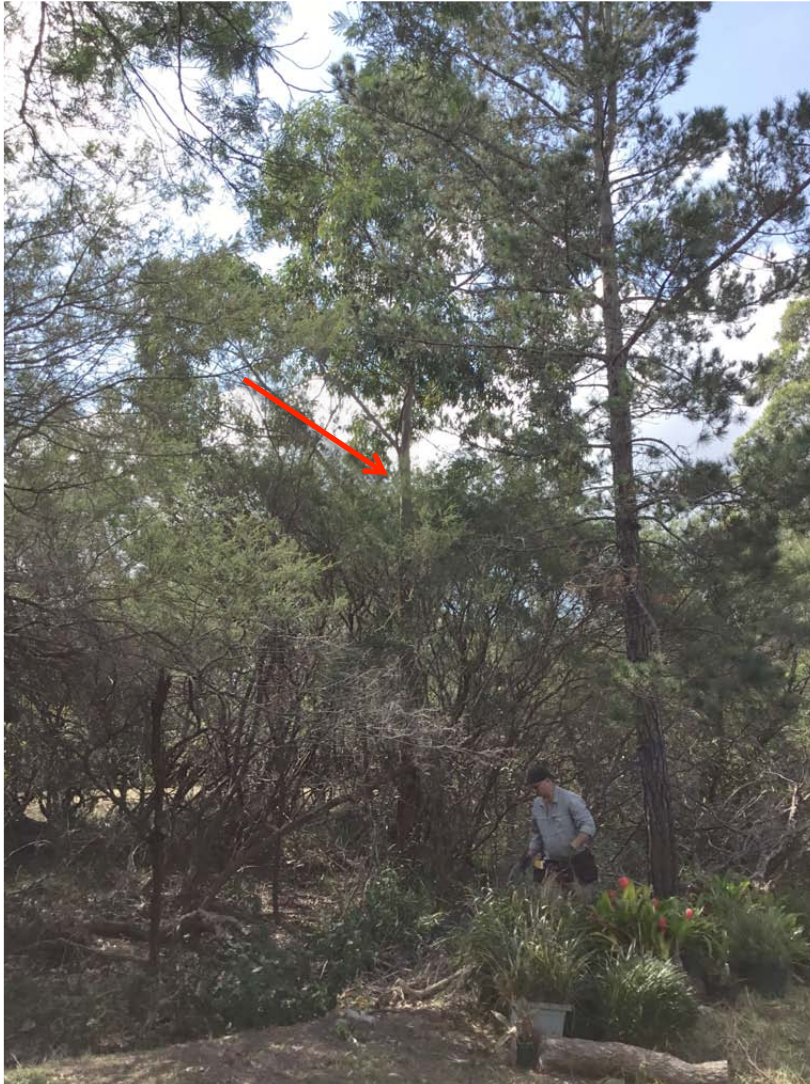
T76 is a young and healthy tree located adjacent to the northern site boundary just north of the proposed extent of works. The existing carpark is to be extended north and a garbage bin storage area is proposed adjacent to this tree. The carpark has been designed around the tree to minimise construction impacts to the tree and allow its retention. The potential disturbance caused by the construction of the bin storage facility results in a minor incursion to the southern portion of the TPZ of 10%. Any other root impacts are expected to be minimal and it is the author's opinion that this incursion is acceptable and likely to have little impact to the condition of this young tree.

Figure 10 – T76 view to the north from the northern edge of the existing carpark (Photo: Arterra 21/4/18)

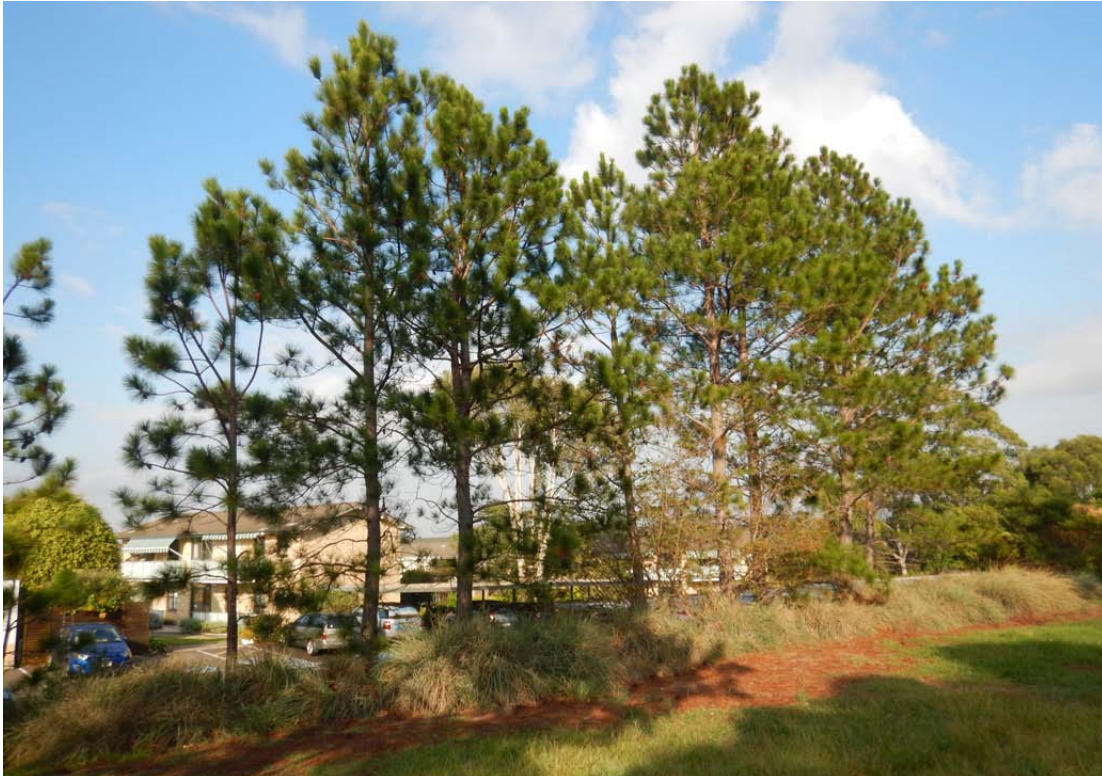
There are several Pine trees (believed to be *Pinus canariensis*) located on the boundary embankment along the southern edge of the development site. Pinus are an exempt species and may be removed without approval. These are a potentially invasive species and are growing on the edge of a steep drop-off. Given the above exemption and the likely shallow soils and limited root development to the southern side of these trees we believe it is prudent to remove them. Suitable replacement planting is proposed within the new landscaping of the site, which will continue to provide suitable low level screening between the new development and Allambie Heights Village to the south.

Figure 10 – T03-T12- view south-west from rear of William Charlton Village. (Photo: Arterra 21/4/18)
