# Geotechnical Site Investigation

Lot. 2 No. 40 Wellman Road, Forestville NSW 2087

Site Number 117640

**Date** 20/09/2019 **Author** Raj Singh

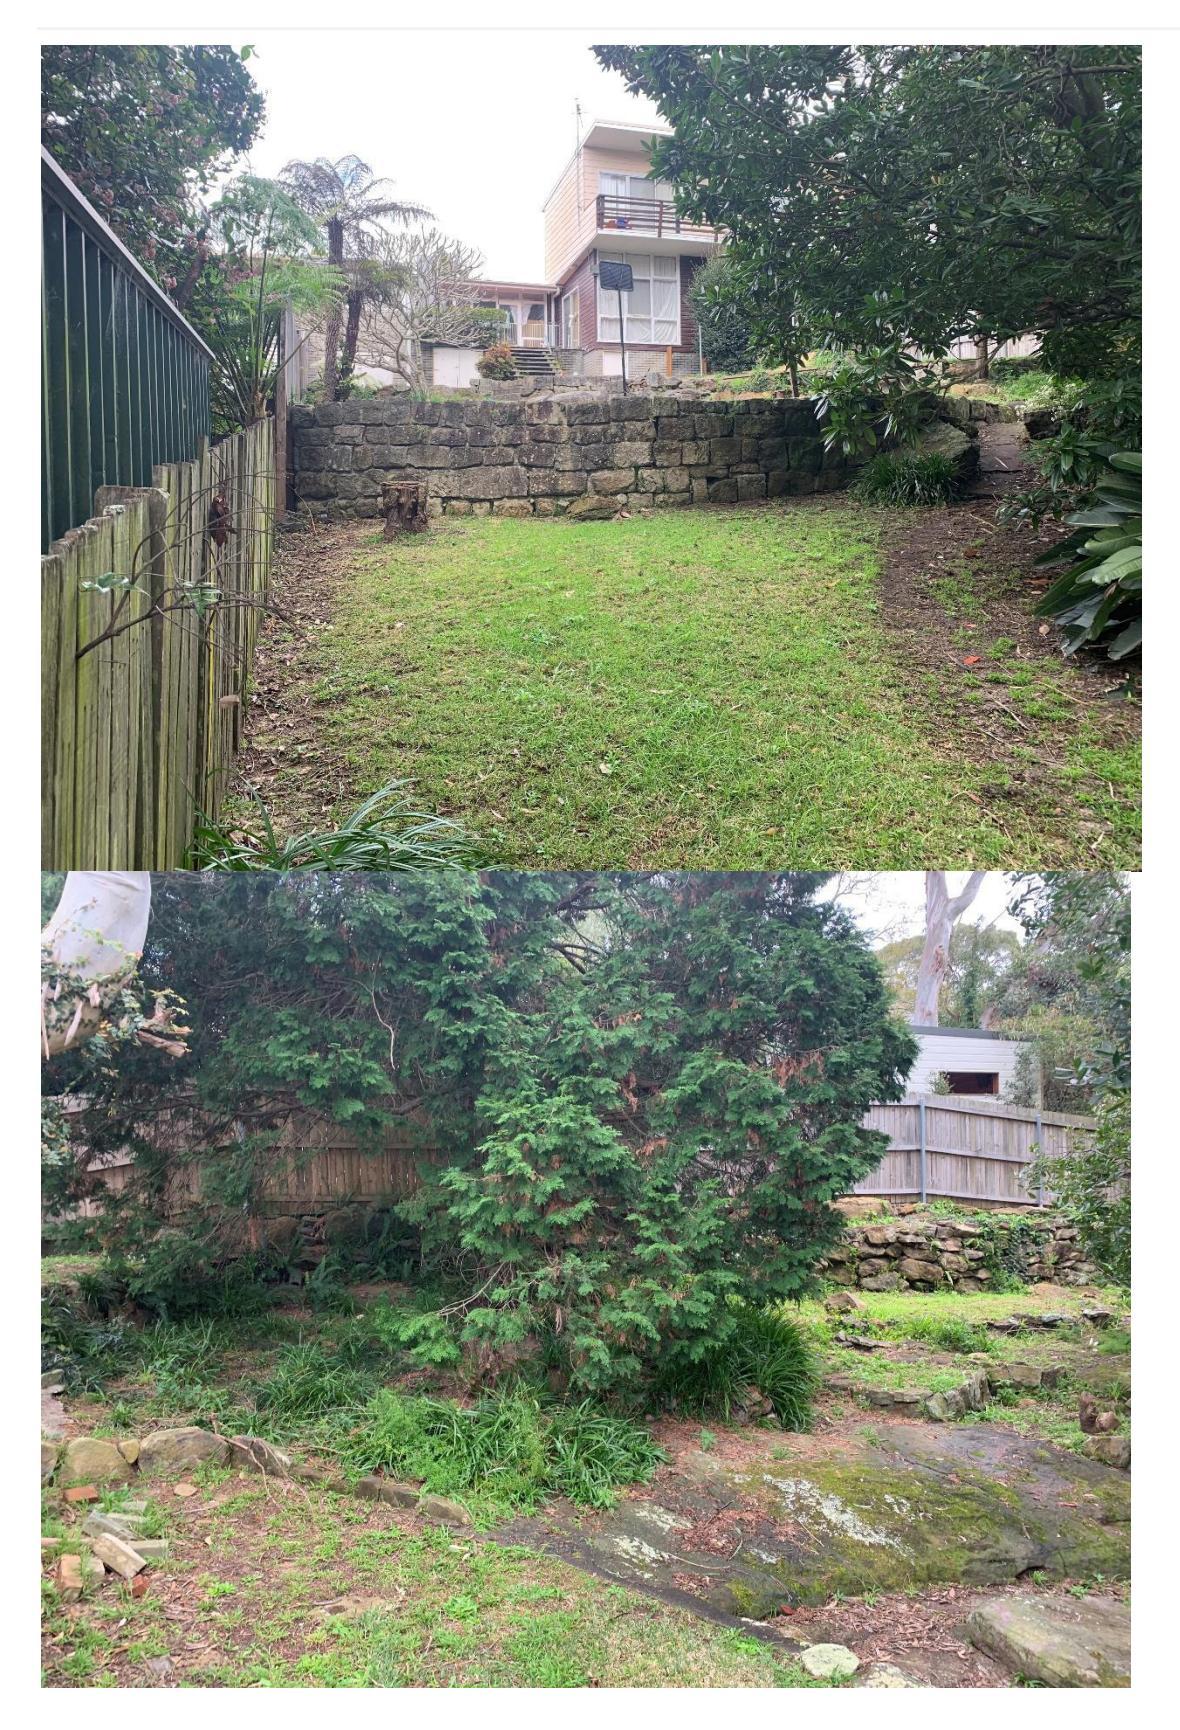
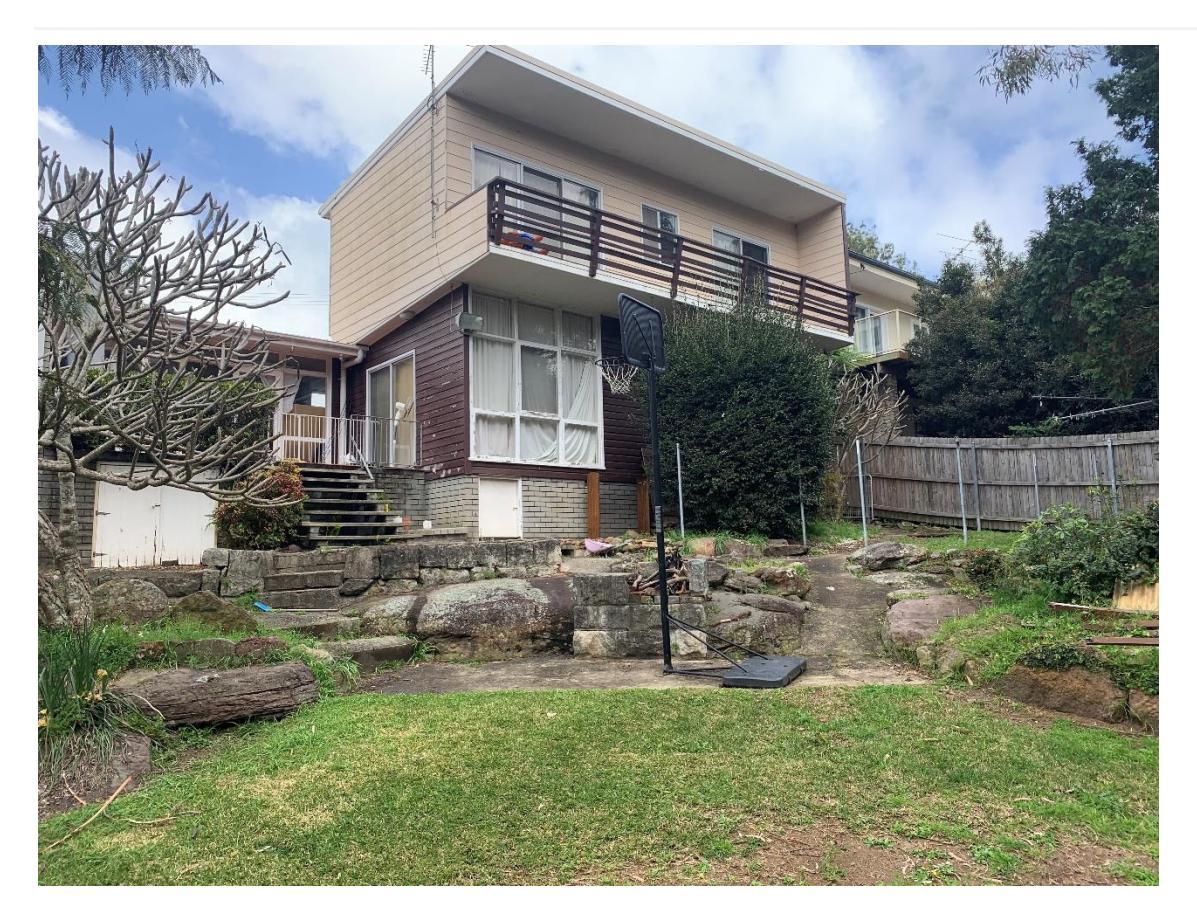
Site Photography

Site was occupied with a double storey brick house. It was observed that existing residential dwelling is may be supported by timber beams which resting on brick piers. At the time of preparing this report, Intrax does not have any structural details about the existing residential dwelling. The site has an overall slope of about  $8^{\circ}$  -  $9^{\circ}$  towards the rear boundary as observed from the Wellman Road.

From the middle of property, the ground is sloping downwards for about 3 to 4m at 12° - 15°. The area contains several large trees and retaining walls. A 1.7m retaining wall is observed on the western side of the property. Another retaining is observed running between the boundary of two properties along the eastern side. Large sandstone boulders and large trees were observed throughout the area. The large sandstone boulders appeared to be in-situ rock.
