4 Laura Street, Seaforth

Geotechnical Comments for Section 4.55

GEOTECHNICAL INVESTIGATION:

Landscaping at 4 Laura Street, Seaforth

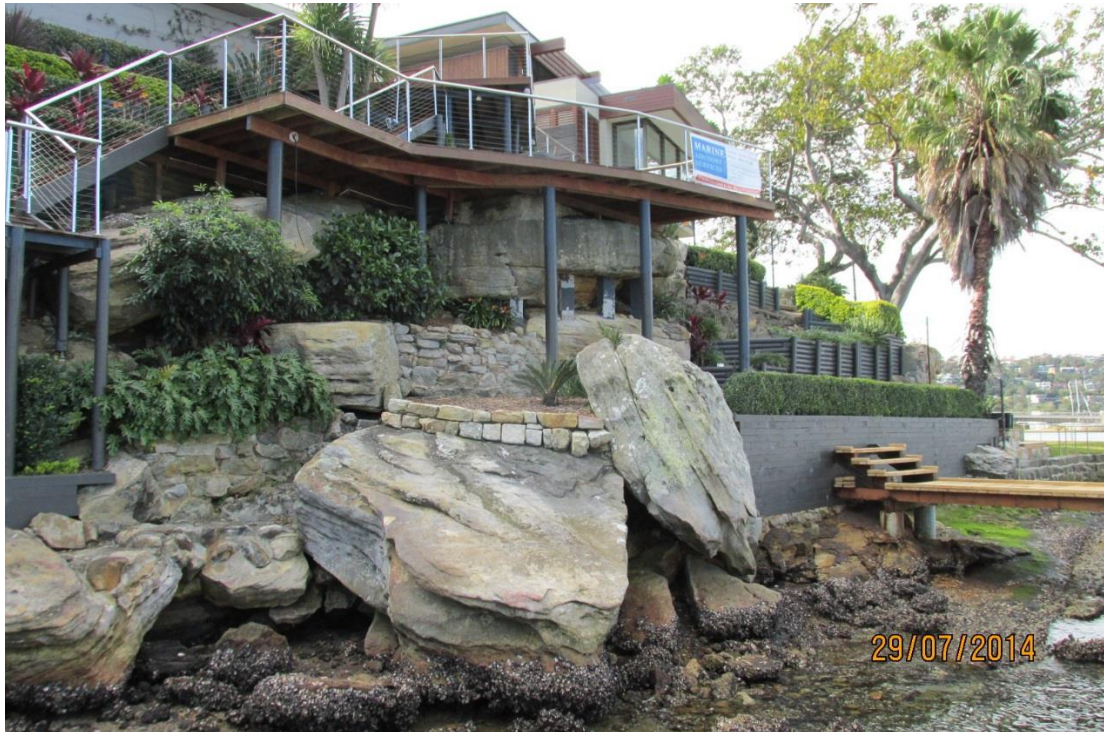
Photo 1

- 2.3** Sandstone bedrock is visible at the waterfront and also in the steep slope immediately above. Several loose boulders are scattered along the waterfront (Photo 1). These appear to be in stable positions. One in particular is lodged at a high angle and has come to rest on several other boulders (Photo 2). This boulder has been in place for a long time and is currently considered stable but care should be taken not to disturb its contact points during the construction. The boulder would not be stable should there be a significant seismic movement. The slope above has been landscaped with poorly constructed treated timber retaining walls and timber decks and walkways (Photo 1 & 3). The soldier piles supporting the walls are inadequately embedded and are tilting at angles up to 10 degrees from vertical (Photo 4). The decks and walkways are not all plum and some of the supporting timber posts can be seen to be tilting down slope. These works will be replaced as part of the proposed development.

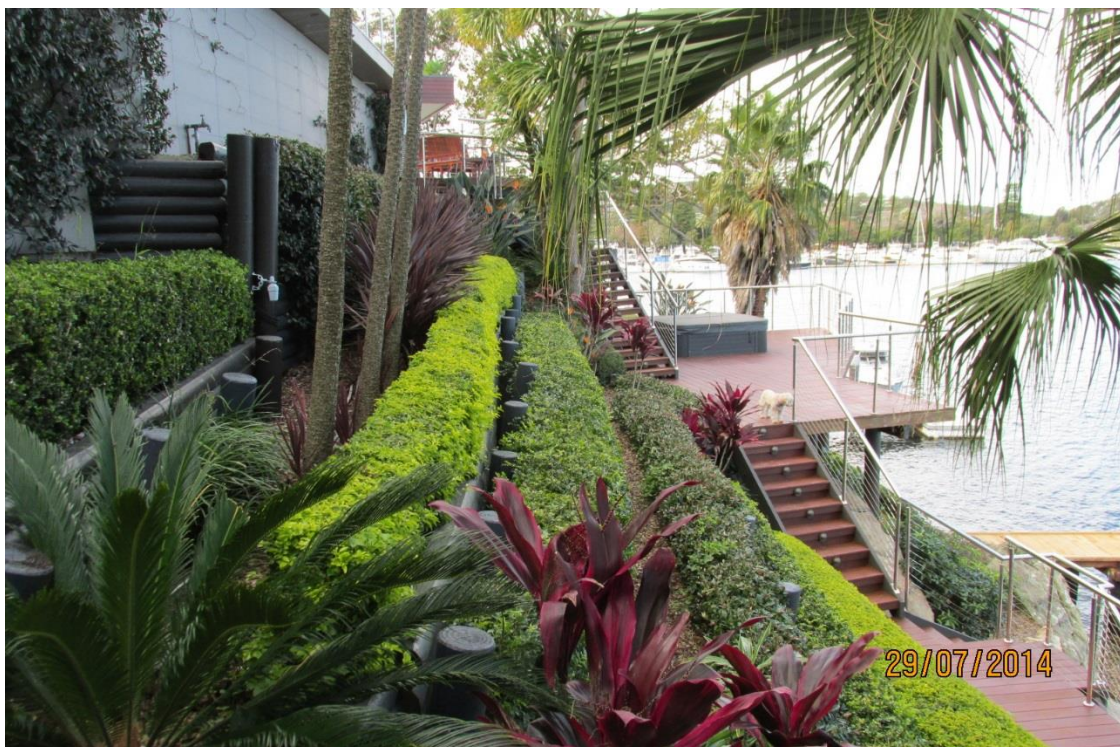
Photo 4

HAZARDS	Hazard One	Hazard One
TYPE	The slope that rises across the property failing and impacting on the house.	The tilting timber retaining walls below the pool failing.
LIKELIHOOD	'Unlikely' (10^{-4})	'Possible' (10^{-3})
CONSEQUENCES TO PROPERTY	'Minor' (8%)	'Medium' (15%)
RISK TO PROPERTY	'Low' (5×10^{-6})	'Medium' (2×10^{-4})
RISK TO LIFE	8.3×10^{-7} /annum	8.3×10^{-6} /annum
COMMENTS	'Acceptable' level of risk.	'Unacceptable' level of risk. To move risk to 'Acceptable' levels the retaining walls are to be replaced.

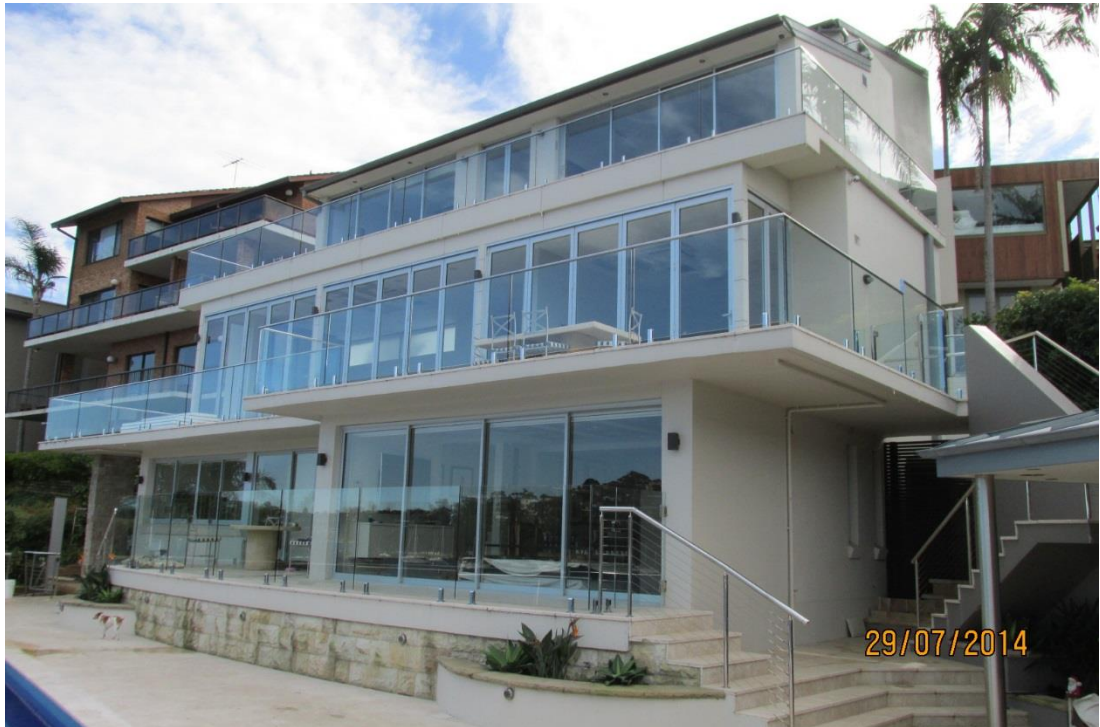
Photo 5

2.4 Above the landscaped waterfront slope the pool and part three level masonry house steps up the slope with the footprint of these structures covering the upper portion of the block (Photo 5). No signs of movement were observed in the supporting walls of the house or in the pool. A cut behind the lower level of the house is through stable sandstone bedrock (Photo 6).
