## ARBORICULTURAL IMPACT ASSESSMENT REPORT

54 Bardo Road, Newport

**Built Projects**

16<sup>th</sup> March 2021

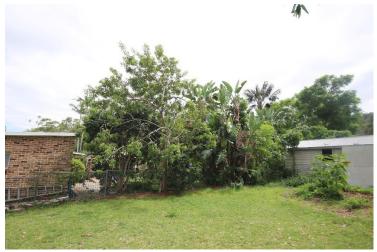
Plate 1: Tree 1

1. Tree *Fraxinus griffithii* is a mature tree with fair condition with sparse canopy density – refer plate 1.

The development has a major encroachment within this trees TPZ – exceeding 26%.

This tree is assessed to be of low retention value and can be easily replaced in the landscape works.

Due to the low retention value, sparse canopy density and the major level of impact, removal of this tree is recommended. Note for removal in the Tree Management Plan (TMP).

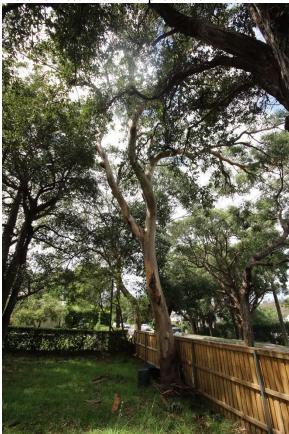
Plate 3: tree 4

4. Tree 4 *Eucalyptus punctata* shows good condition with minor deadwood scattered around the canopy – refer plate 3. This tree has a high retention value.

- a. Light weight front fence on isolated posts.
- b. Entrance, letter box and walkway to units all an elevated structure.
- c. Deletion of the impervious pathway to G01.
- d. POS to G01 on a suspended slab with an air gap.
- e. Basement adjusted away from TPZ.
- f. Refer Annexure C.

In view of these design changes the long-term retention of this tree will be achieved and is supported. Tree protection to be installed during development works.

Note for retention and protection in the TMP.

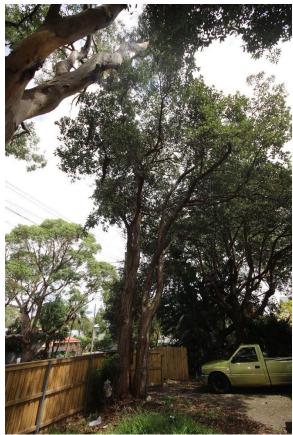
Plate 4: tree 5

5. Tree 5 *Syncarpia glomulifera* shows good vitality with previous lower branch pruning – refer Plate 4.

Consequently, this tree will need to be removed to excavate and construct the double width driveway / waiting bay to the basement – refer Annexure C.

It is acknowledged this tree is of high retention value and forms part of the streetscape. However, rather than merely cutting this tree down, a replacement tree of the same species can be replanted on site to ensure benefit of trees in this locality.

Note this tree for removal with replacement planting on site.

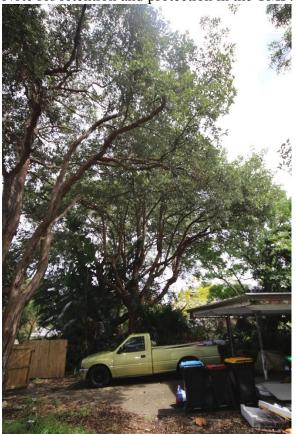
7. Tree 7 *Syncarpia glomulifera* shows good vitality with previous lower branch pruning – refer Plate 5.

It is acknowledged there is an existing concrete driveway beside this tree. It is proposed to install the basement driveway and standing bay within this tree's TPZ – refer Annexure C.

Plate 5: tree 7 – note existing concrete driveway on site.

To reduce the potential impacts on this tree, the proposed driveway will incorporate the removal of the existing concrete driveway with rubber tract excavators (i.e. spreading the load), then providing an aggregated layer of 100mm (no fines), a 200Um Fordicon layer (prevent leeching of lime into the root plate) and a new concrete driveway – refer Annexure C, Driveway Detail.

It will be essential to install trunk protection around this tree before Site Establishment – refer Annexure D.

The above design considerations will ensure the longevity of this high retention tree. Note for retention and protection in the TMP.

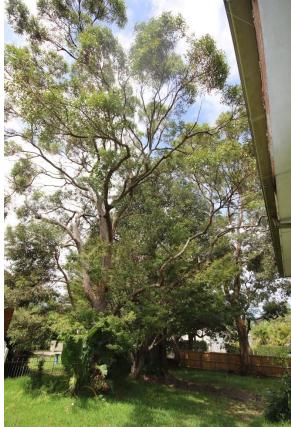
Plate 6: tree 9

9. Tree 9 *Eucalyptus botryoides* shows fair to average condition with less than normal canopy density and suppressed development – refer plate 6. Medium retention value.

This tree is within the proposed development – refer Annexure C. In view of its fair - average condition and poor form, removal is supported.

Note for removal in the TMP.

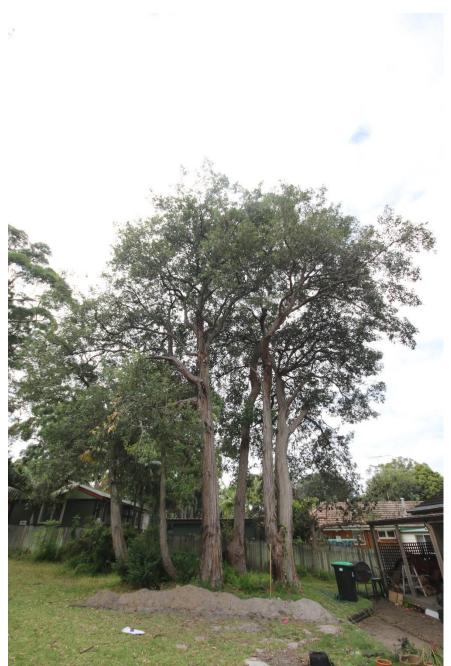
Plate 7: Tree 15, 14, 13, 12 & 11.

Tree 11, 14 & 15 have suppressed form as a consequence of suppression by the dominant trees: 13 & 12 - refer plate 7.

- a. Basement adjusted away from the TPZ of these trees.
- b. Walkway to units all an elevated structure.
- c. Unit G04 incorporates a suspended slab over the TPZ of Tree 12 & 13 to ensure air and moisture exchange with the root system.
- d. No canopy pruning is required to undertake the development works.
- e. It is proposed to remove Tree 11, 14 & 15 to provide greater deep soil area for the roots of Trees 12 & 13 i.e. reduced competition for soil moisture and nutrients.
- f. The longevity of Trees 12 & 13 will be enhanced by the reduced competition with the removal of Trees 11, 14 & 15, including greater access to sunlight for their natural process of photosynthesis and nutrient uptake.
- g. An irrigation system can be added in the landscape works to augment the supply of water.

Removal of Trees 11, 14 & 15 is supported. Retention of Trees 12 & 13 is justified.

Note Trees 11, 14 & 15 for removal and Trees 12 & 13 for retention in the TMP.

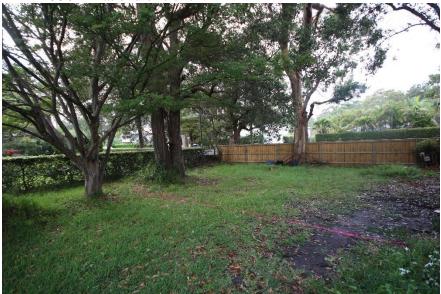
Plate 8 – trench 1.

Trench No 1 was located between Trees 6 & 8 - at a distance of 2m centre line of Tree 8.

Trench 1 found 19 roots varying from 20mm to 120 mm all within the TPZ of these trees i.e. woody & non-woody roots<sup>3</sup>. Root 2, 10, 11, 12, 14, 16, 17 & 19 do not appear to be from Tree 8. The roots are scattered along the trench. Roots 1, 4 & 15 are classified as "Non-Structural Roots" (Draper & Richards 2009).

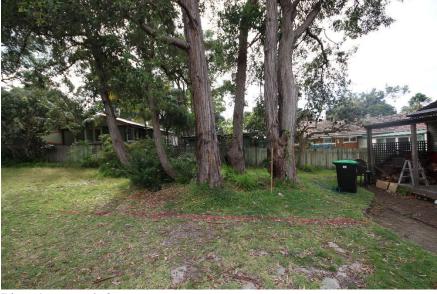
Plate 9 – trench 2.

Trench No 2 was located on the east side of Trees 11, 13, 14 & 15 - at a distance of 1.8m centre line of Tree 13.

Trench 2 found 24 roots varying in size from 25mm to 160mm. Roots 1, 5, 6, 7, 9, 12, 13, 16, 17, 18, 22 & 24 are non-woody roots. N.B. It was difficult to determine which roots were from these trees.
