J3241 8th March, 2021 Page 1.

GEOTECHNICAL INVESTIGATION:

Alterations and Additions and New Pool at 49 Binburra Road, Avalon

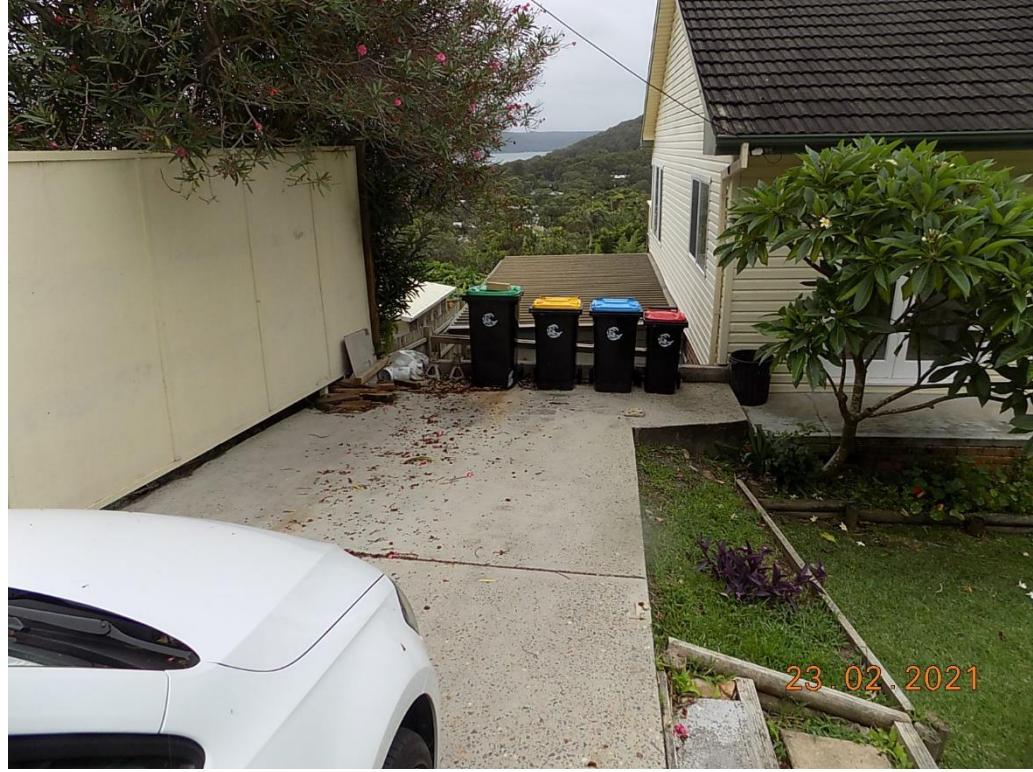
Photo 1

2.3 At the road frontage, a stone-paved driveway runs to a concrete parking area on the uphill side of the property (Photo 1). The fill for the road is lawn-covered, battered to stable angles, and merges into the natural slope. Between the road frontage and the house is a gently sloping lawn (Photo 2). The part two-storey brick and timber framed and clad house is supported on brick walls (Photo 3). Cracking was observed in the NE and SW supporting walls of the house (Photos 4 & 5). However,

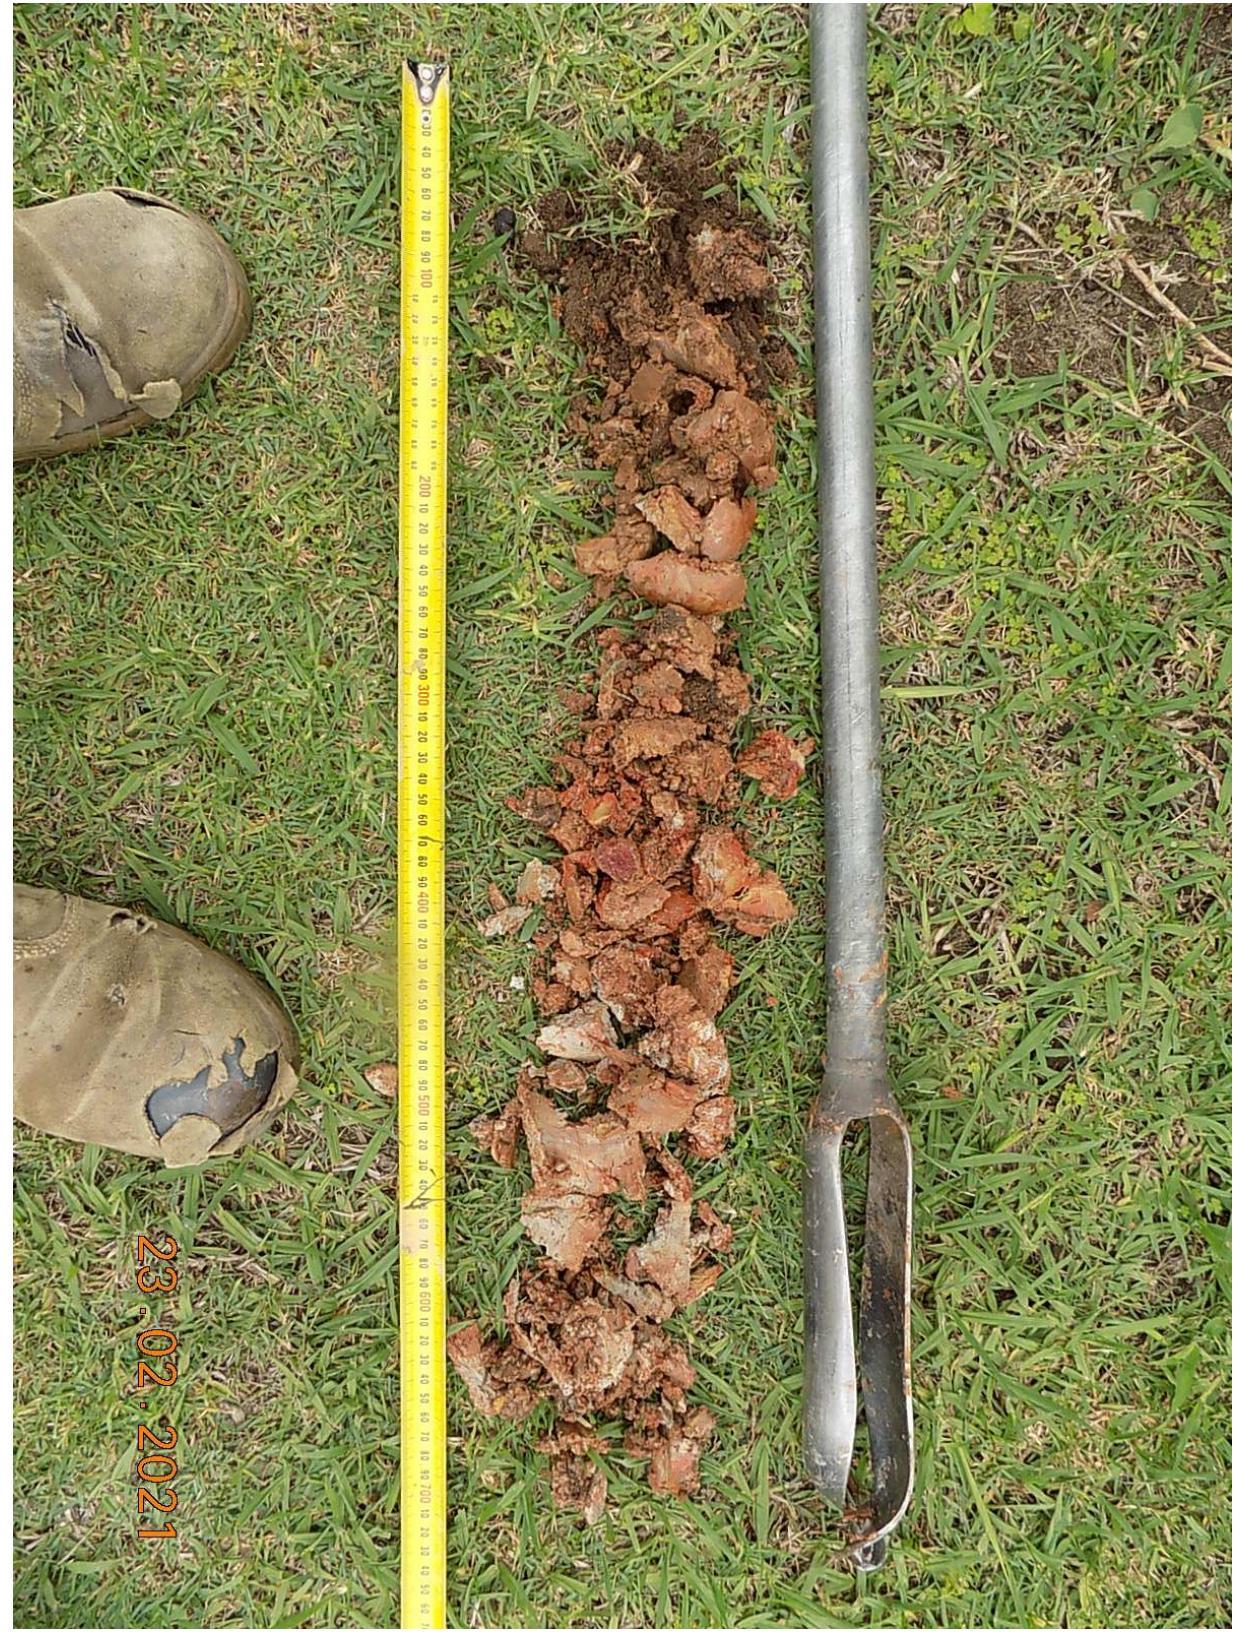
AUGER HOLE 1 (~RL47.0) – AH1 (Photo 9)

Depth (m)	Material Encountered
0.0 to 0.1	FILL , disturbed sandy soil, dark brown, medium dense, dry, medium to coarse grained with fine trace organic matter.
0.1 to 0.7	FILL , disturbed clay derived from weathered shale, brown, dark brown and mottled orange, maroon, and grey, firm to very stiff, dry, fine to medium grained.

End of hole @ 0.7m in fill. No water table encountered.

Photo 9: AH1 – Downhole is from top to bottom.
