Geotechnical Assessment

Project: New Pool & Landscaping
20 Spring Cove Avenue, Manly NSW

Prepared for:
Lee Sar, c/ Harrison's Landscaping

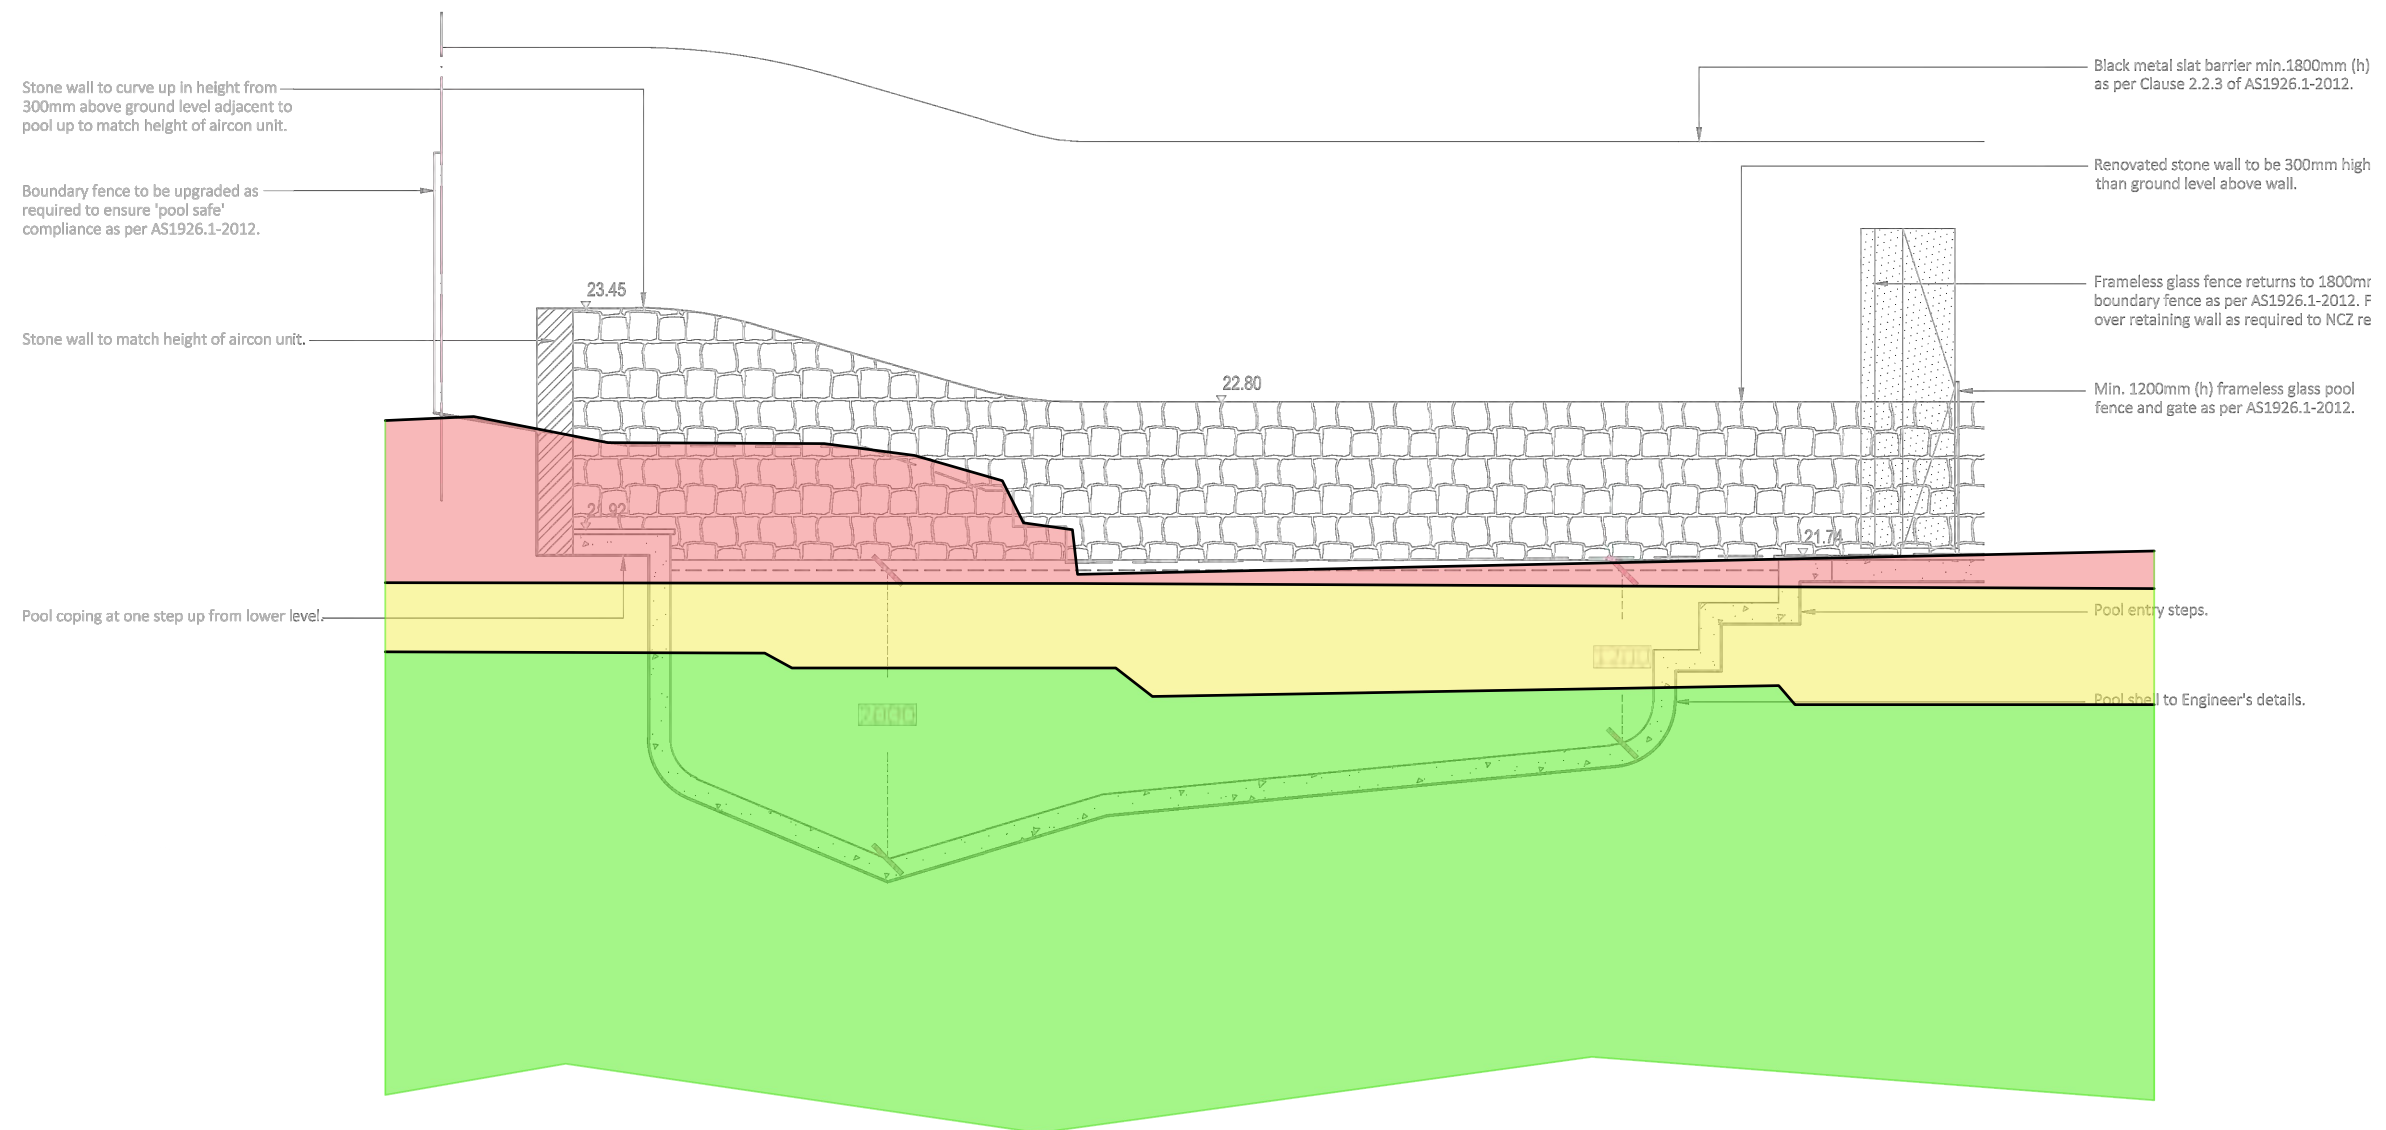
INFERRED GEOLOGICAL SECTION
SCALE NTS

The soil profile consists of shallow uncontrolled fill and silty topsoil (O & A Horizons), silty sand (B Horizon) and weathered bedrock (C Horizon). Based on our observations and the results of testing on site, we would expect weathered sandstone bedrock to be found within 1.0 to 1.70 metres below current surface levels across the area of the proposed works and potentially deeper where filling has been carried out.
