J5771. 29<sup>th</sup> October, 2024. Page 1.

# **INFILTRATION TESTING:**

For Proposed Infiltration Trench at **12 Pacific Parade, Manly**

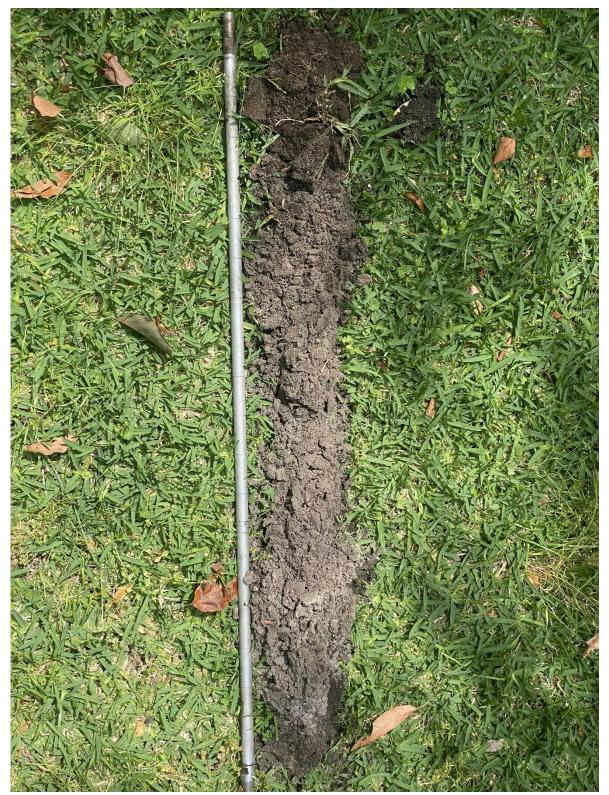
**STAND PIPE 1** (~RL4.4) – SP1 (Photo 1)

- Depth (m) Material Encountered
- 0.0 to 0.2 **SAND**, dark brown, medium to coarse grained with fine trace organic matter.
- 0.2 to 0.9 **SAND**, grey and light brown, medium dense, damp, medium grained.

End of Hole @ 0.9m in Medium Dense Sand.

Photo 1: SP1 – Downhole is from top to bottom.
