ARBORICULTURAL IMPACT ASSESSMENT  
&  
TREE PROTECTION SPECIFICATION

REF: L&Co22032 | 16 December 2024 | v4  
SITE ADDRESS | 113 Orchard Street, Warriewood  
PREPARED FOR | Jill Hunter  
PREPARED BY |  
**Dr Matthew Laurence**  
BSc. (Hons)  
PhD (Plant Pathology)  
Grad Cert (Arboriculture)

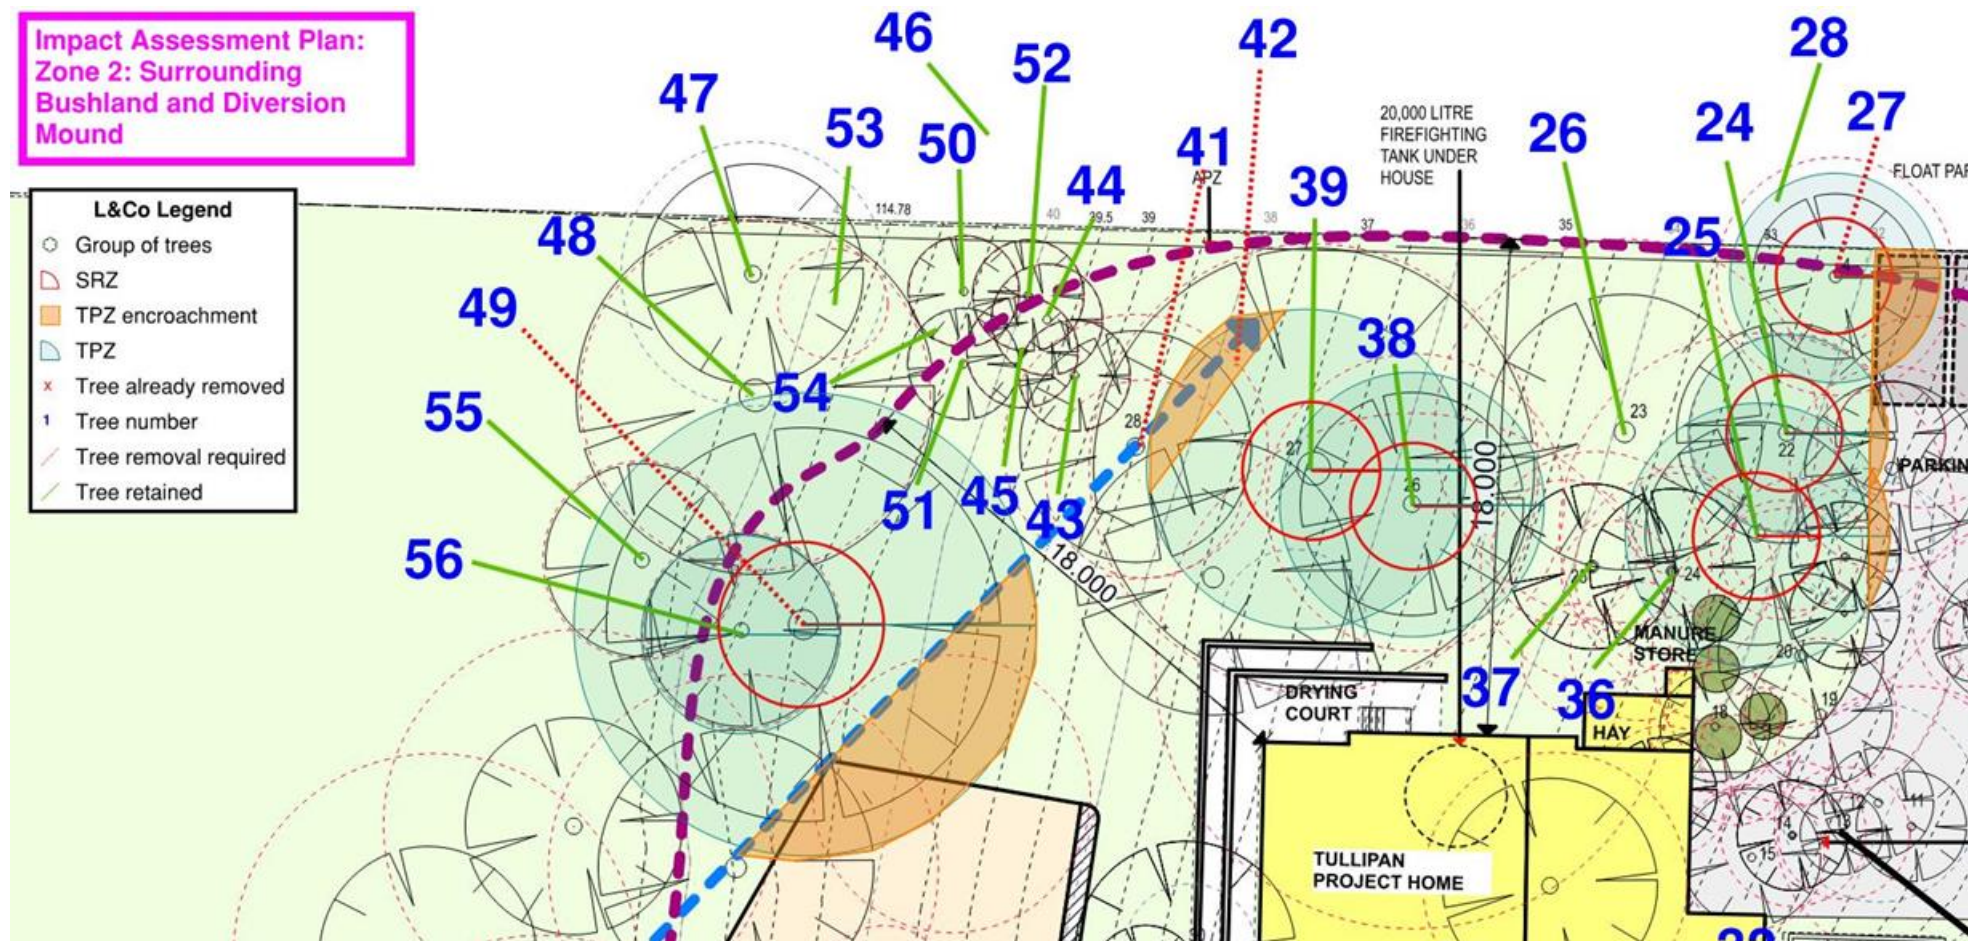
**Impact Assessment Plan:  
Zone 2: Surrounding  
Bushland and Diversion  
Mound**

- 4.9.2 The supplied plans show the proposed driveway and clean water diversion mound is within the TPZs of Trees 24, 25 & 39. The proposed TPZ encroachments are approximately 4.0%, 3.5% and 9.8%, respectively, which represent *Minor Encroachments* as defined by AS4970 and is considered acceptable by the standard when it is compensated for elsewhere and contiguous within the TPZ, as in the current cases. Given the good physiological condition of the trees and the size of the encroachments, the proposed development can be accommodated without affecting the long term structural and physiological viability of Trees 24, 25 & 39 if the following tree sensitive construction methods and protection measures are carefully implemented under the supervision of the Project Arborist.

- 4.10.2 The supplied plans show that Trees 41 & 42 are within the footprint of the proposed clean water diversion mound and will need to be removed.
- 4.10.3 Removal and replacement with healthy advanced size specimens would replace the loss of amenity within a short to medium timeframe.

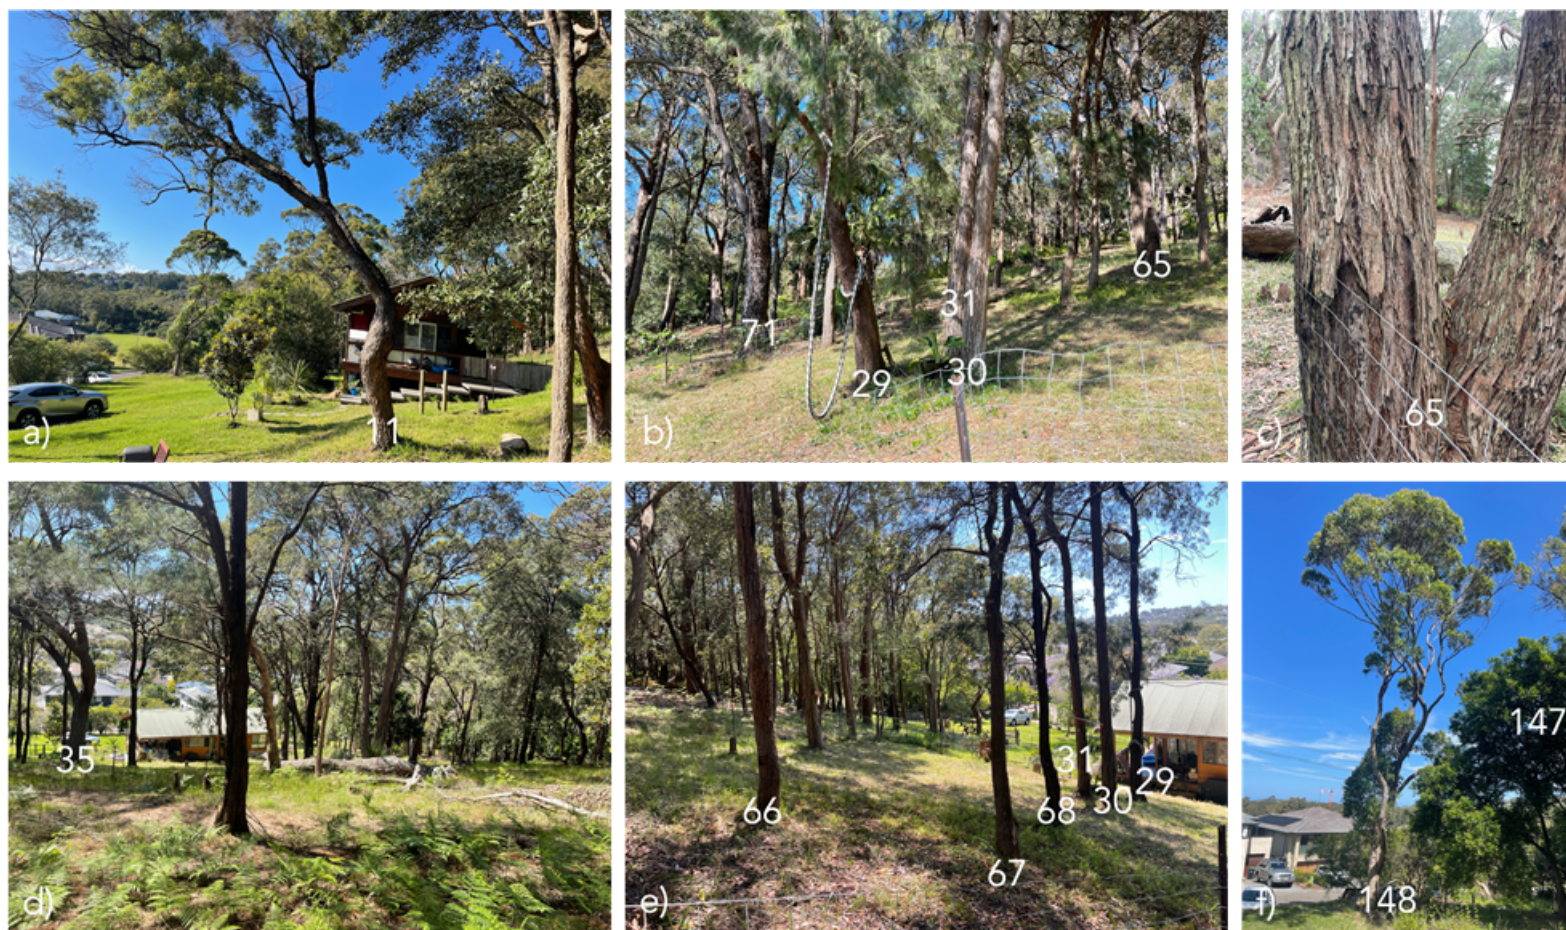
a) Showing Tree 11. b) Showing Trees 29, 30, 31, 65 & 71. c) Showing Tree 65 in conflict with fencing. d) Showing Tree 35. e) Showing Trees 29, 30, 31, 66, 67 & 68. f) Showing Trees 147 & 148.
