Our Reference AWG40793

No.7

Cooleena Road

Slope Stability Assessment

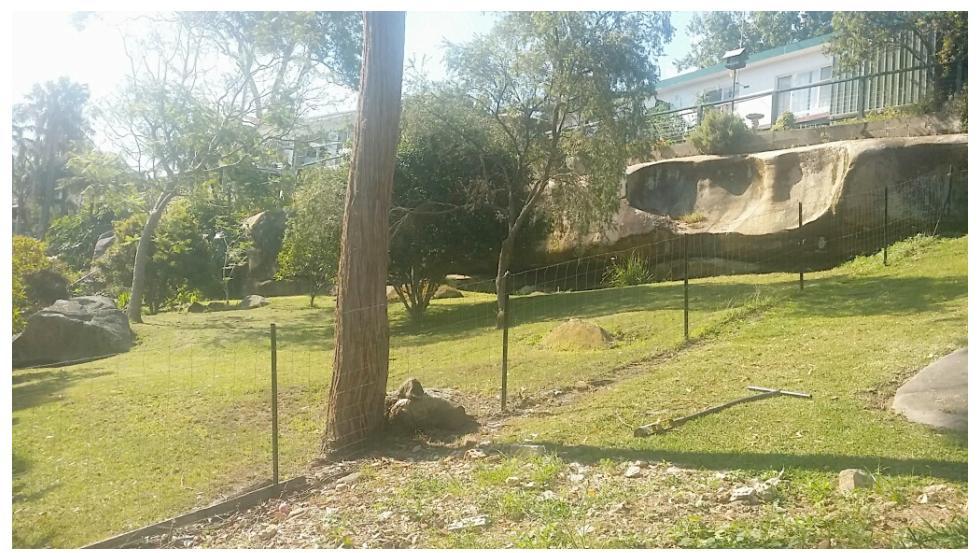
- 2.3. Just beyond the existing dwelling is a rock outcrop, which trends east-west and can be seen in the adjoining allotments.

Rock outcrop within adjoining western property

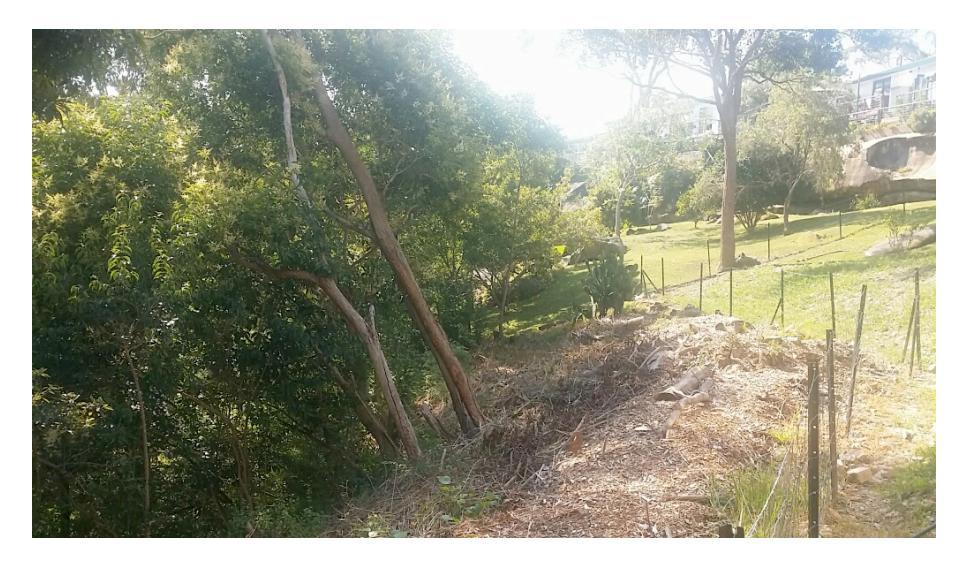
- 2.4. The existing ground slope in the area of the proposed building envelope varies from  $9-10^{\circ}$  in the east to  $19-20^{\circ}$  in the west (see attached site sketch).
- 2.5. Beyond this proposed building footprint is a break of slope, where the slope steepens to between  $25-30^{\circ}$ .
- 2.6. The vegetation around the existing dwelling is mainly trees, garden and grasses.
- 2.7. The vegetation in and around the proposed building footprint is mainly grasses, scattered trees and there is some rock outcropping.
- 2.8. On the steep slope at the rear, initially there are some small trees with very dense undergrowth, then further down the slope the vegetation has been cleared.
- 2.9. At the break of slope down to the steeper area at the rear is a fence and a crude surface drain/bund, which is obviously in place to capture and divert surface waters away from this steeper area.

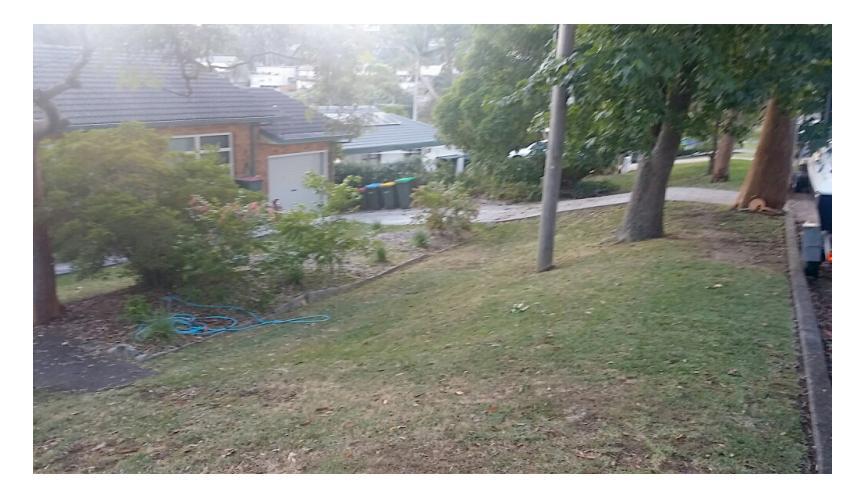
- 7.4. One could argue that random trees have been affected by soil creep during their lifespan such as this tree:

However there are other influences which can produce growth patterns like this.

7.5. Within the nearby surrounds of the proposed building envelope, the majority of trees appear unaffected by soil creep (particularly the older trees) whereas some of the younger trees do have non-vertical growth patterns.

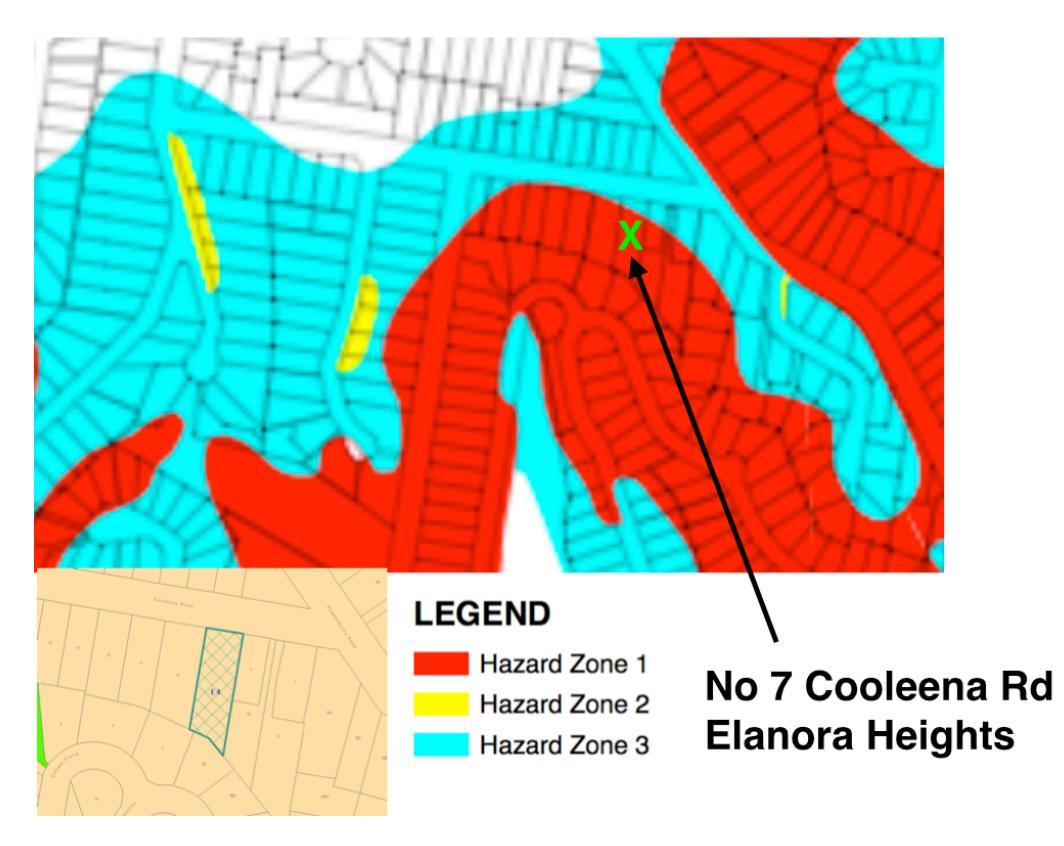
7.6.1 The Pittwater council have their own slope instability hazard maps, which have three(3) zones as follows;

7.6.2 The majority of this subject site plots within the Hazard Zone 1, and a local area at the front plots within Hazard Zone 3.
