## Arboricultural Impact Assessment

**Client Name:** Matthew Hambly  
**Site Address:** 19 Curl Curl Parade, Curl Curl, NSW  
**Authors Details:** Hugh Millington  
**Email:** [hugh@hughthearborist.com.au](mailto:hugh@hughthearborist.com.au)  
**Phone:** 0426836701  
**Date Prepared:** 19 November 2020

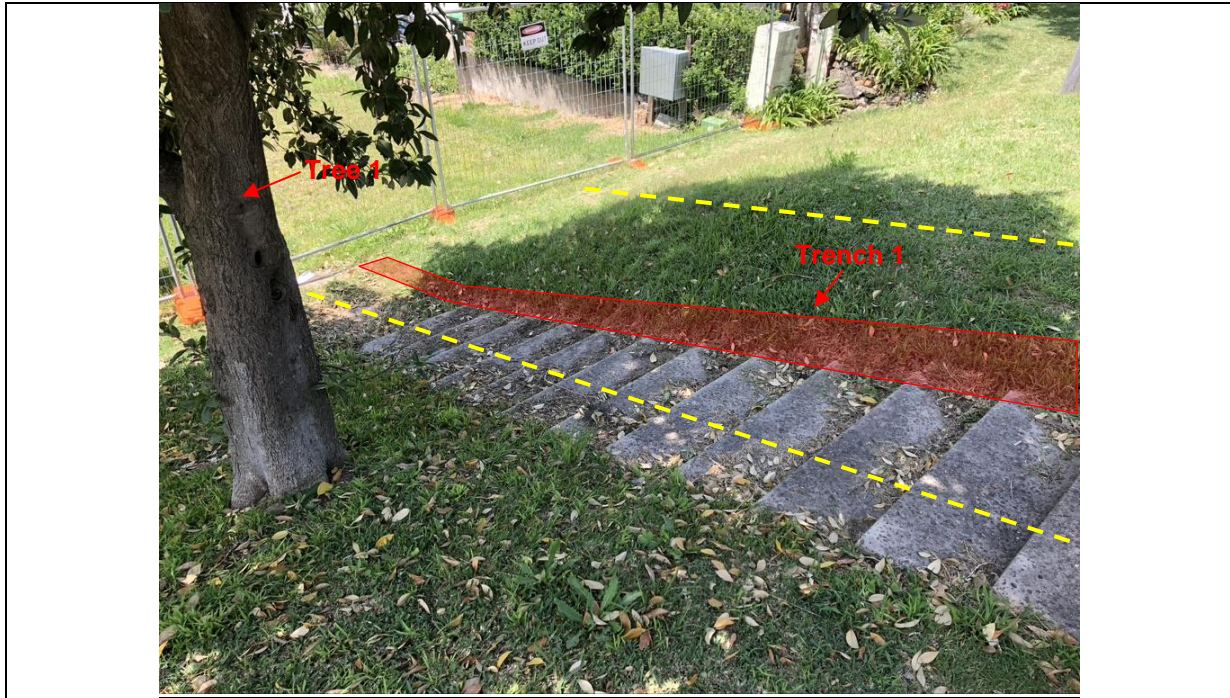
- 8.1.3 The existing concrete stair case appears to have restricted/limited all significant root growth to the East where the driveway crossover is proposed. This indicates the proposed driveway crossover will not significantly impact the condition or stability of the tree.

**Image 1:** Looking North East towards tree 1. Showing the approximate location of the proposed driveway crossover (area between the yellow dashed lines) and the location of the root investigation trench (red hatched area). The root investigation trench could not be excavated along the closest line of the proposed driveway due to the existing concrete stair case.

- 8.1.4 To ensure the tree is not significantly impacted by the proposed development, the footings of the proposed driveway crossover must not exceed the depth of the base of the existing concrete stair case. Alternatively, the existing concrete stair case could be retained and used as a footing for the retaining wall/edge of the proposed driveway crossover. It must be demonstrated that these recommendations can be followed whilst being in accordance with all other non-tree related legislation and requirements.

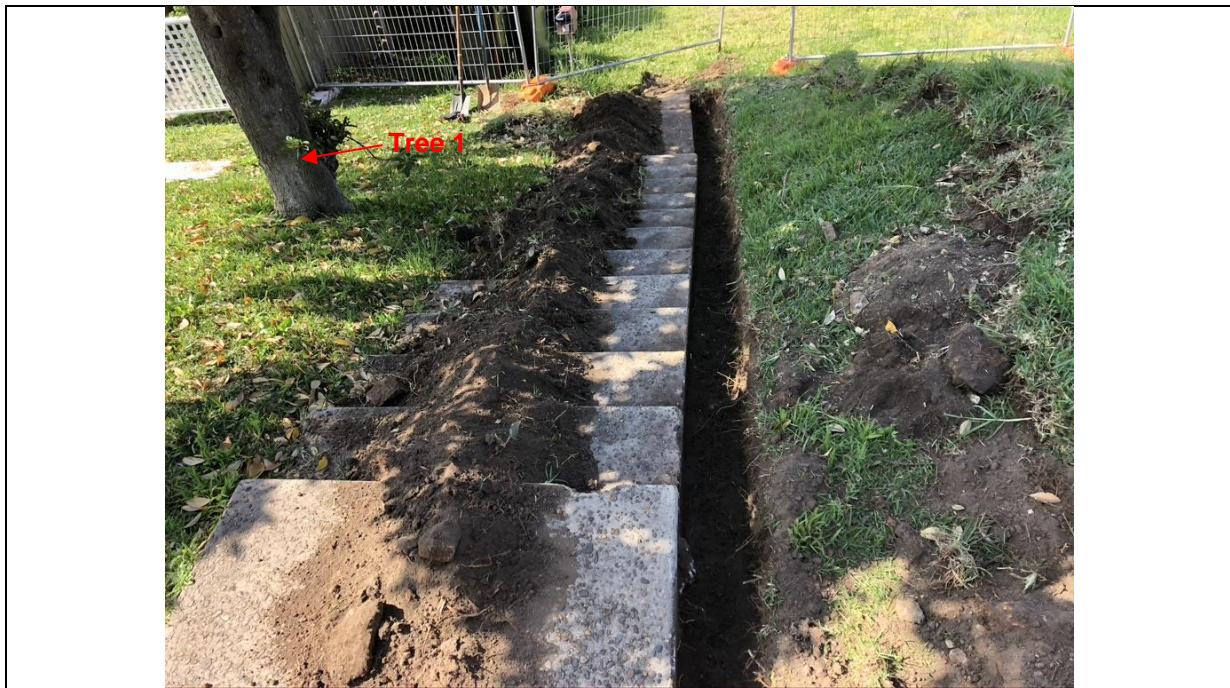
**Image 2:** Looking North along the root investigations. No significant roots identified.

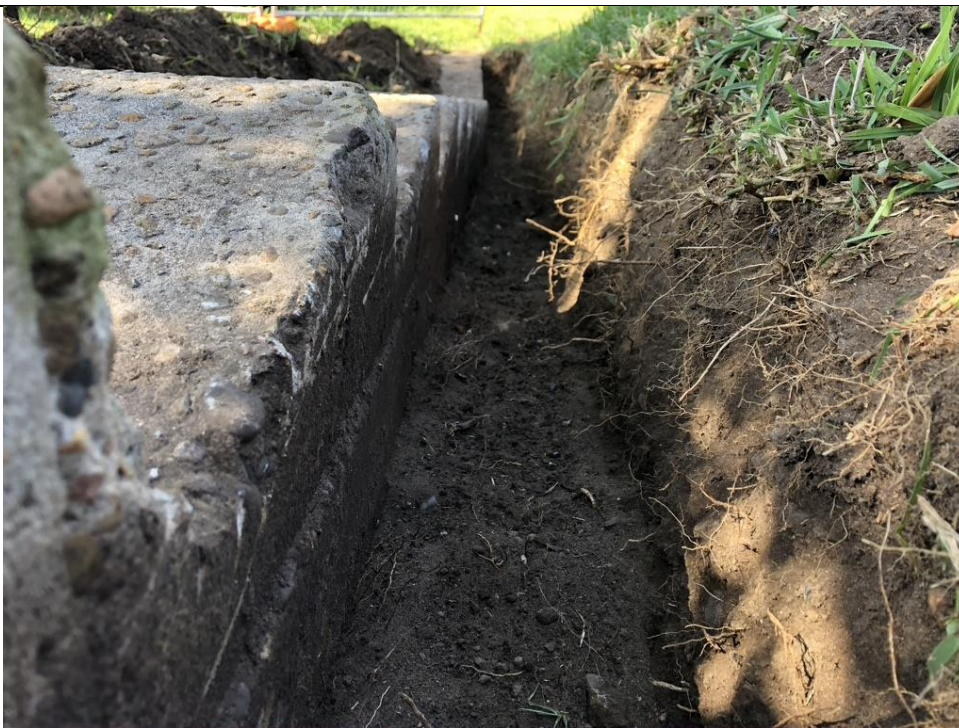
**Image 3:** Looking North within the root investigation trench. No significant roots identified.

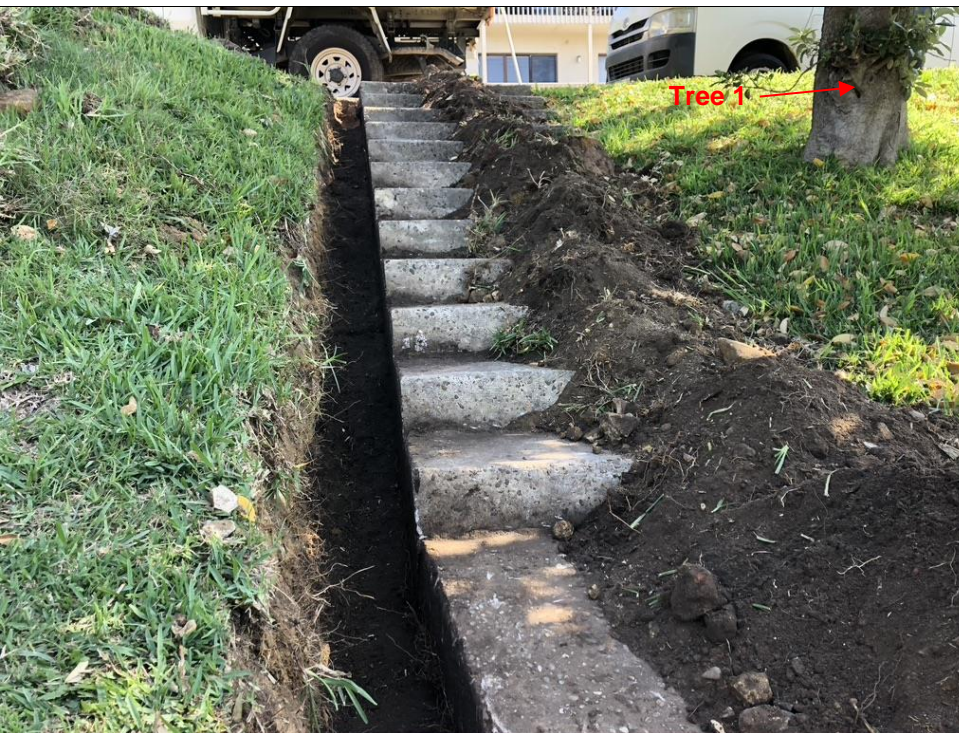
**Image 4:** Looking South along the root investigations. No significant roots identified.

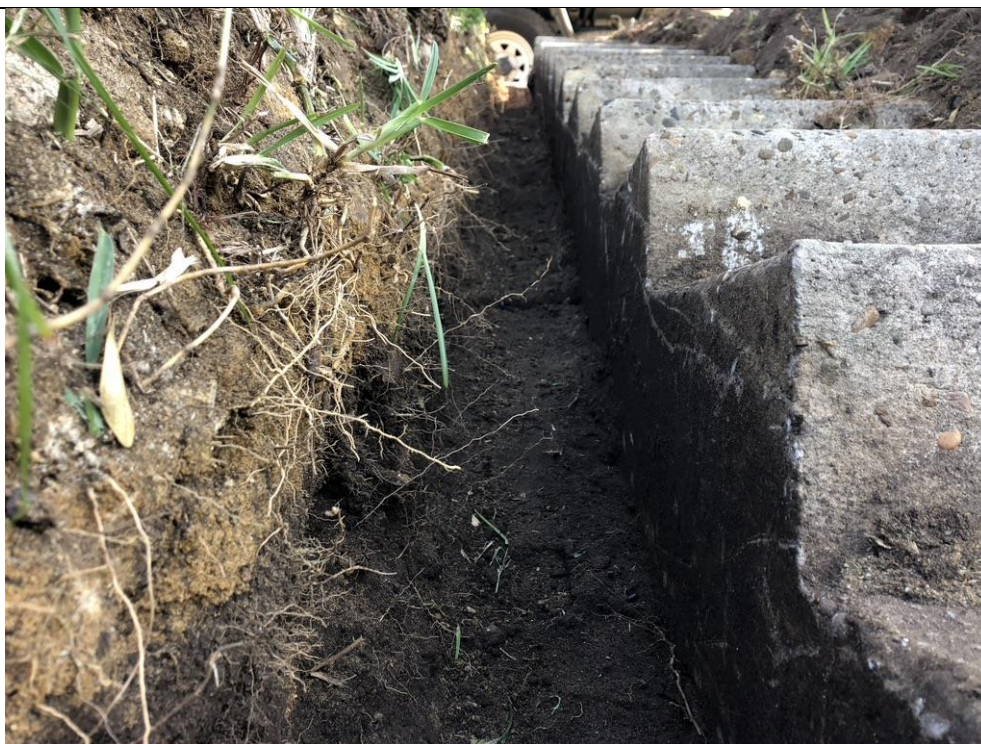
**Image 5:** Looking South within the root investigation trench. No significant roots identified.
