Construction Impact & Management Statement for soon to be Lodged Development Application

September 2019, updated April 2020

Site: Lot 1 in DP 308956
34 Hudson Parade
AVALON BEACH, NSW

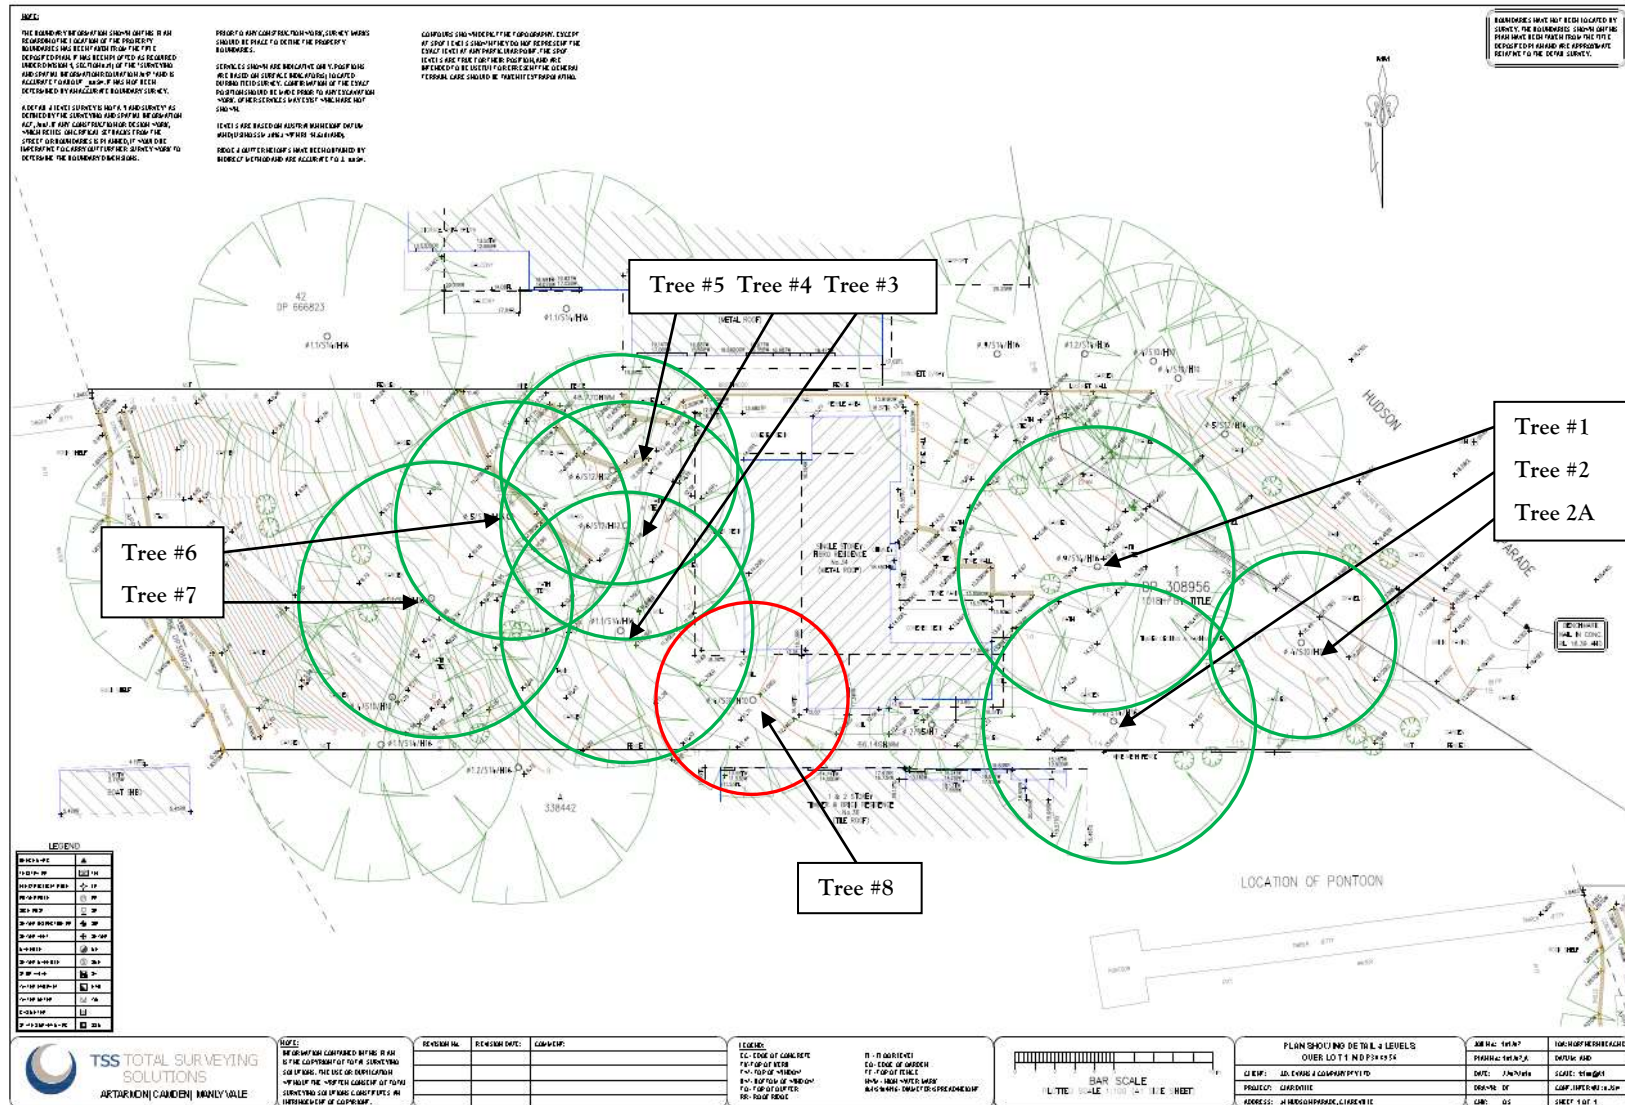
Figure 4: Site Survey with discussed tree locations plotted.

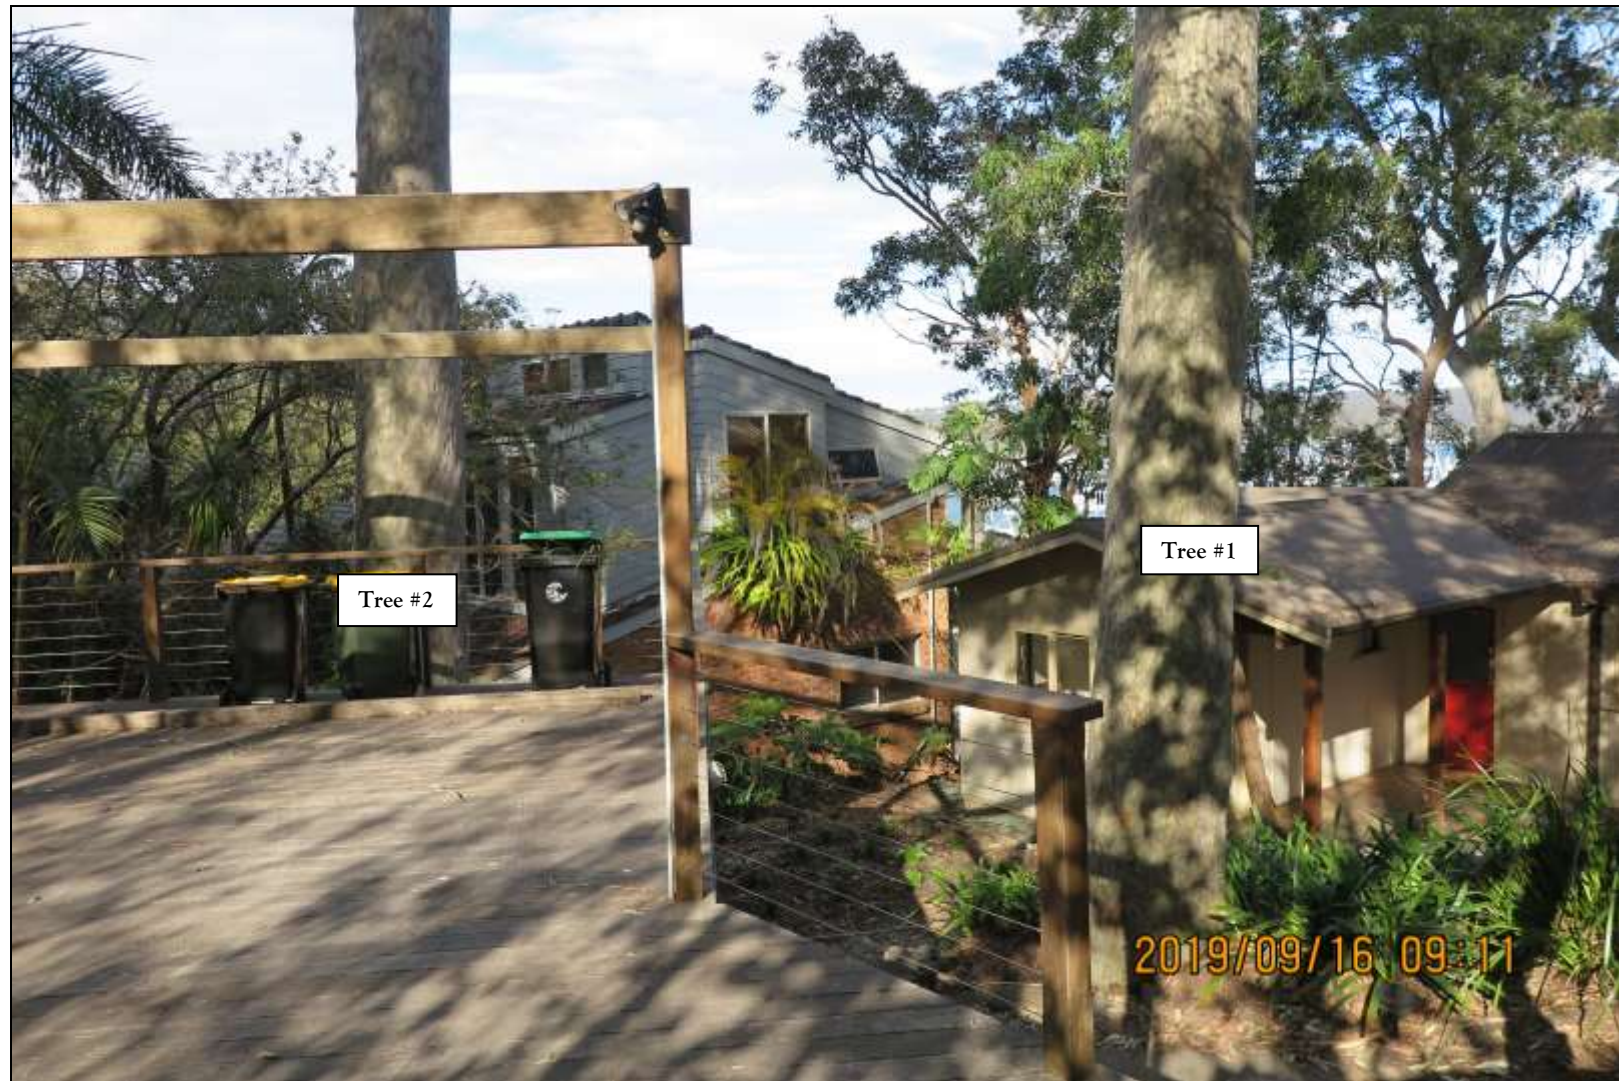
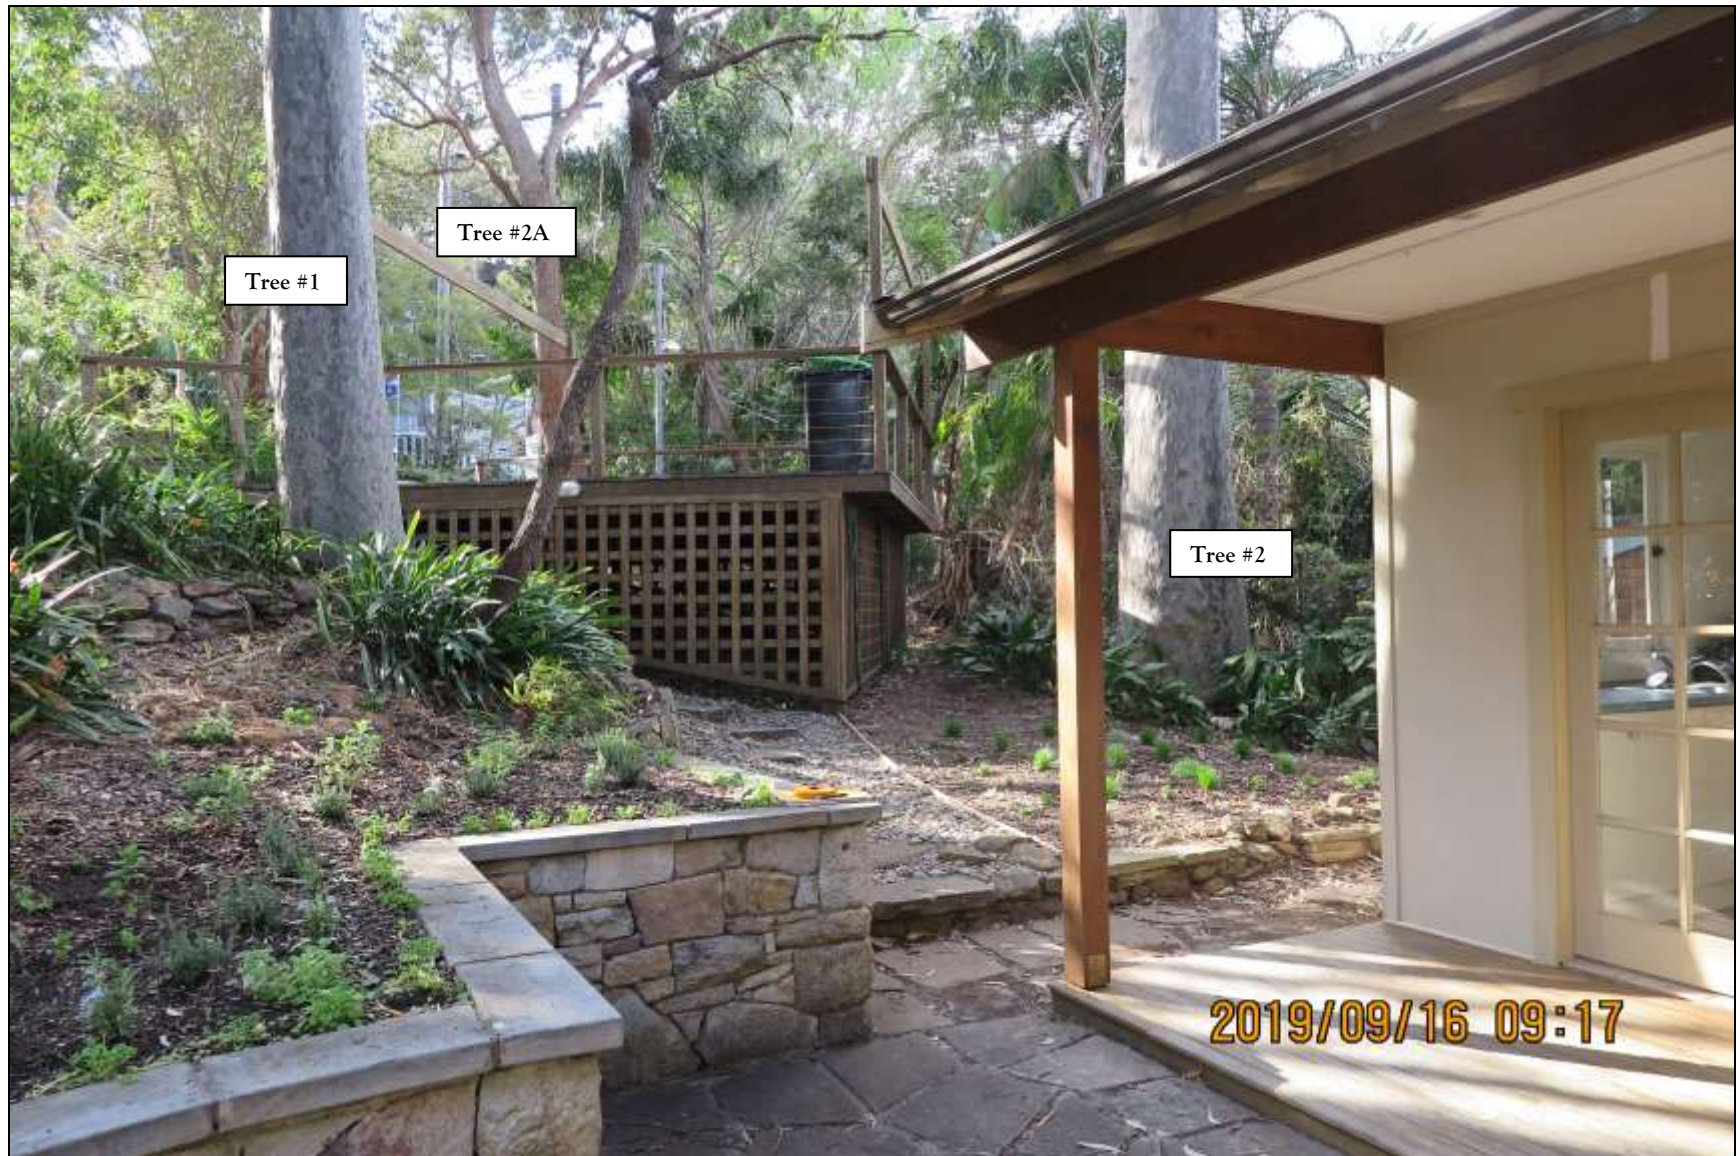
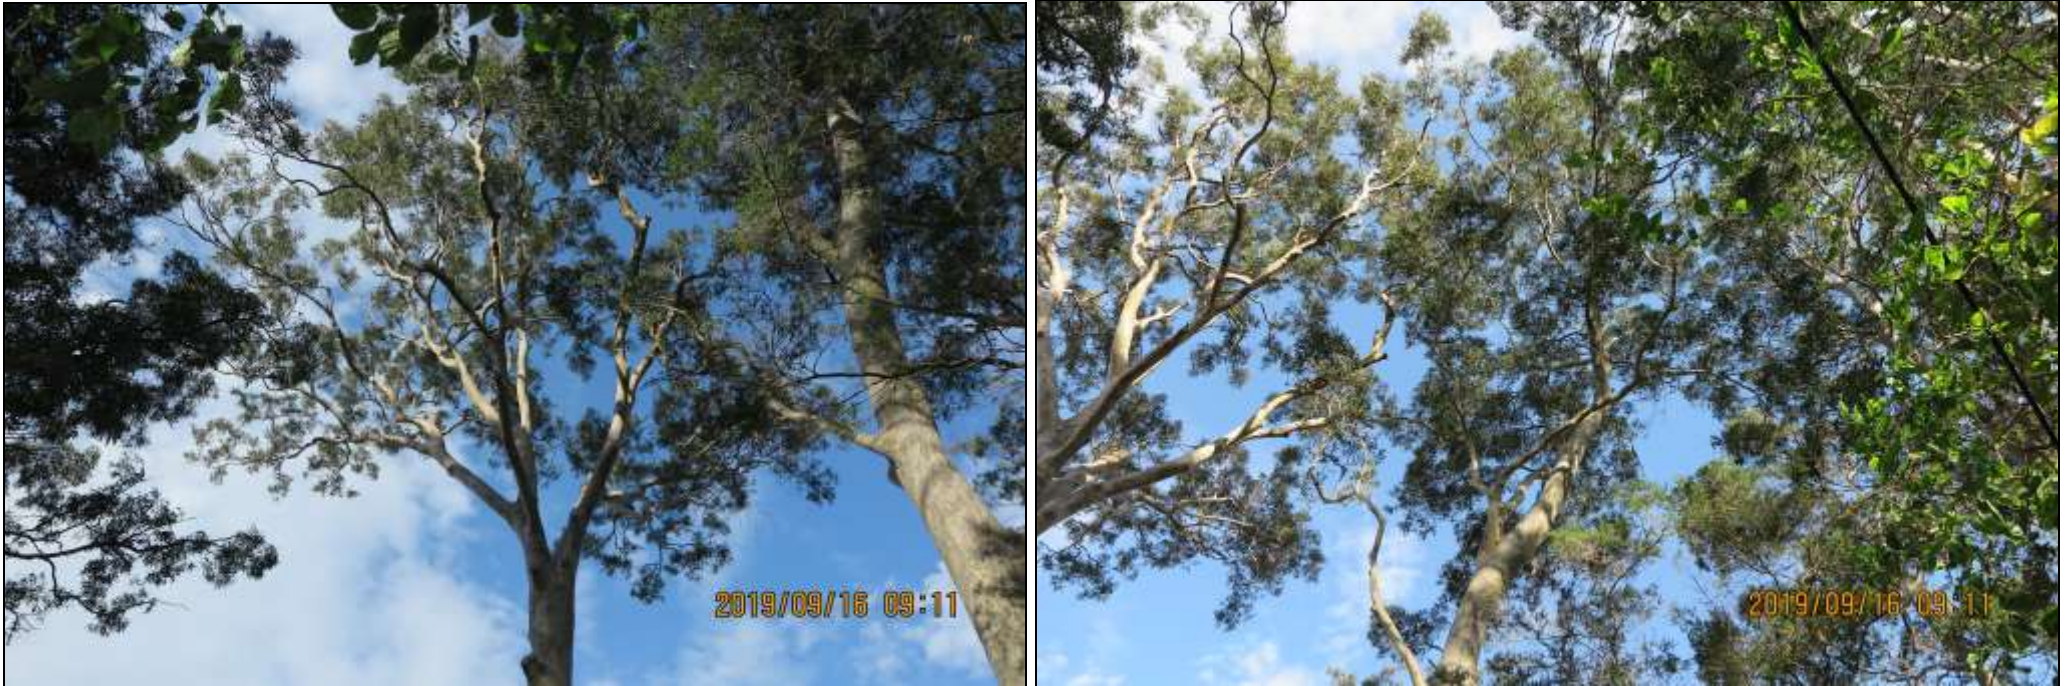
Figure 6: Confirms the location & canopies for Tree #1 & Tree #2.

TREE #1: As can be seen on pages 14 thru 16 photographs, this tree is deemed to be of good health & good vigour. Simply, to maintain its *Useful Life Expectancy* (from herein ULE) & retention & significance values any ground level disturbance must be manually excavated to support 'flexibly located footings/piers so as to avoid damage to any significant diameter 'live woody tree roots. The reason for the below specification is to not adversely impact upon the root system or the total tree natural ULE.

TREE #2: As can be seen on pages 14 thru 16 photographs, this tree is deemed to be of good health & good vigour. Simply, to maintain its ULE, retention & significance values any ground level disturbance must be manually excavated to support 'flexibly located footings/piers so as to avoid damage to any significant diameter 'live woody tree roots. The reason for the below specification is to not adversely impact upon the root system or the total tree natural ULE.

The tree will be specified to have 'temporary metal mesh' isolation fencing installed as far away from the tree trunk as site/proposed built form will allow. Additionally, as the new proposed garage/home office will be suspended over its Structural Root Zone (from herein SRZ) radial distance of 3.04m a 'Tree Trunk Guard' to a minimum height of 5.00m is specified as the TPZ/STZ areas will need to be breached until the proposed structure is well out of the ground.

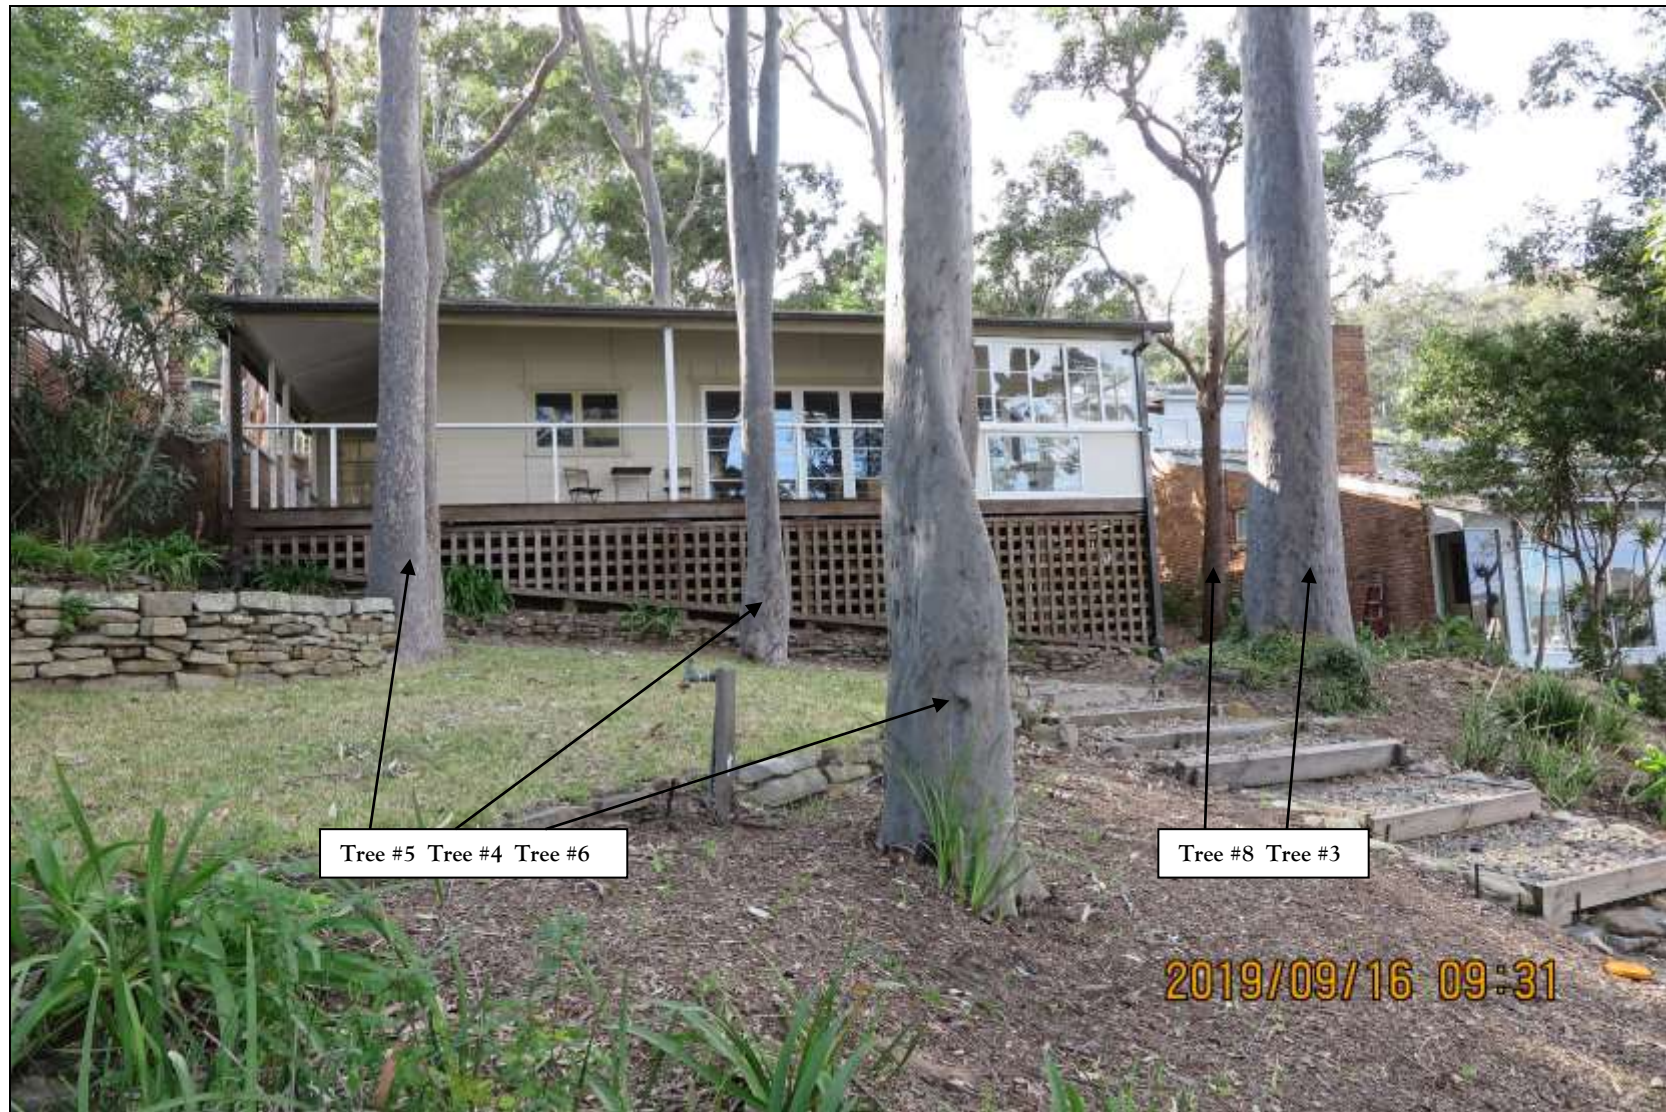
Figure 7: Illustrates waterfront yard trees discussed with the exception of Tree #7.

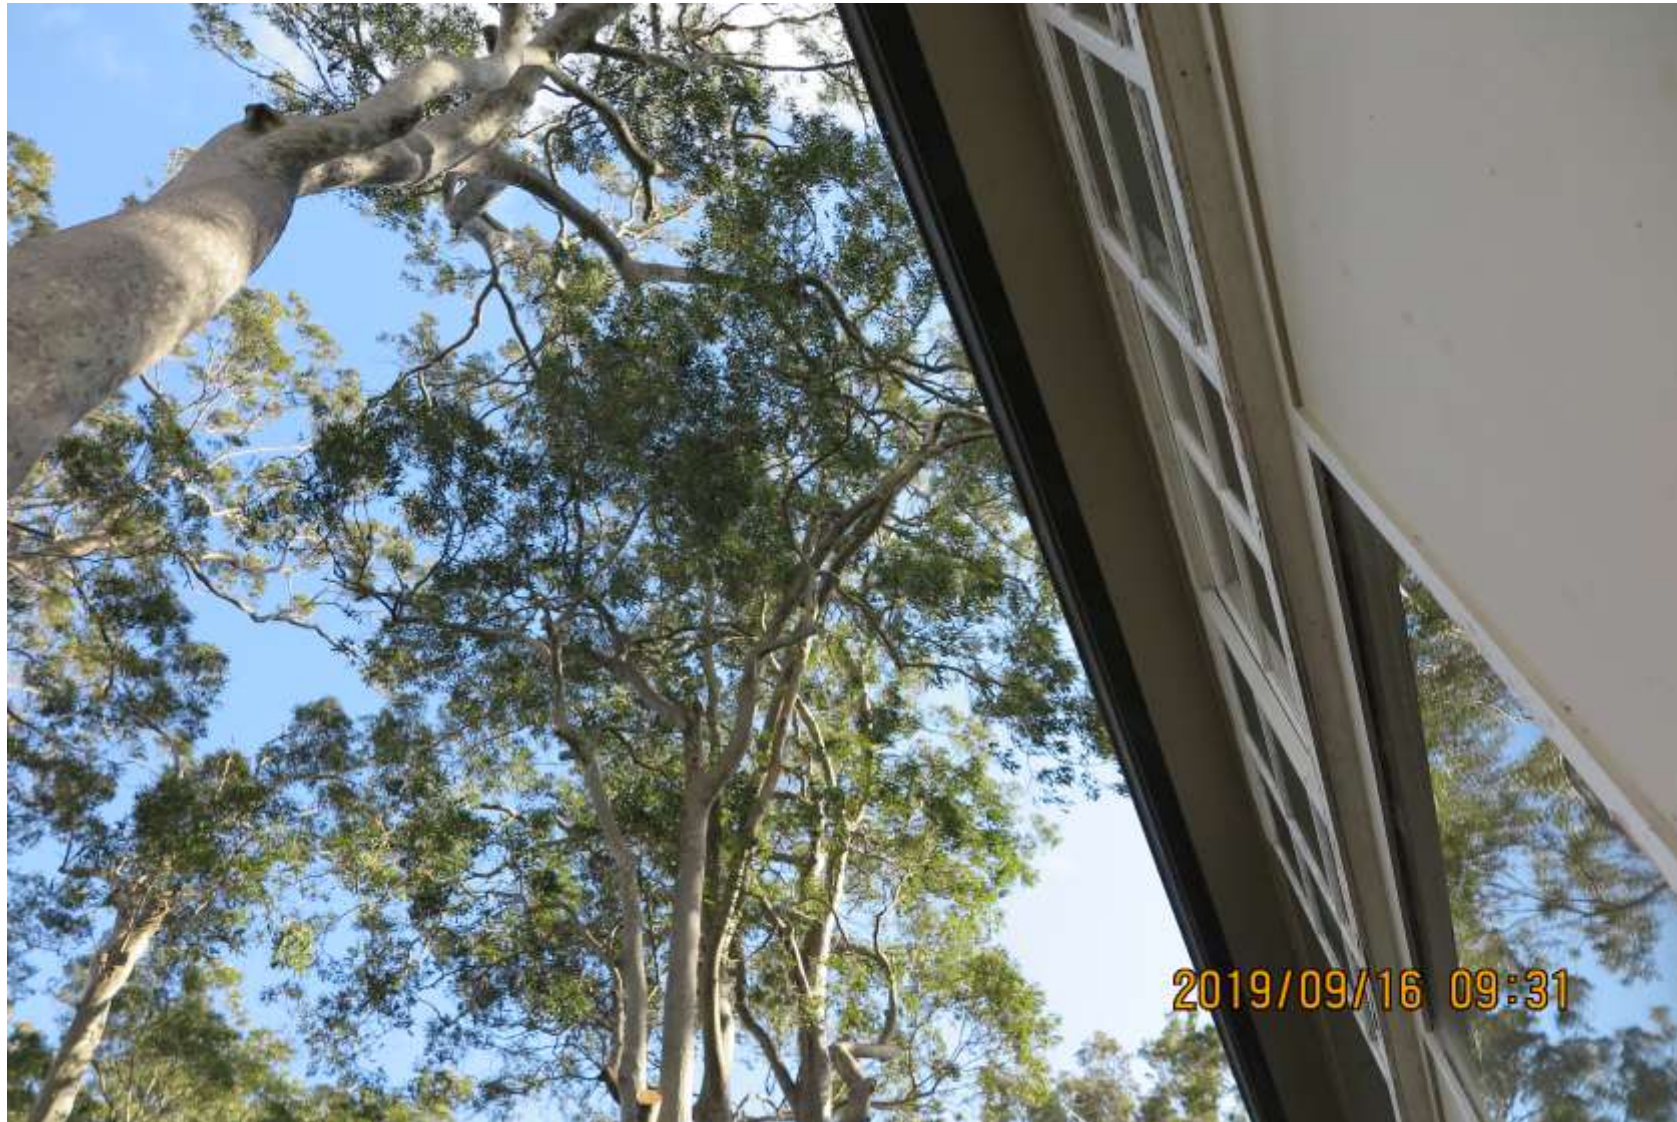
Figure 8: Illustrates canopies of discussed Tree #3, Tree #4 & Tree #5.

TREE #3: As can be seen on page 17 photograph, this tree is deemed to be of good health & good vigour. Simply, to maintain its *ULE*, retention & significance values any ground level disturbance must be manually excavated to support with 'flexibly located footings/piers so as to avoid damage to any significant diameter 'live woody tree roots. The reason for the below specification is to not adversely impact upon the root system or the total tree natural *ULE*.

TREE #4: As can be seen on pages 17 & 18 photographs, this tree is deemed to be of fair health & fair vigour. Simply, to maintain its *ULE*, retention & significance values any ground level disturbance must be manually excavated to support 'flexibly located footings/piers so as to avoid damage to any significant diameter 'live woody tree roots. The reason for the below specification is to not adversely impact upon the root system or the total tree natural *ULE*.

TREE #5: As can be seen on pages 17 & 18 photographs, this tree is deemed to be of good health & good vigour. Simply, to maintain its *ULE*, retention & significance values any ground level disturbance must be manually excavated to support 'flexibly located footings/piers so as to avoid damage to any significant diameter 'live woody tree roots. The reason for the below specification is to not adversely impact upon the root system or the total tree natural *ULE*.

Additionally, the tree will be specified to have a 'tree trunk guard' installed around its trunk to a minimum height of 4:50m as is impractical to install 'temporary metal mesh fencing' relative to the required access for the builders.

Additionally, the tree will be specified to have a 'tree trunk guard' as the proposed new deck/stairs are suspended over its Structural Root Zone (from herein SRZ) radial distance of 2.37m.

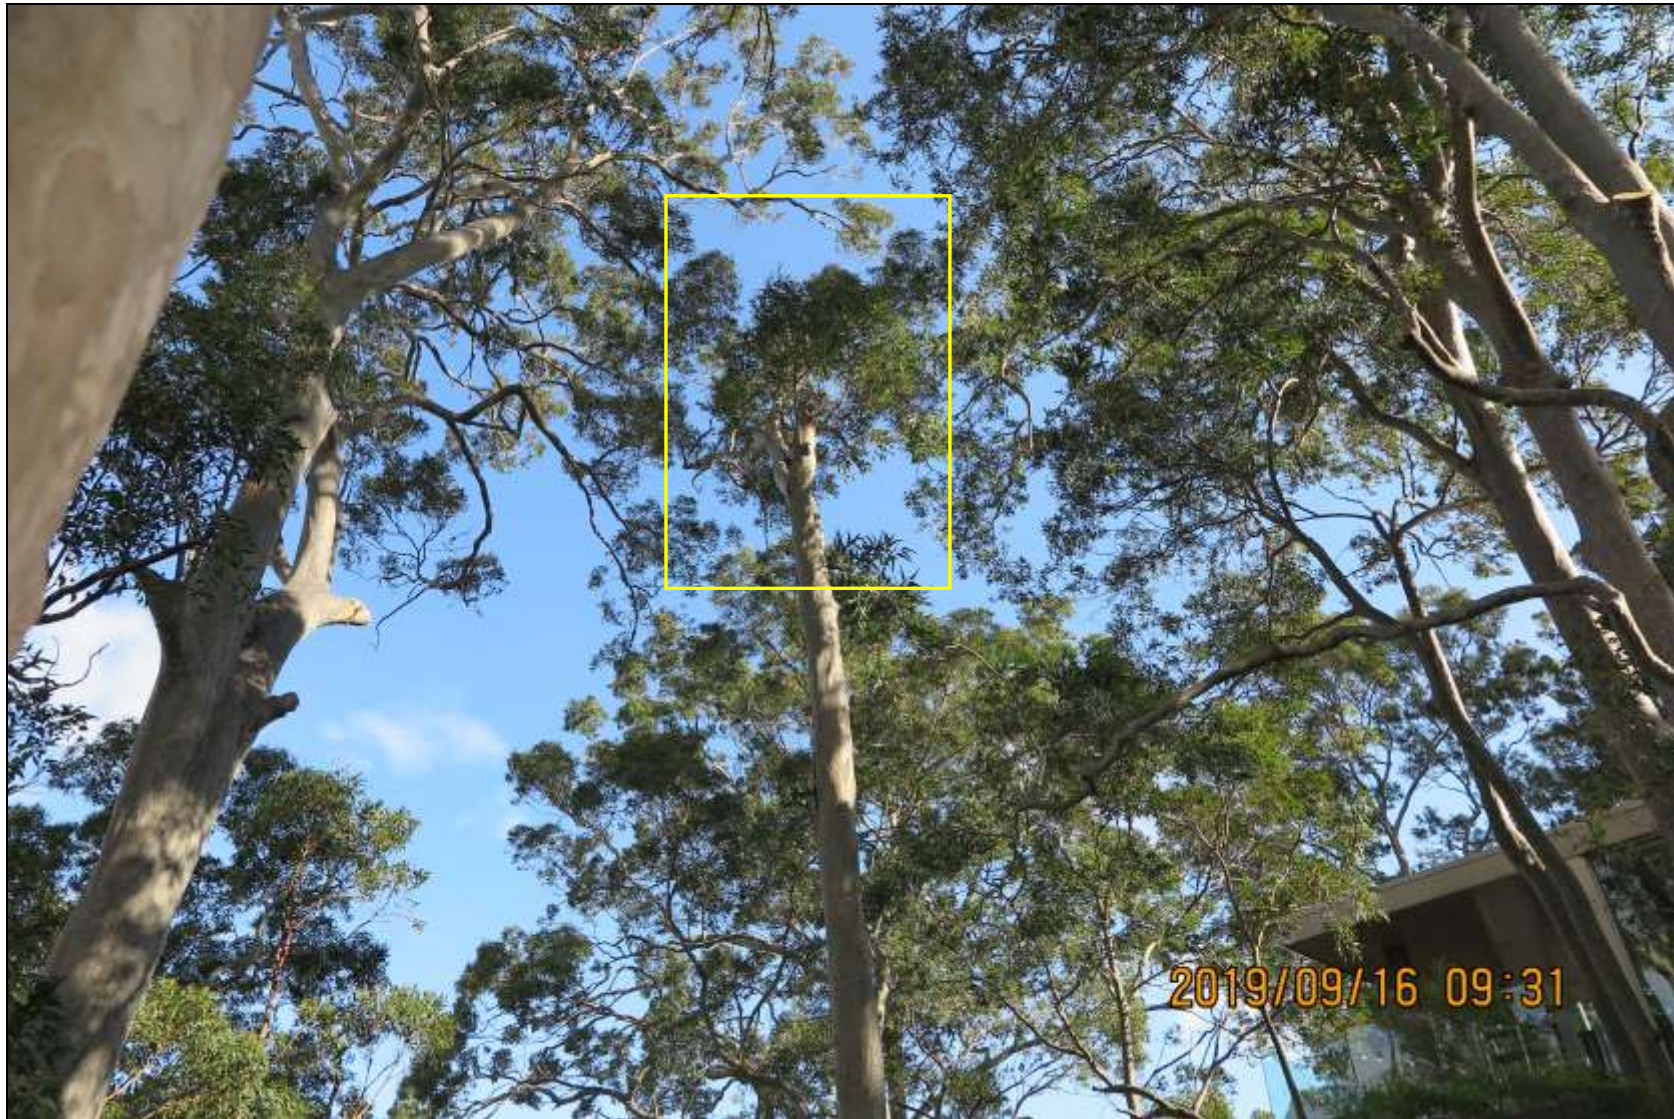
Figure 9: Confirms the canopy condition for discussed Tree #6.

TREE #6: As can be seen on page 19 photograph, this tree is deemed to be of fair health & fair vigour. Simply, to maintain its *ULE*, retention & significance values any ground level disturbance must be manually excavated to support 'flexibly located footings/piers so as to avoid damage to any significant diameter 'live woody tree roots. The reason for the below specification is to not adversely impact upon the root system or the total tree natural *ULE*.

Additionally, the tree will be specified to have a 'tree trunk guard' as the proposed new deck/stairs are suspended over its Structural Root Zone (from herein SRZ) radial distance of 2.63m.

The existing ground level within the retained tree's calculated TPZ radial distance (5.76m) must be covered & maintained throughout the project with a 'native mulch' that comprises both woody & foliage components. The mulch at all times must be between 50mm & 75mm thick. Water applications in the absence of natural rainfall events is essential & is to be applied in compliance with at time of construction processes "Water Restrictions" status.

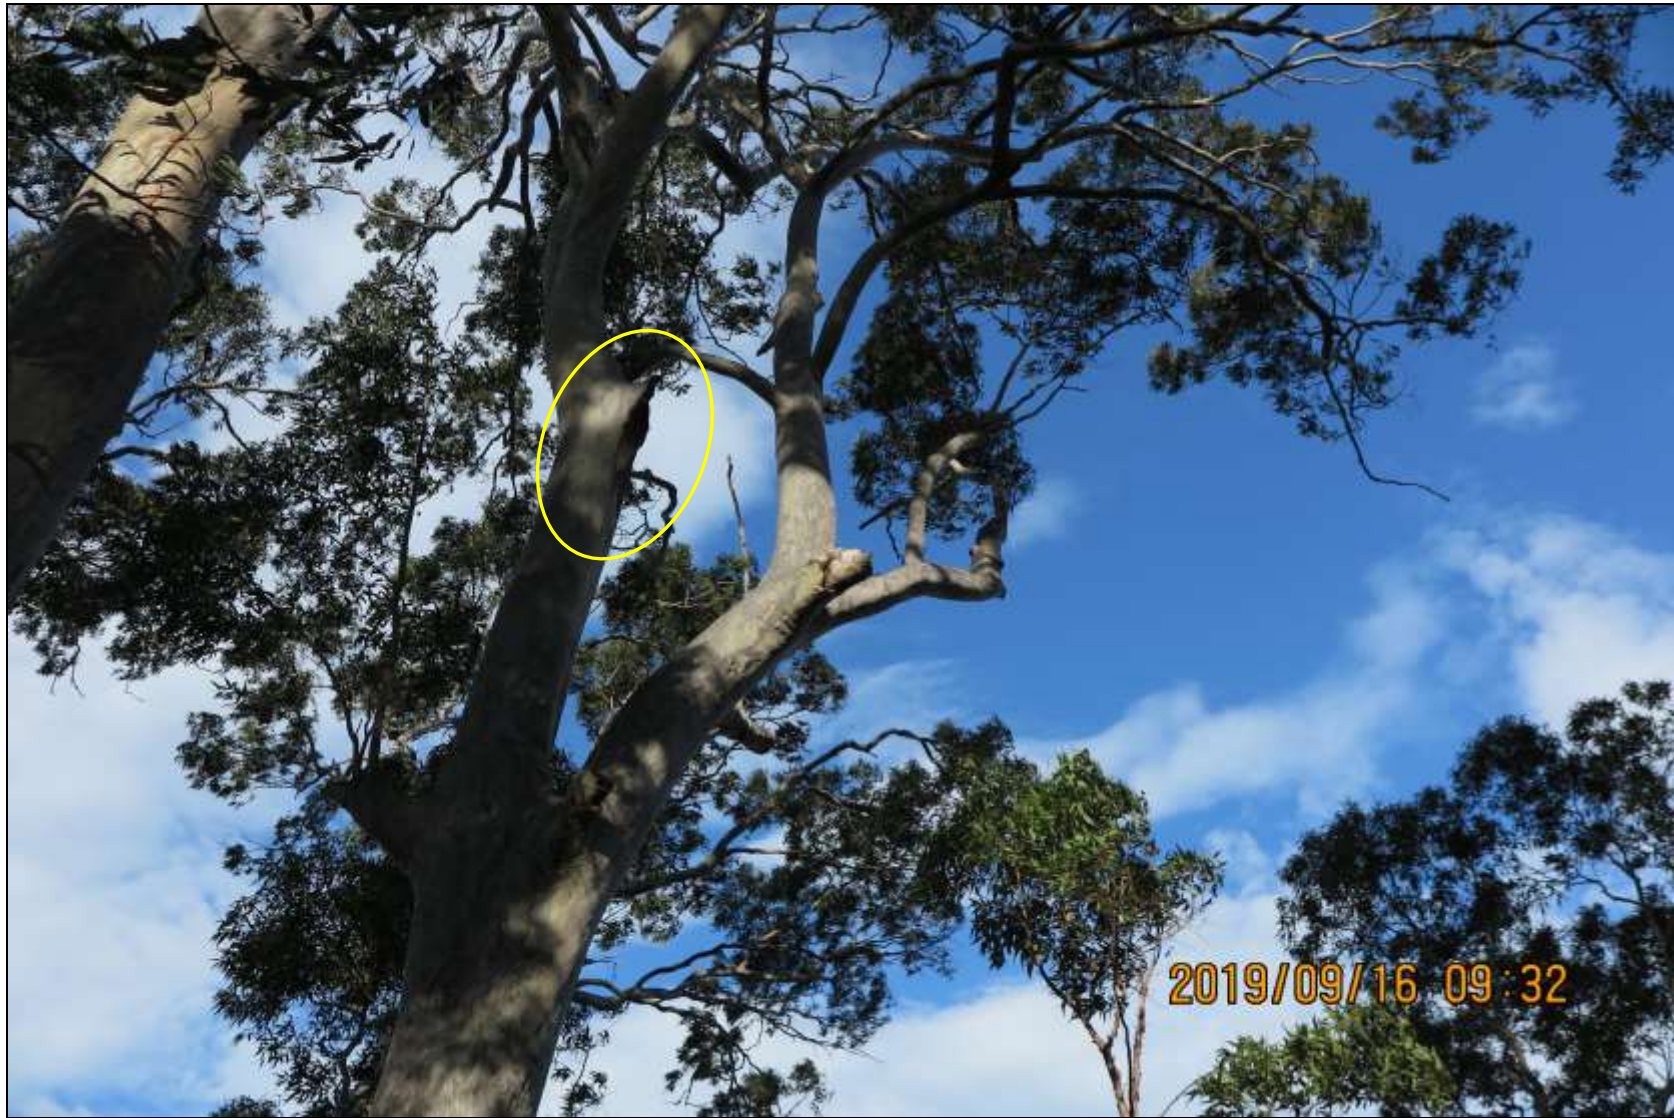
Figure 10: Illustrates the defects (dead/dying branches/stubs) plus site of recent large diameter 'live branch failure' (Yellow Circle) for Tree #7.

TREE #7: As can be seen on page 20 photograph, this tree is deemed to be of fair health & fair vigour. Simply, to maintain its *ULE*, retention & significance values any ground level disturbance must be manually excavated to support 'flexibly located footings/piers so as to avoid damage to any significant diameter 'live woody tree roots. The reason for the below specification is to not adversely impact upon the root system or the total tree natural *ULE*.

Additionally, the tree will be specified to have a 'tree trunk guard' as the proposed new deck/stairs are suspended over its Structural Root Zone (from herein SRZ) radial distance of 3.44m.

The existing ground level within the retained tree's calculated TPZ radial distance (11.16m) must be covered & maintained throughout the project with a 'native mulch' that comprises both woody & foliage components. The mulch at all times must be between 50mm & 75mm thick. Water applications in the absence of natural rainfall events is essential & is to be applied in compliance with at time of construction processes "Water Restrictions" status.

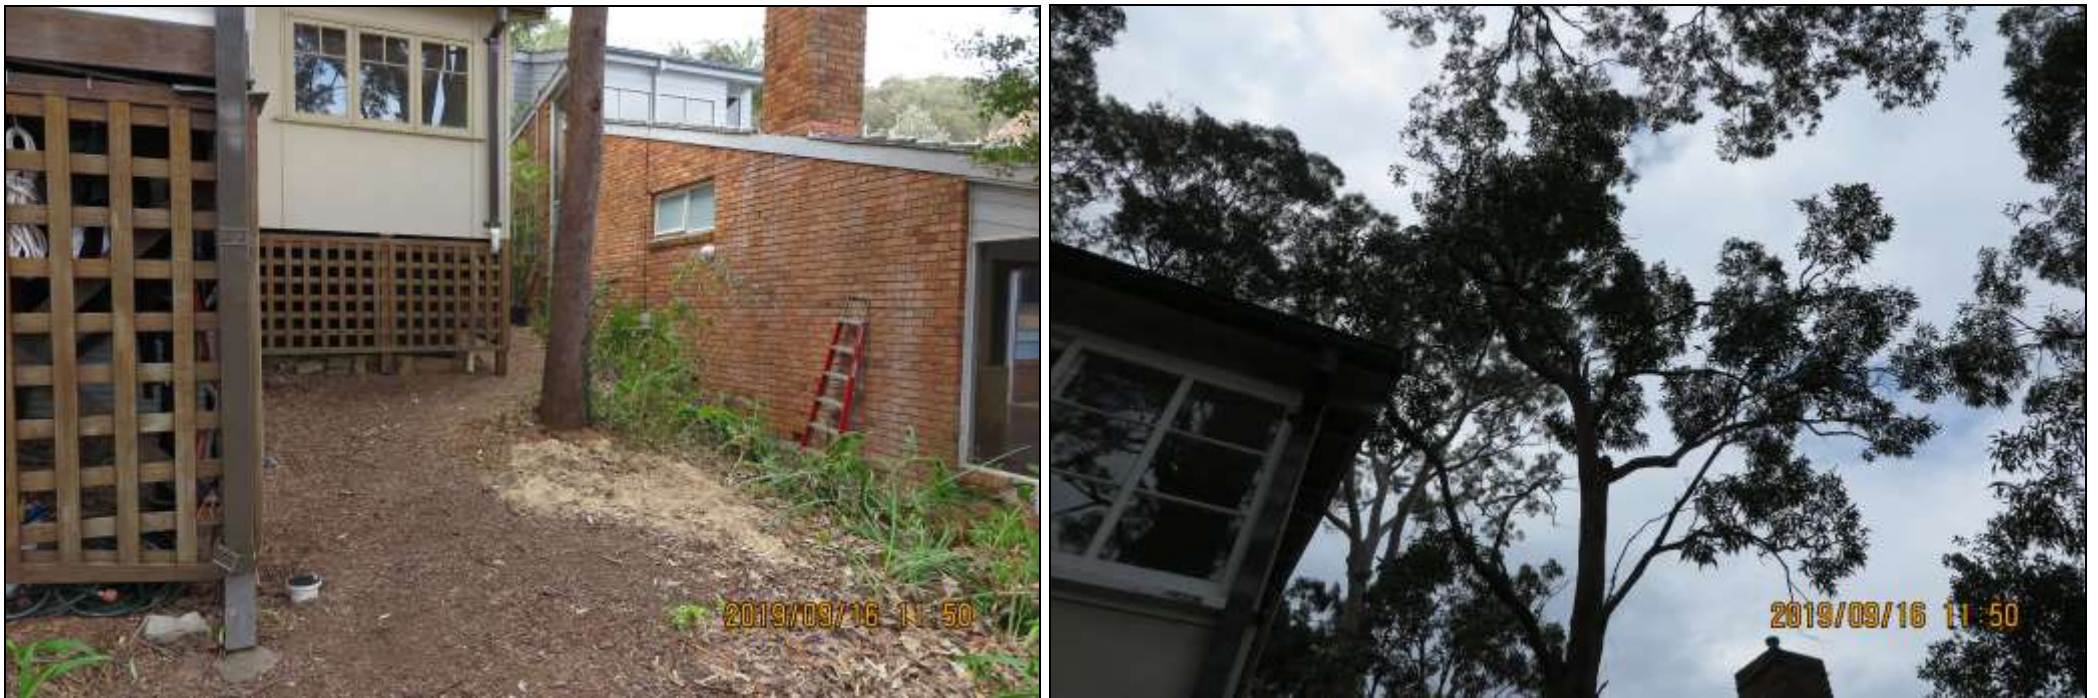
Figure 11: Illustrates the location & canopy condition for Tree #8.

8	<i>Eucalyptus</i> spp. (likely <i>E. acmenoides</i>) White Mahogany Gum	<10.50	<5.50	0.33	3.96	2.23	M	Fair & Fair	Typical	Atypical, Appears suppressed by competition for solar access.	<u>Remove & Replace:</u> The tree is within the proposed footprint of an additional room to be added to the south west corner of the residence dwelling.

TREE #8: Remove & Replace. This tree is located where the proposed existing residence main floor & lower floor areas are to have new verandas constructed.
