Construction Impact Assessment and Management Plan

7 Rock Bath Road, Palm Beach

Prepared for: Dylan Ferrell Design **Prepared by:** George Palmer

Dated: December, 2018

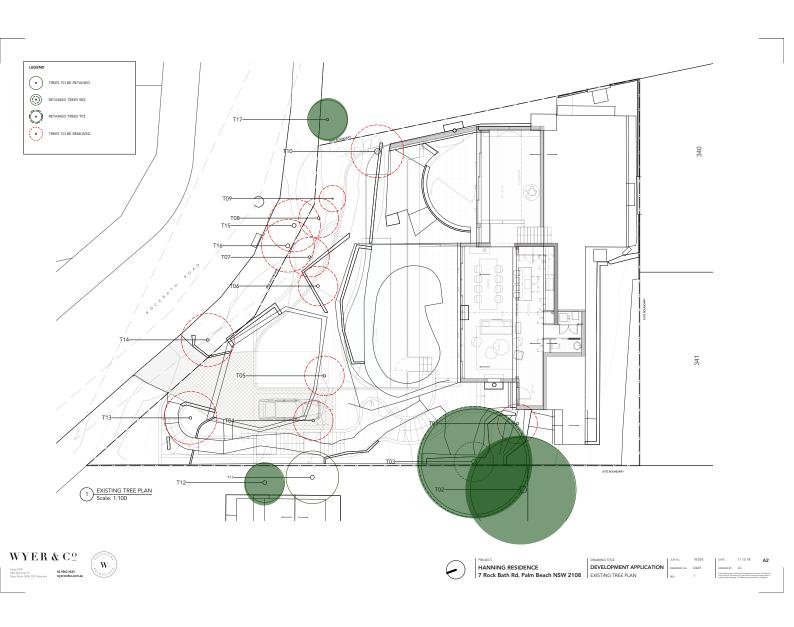
Figure 1 Shows the locations of the documented trees in relation to the proposed development and the TPZ required for ongoing consideration.

- 8.3 All Tree Protection Zones as outlined in **Figure 1** will need to be recognised and all works with them done in accordance with AS4970 Standards for the Protection of Trees on Development Sites.

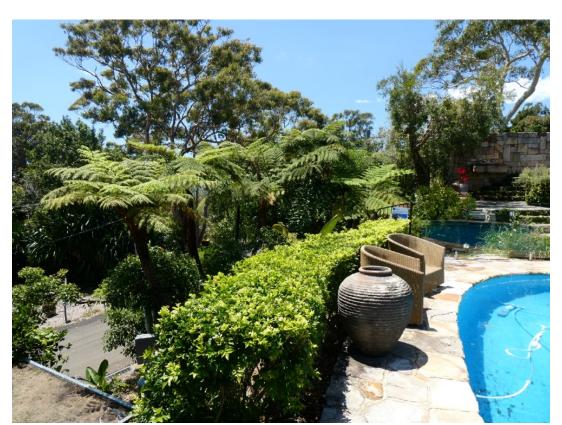
- 5.3 There is a stand of well established *Cyathea cooperi*, or Australian tree ferns (Trees 4, 5, 6, 7 and 8) located between the rear of the carport and the swimming pool. These appear to be in both good health and condition, clearly benefiting from high soil moisture levels and an impermeable, underground bedrock.

- 6.5 Trees 4, 5, 6, 7 and 8 are all Cyathea cooperi, or Australian Tree ferns located between the rear of the carport and the northern edge of the swimming pool. These are all well established, semi mature examples of the species.

Figure 2 Shows the existing pool and the tree ferns required for removal.

- 7.1 The proposed works will involve the excavation of the front portion of the site to allow for the construction. This will require the removal of those trees located here. This includes the *Cyathea cooperi*, or Tree frees detailed as Trees 4, 5, 6, 7 and 8.
- 7.2 Additional trees recommend for removal include the Port Wine Magnolia documented as Tree 1. This is less than 5m in height and has a history of poor pruning affecting its amenity contribution. The tree is also out of context in this landscape setting.

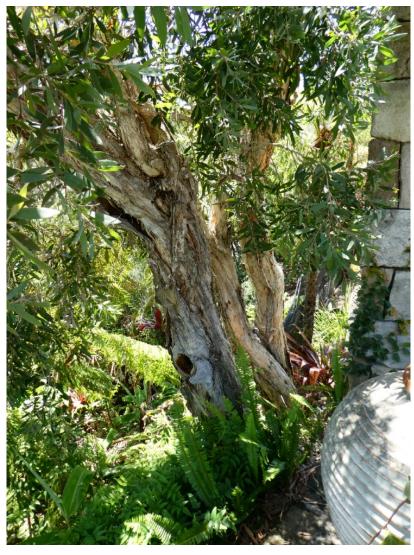
- 6.7 Trees 10 and 17 are both *Melaleuca quinquenervia*, or Paperbark trees located within the front garden. These are a native tree species that will have been planted here as part of the early landscape works that will have occurred following this portion of the construction. As noted, both have been reduction pruned, or "lopped" to maintain visual access to Palm Beach and the ocean.

Figure 3 Shows the poor basal structure of the Melaleuca documented as Tree 10.

- 8.1 It will be recommended that Trees 1, 4, 5, 6, 7, 8, 9, 10, 13 and 14 be removed for the reasons outlined. This should be done in accordance with WorkCover Standards http://www.safework.nsw.gov.au/ data/assets/pdf_file/0009/52866/
 Amenity-Tree-Industry-Code-of-Practice.pdf. following formal approval from Northern Beaches Council.
