### Re: EXISTING FAÇADE. 17-19 SYDNEY ROAD, MANLY.

### **1.0 INTRODUCTION.**

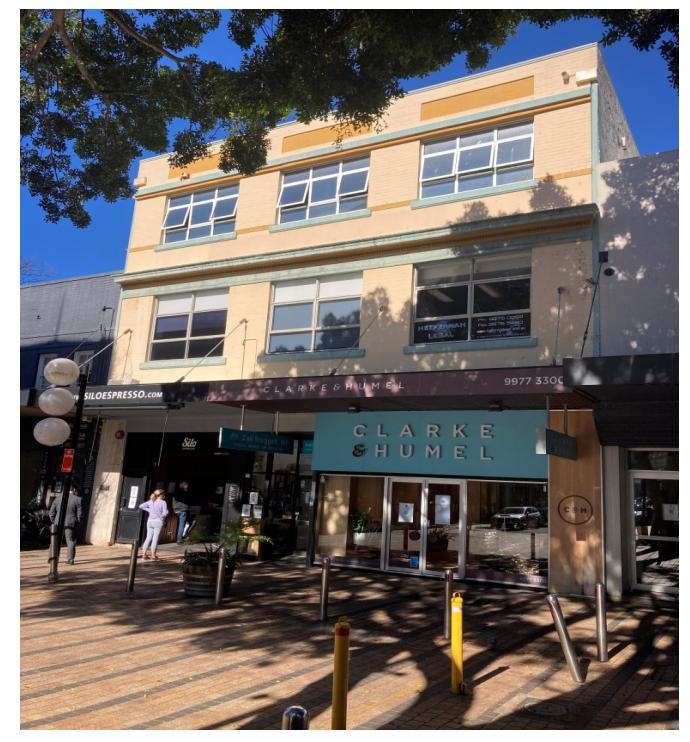
The northern façade has been constructed from a concrete, glass and steel framed ground floor with masonry walling with flyash lintels and corbels to the first and second storey levels.

Refer to the adjacent photograph 1.

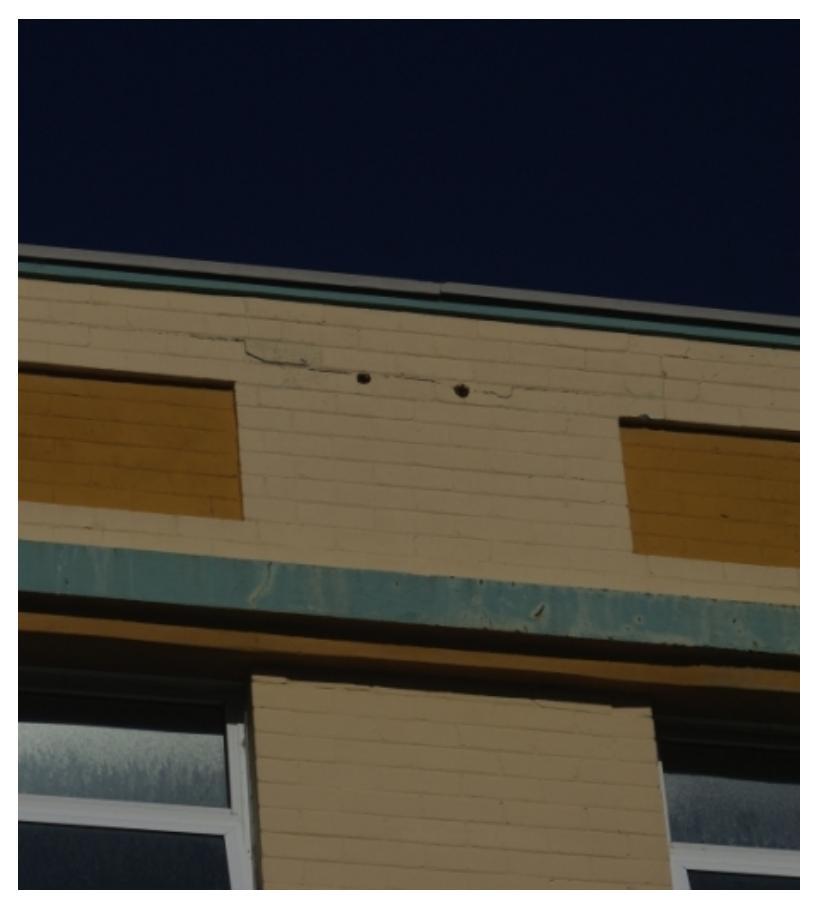
The masonry parapet has significant cracking throughout. The majority of this cracking has been obscured by patching and painting.

The cracking at the parapet has

re-opened in the location shown in photograph 2.

The parapet of the Sydney Road façade suffers from ongoing cracking and has and will require maintenance on a maximum 5 yearly cycles.

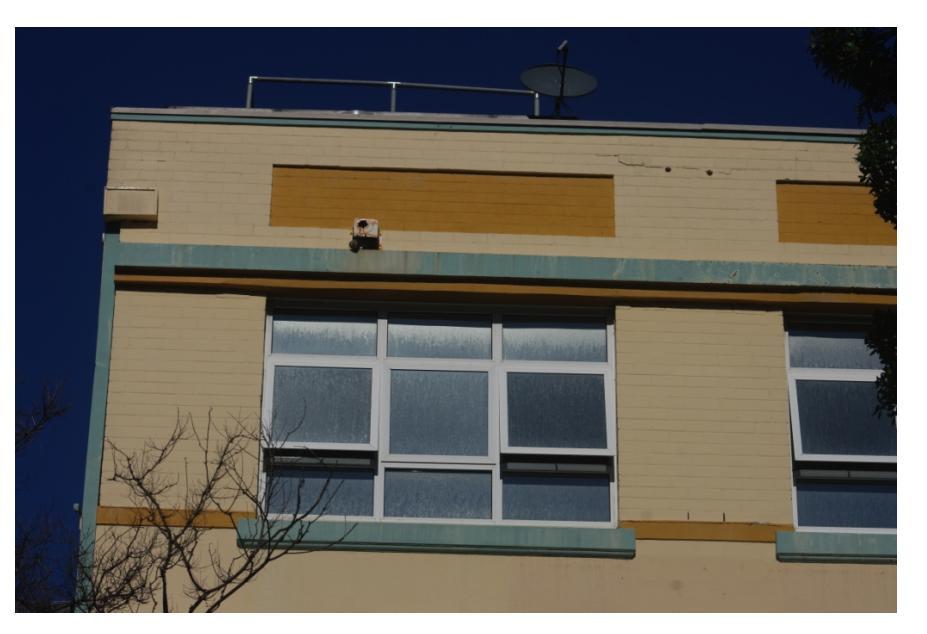
The parapet has a lateral differential movement of 8mm in this location.

Refer to the adjacent photograph 3.

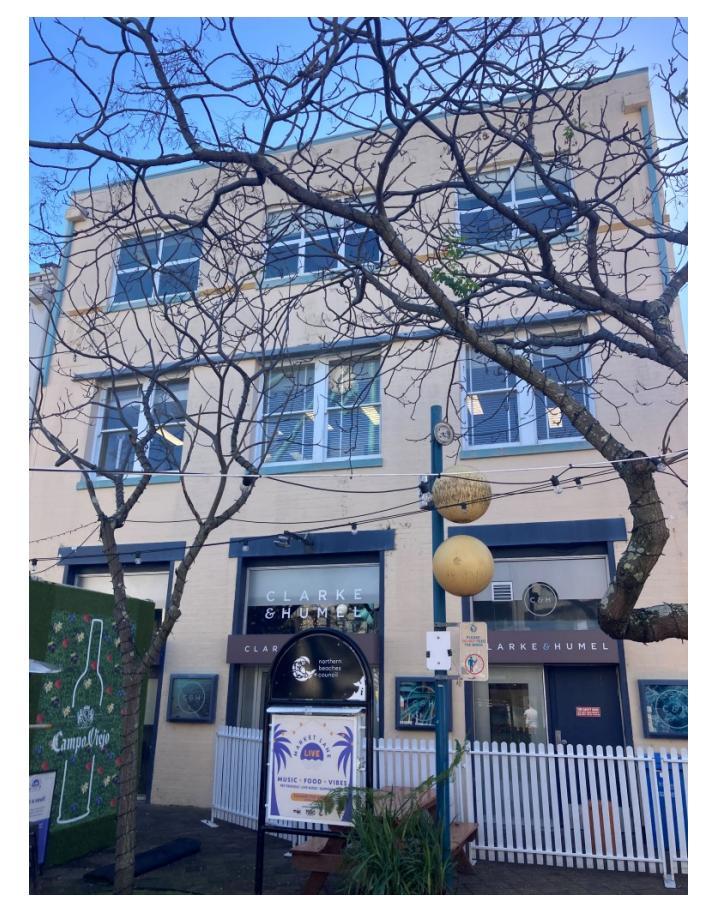
The first floor corbel has numerous cracks resulting from differential thermal movements.

These cracks in the concrete corbel have resulted in a failure of the paint system.

Refer to photograph 6.

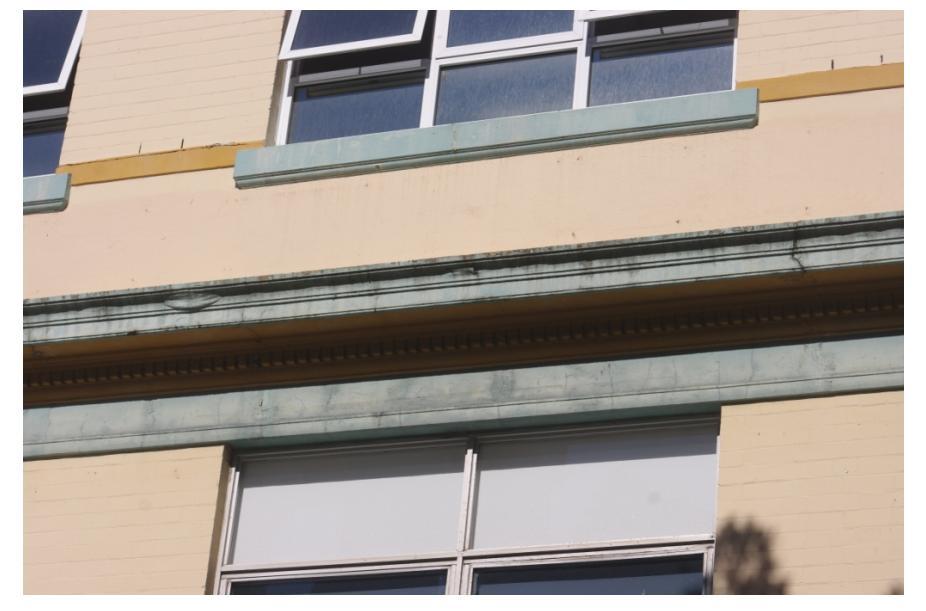
The southern façade is of a similar construction to the northern façade. It has no corbels or awning.

Refer to photograph 7.

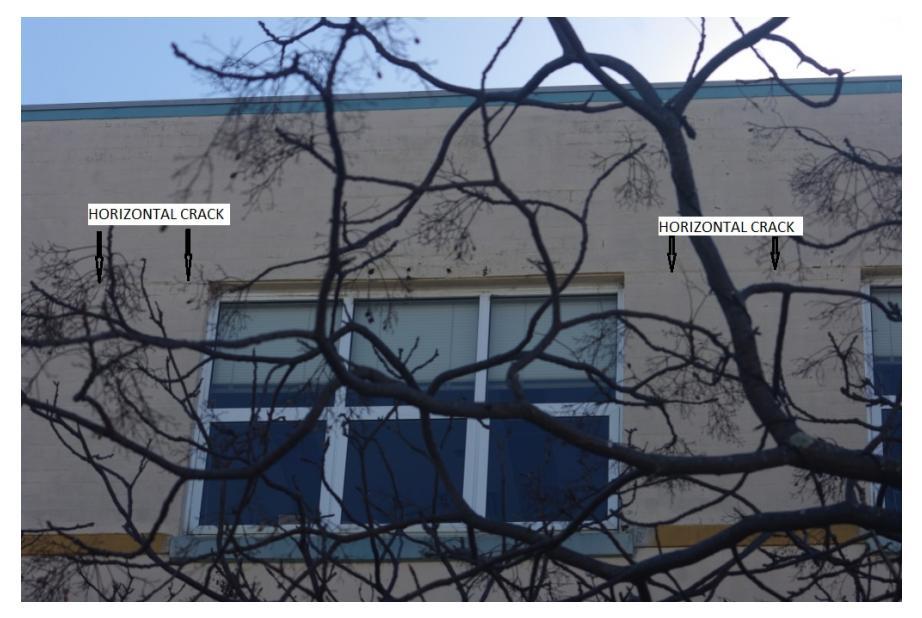
Severe corrosion of the steel lintels at the second floor level has lifted the parapet masonry and roof structure approximately 2-4 mm.

Moisture enters the second floor walling at this

Refer to the above photograph 8.

location. The lintels require removal and replacement.

The second floor 'Market Place' façade steel lintels are severely corroded and require removal and replacement.

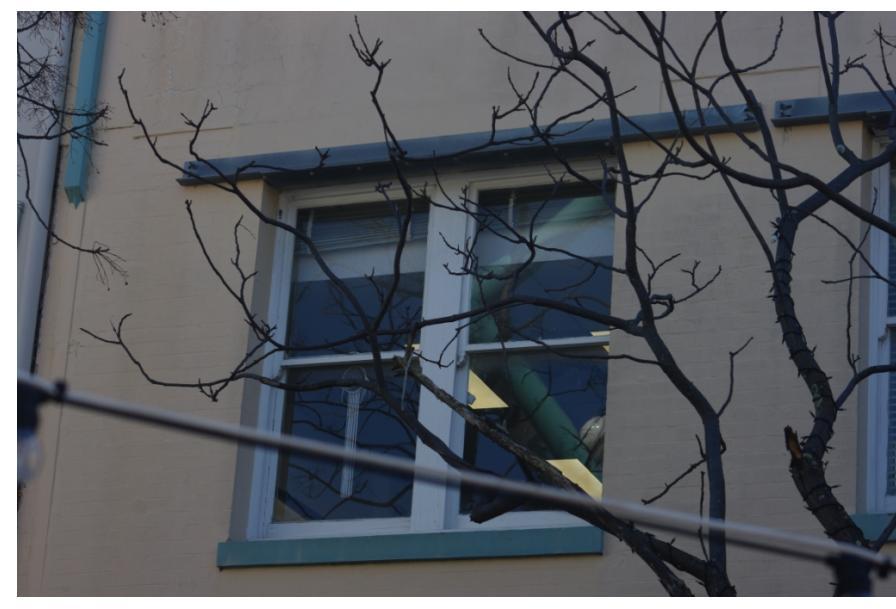
The first floor lintels have been constructed from flyash and mild steel reinforcement. These lintels are severely affected by concrete spalling. Portions of the concrete fell onto the footpath approximately 5 years ago. The area was cordoned off and all remaining sections of loose concrete were removed by scissor lift access.

Structural steel lintels were placed to support the masonry façade and reinstate public safety. Refer to photograph 9.

The first floor 'Market Place' façade flyash lintels are structurally inadequate and have been bypassed by the installation of temporary steel angles and plates. These lintels will require removal and replacement to provide a permanent structural support.

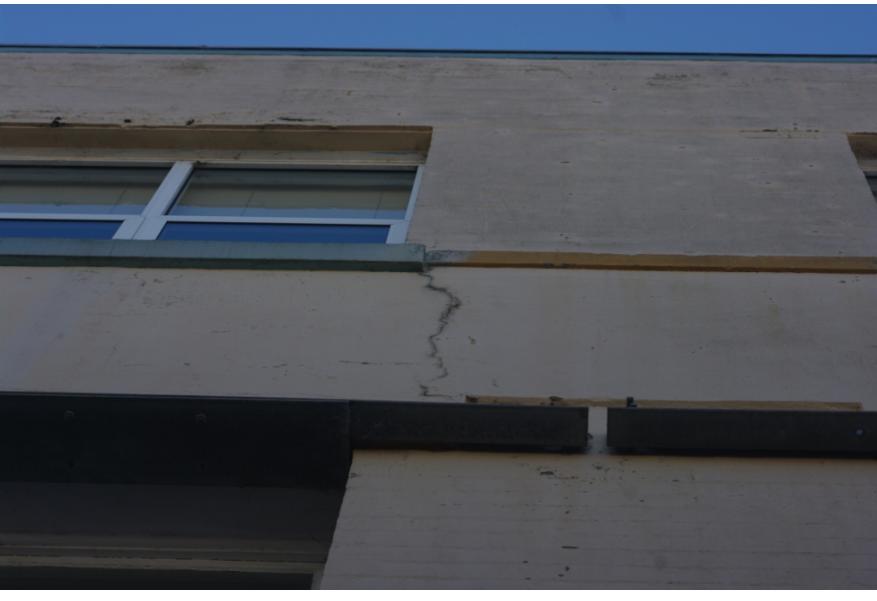
All of the ground floor reinforced flyash lintels have corroded reinforcement. The ends of these lintels have all spalled resulting in a 'splayed end'.

Refer to photograph 10.

All of these lintels require remediation to avoid spalling of concrete.

The ground floor 'Market Place' flyash lintels suffer from concrete cancer and require remediation.
