GEOTECHNICAL INVESTIGATION REPORT PROPOSED POOL HOUSE, SWIMMING POOL AND TERRACE 90 CABBAGE TREE ROAD, BAYVIEW, NEW SOUTH WALES MS YASMINA ELSHAFEI AND MR FORD ENNALS

MMGEO2024YEFE_AB REVISION A JUNE 2024

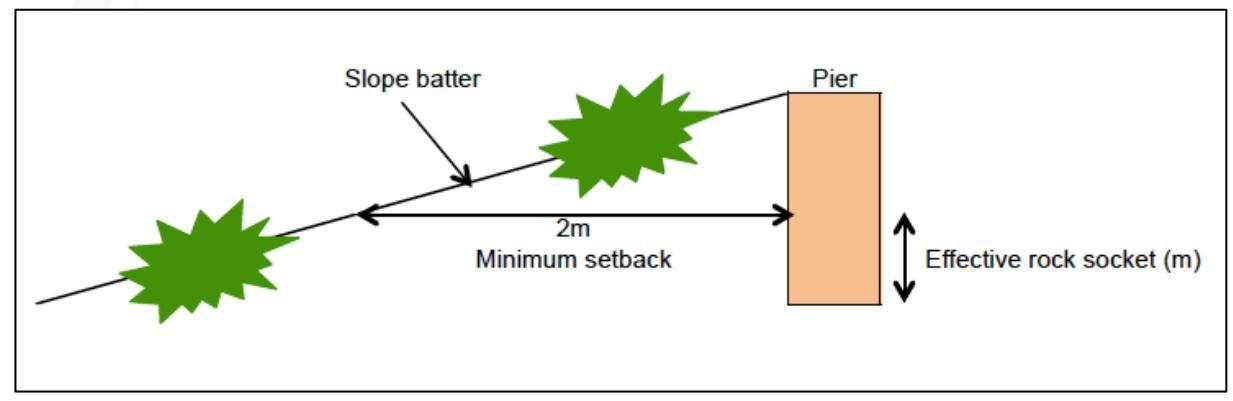
Diagramme 13.1: Required Minimum Setback for Calculation of Effective Rock Socket

To prevent slope instability and reduced bearing capacity from occurring, your attention is drawn to the need of applying the setback criteria shown in Diagramme 13.1 for calculation of effective rock socket length. Otherwise, there would be a need to downgrade the bearing pressure values given in Table 13.1 by a factor of 0.5.

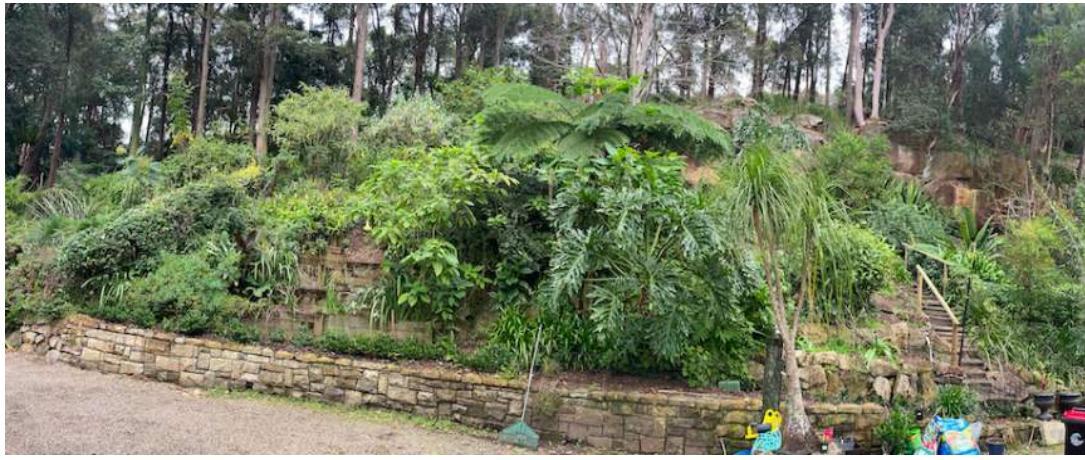
PHOTOGRAPH 4 - SANDSTONE CLIFF (VIEW TO SOUTH)
