Geotechnical Assessment

Project: New Swimming Pool
1 Water Reserve Road, North Balgowlah NSW

Ref: AG 22147
25 April 2022

1 Water Reserve Road, North Balgowlah NSW

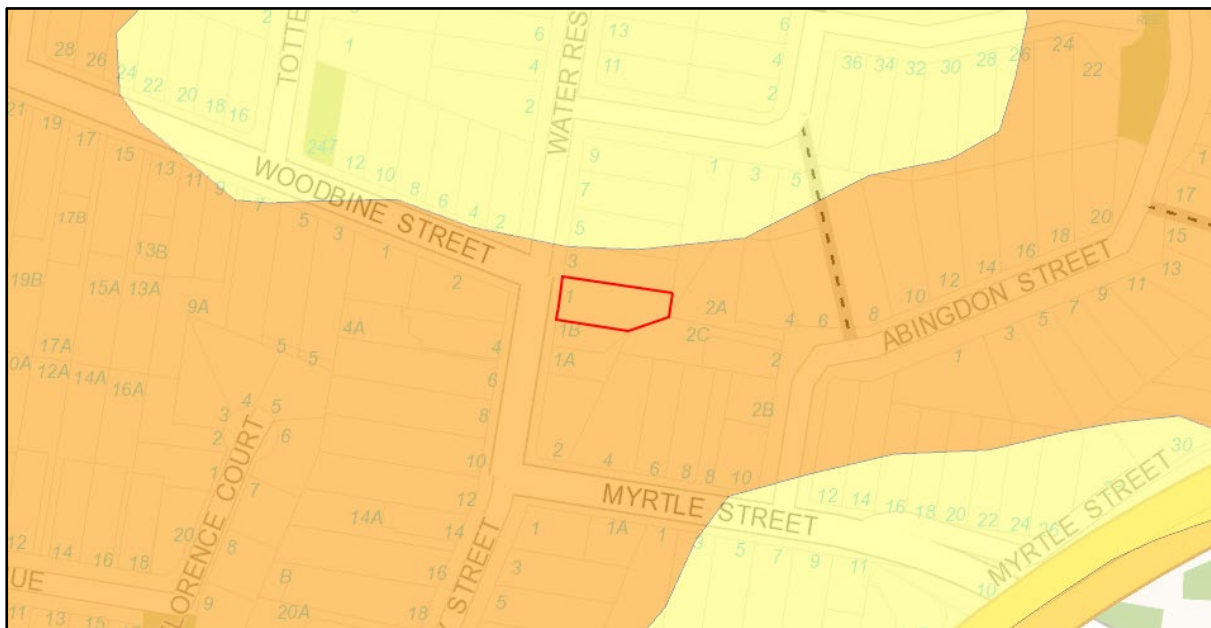
Image 2. WLEP Landslip Risk Map – 1 Water Reserve Road, North Balgowlah NSW ((c) NBC Maps)

- No evidence of significant soil creep, tension cracks or landslip instability were identified across the site or on adjacent properties as viewed from the subject site at the time of our inspection.
- The property is classified as **Area B** with reference to Northern Beaches Council WLEP – Warringah Landslip Risk Map (**Image 2**).

The likelihood of the existing slope failing is assessed as '**UNLIKELY**'; the consequences of such a failure are assessed as '**MINOR**'. The risk to property is '**LOW**'. The existing conditions and proposed development are considered to constitute an '**ACCEPTABLE**' risk to life and a '**LOW**' risk to property *provided that the recommendations outlined in Table 3 in Section 3.6 below are adhered to during design and construction.*

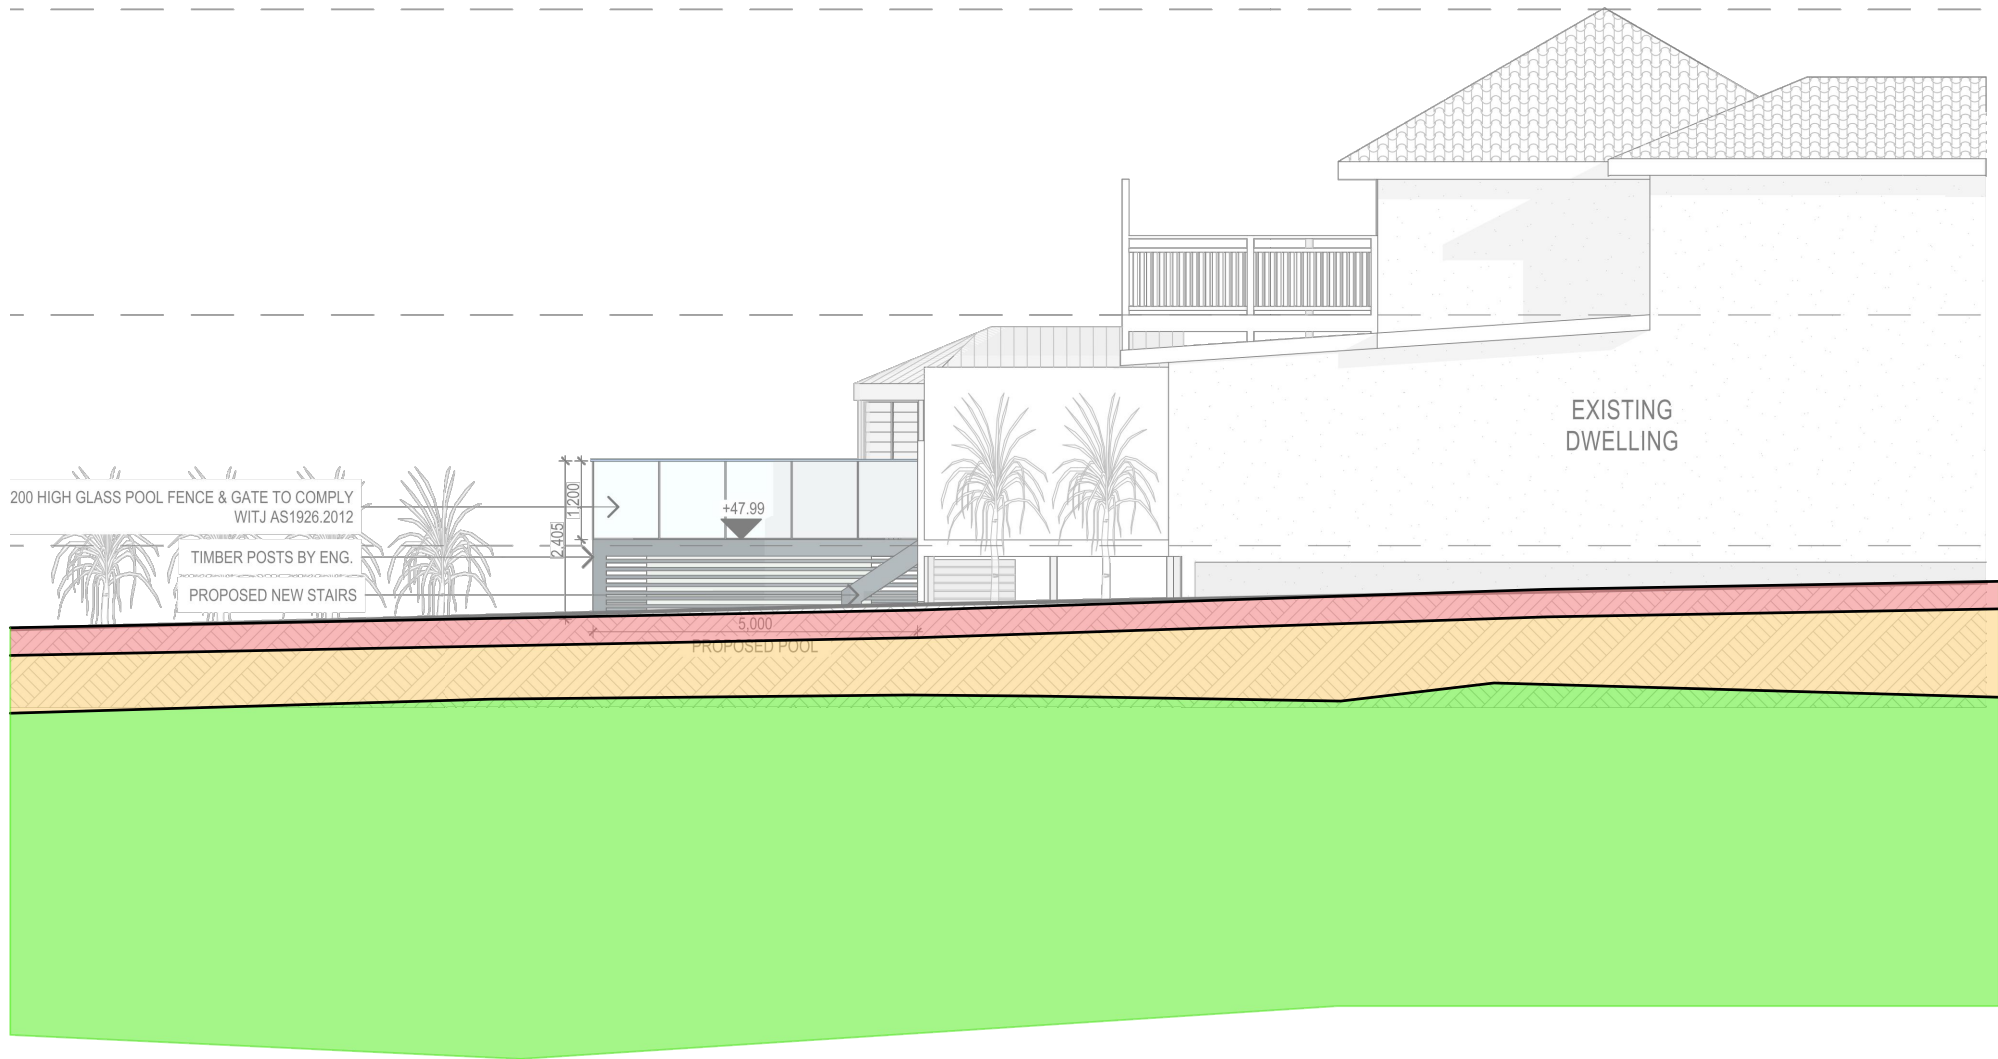
INFERRED GEOLOGICAL SECTION

The soil profile consists of shallow uncontrolled fill and sandy topsoil (O & A Horizons), silty sand (B Horizon) and weathered bedrock (C Horizon). Based on our observations and the results of testing on site, we would expect weathered sandstone bedrock to be found within 0.5 to 0.8 metres below current surface levels across the area of the proposed works.

INTERPRETED SUBSURFACE SECTION ONLY.
ACTUAL GROUND CONDITIONS MAY VARY.
