J3587. 4<sup>th</sup> August, 2021. Page 1.

# Site Classification:

Additions and Alterations at 34 Mary Street, Beacon Hill

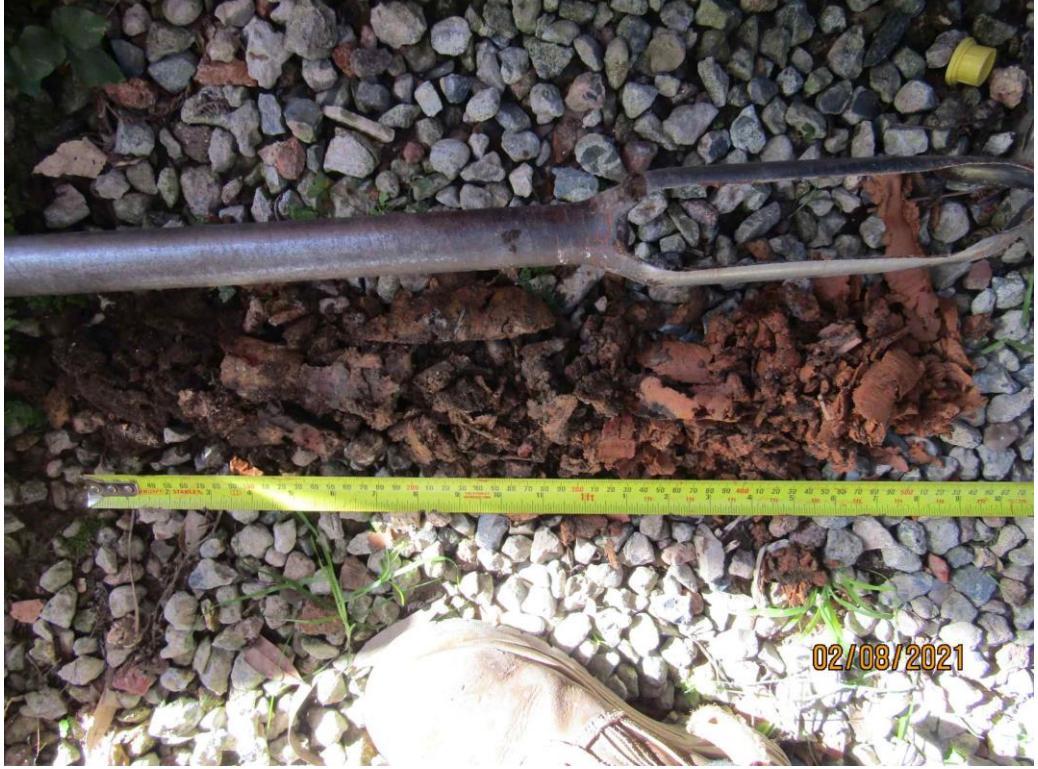
AUGER HOLE 1 (~RL115.6) – AH1 (photo 1)

Depth (m)	Material Encountered	
0.0 to 0.3	FILL, soil and clay, dark brown and orange, moist.	
0.3 to 0.5	<b>CLAY</b> , orange, firm to stiff, moist.

End of Hole @ 0.5m in firm to stiff clay. No watertable encountered.

Photo 1: AH1 – Downhole is from left to right.
