ARBORICULTURAL IMPACT ASSESSMENT REPORT

90 Cabbage Tree Road, Bayview

24th August 2021

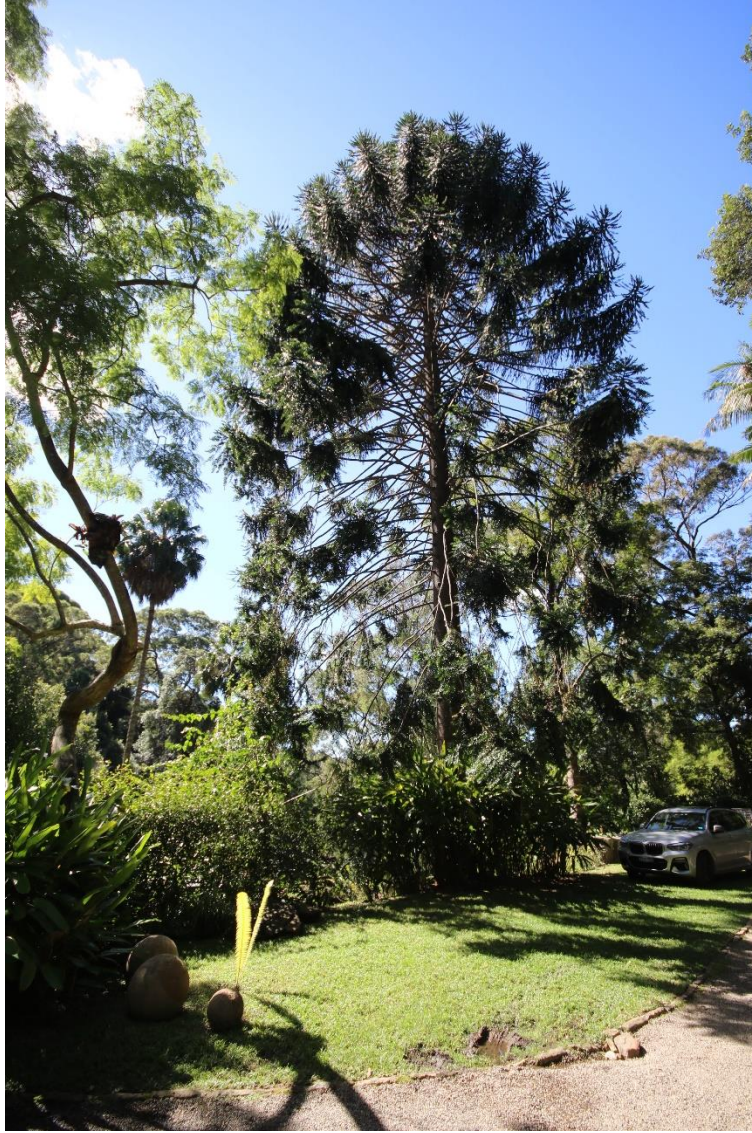
Plate 1: Tree 4.

Tree 4 is a signature specimen tree on site (refer plate 1), it is proposed to be retained as the development works are outside its SRZ and having less than 10% encroachment, retention is proposed. Plus, the development works are down an embankment below this tree and as a consequence, no roots will be encountered.

Note these Exempt trees for retention in the Tree Management Plan (TMP).

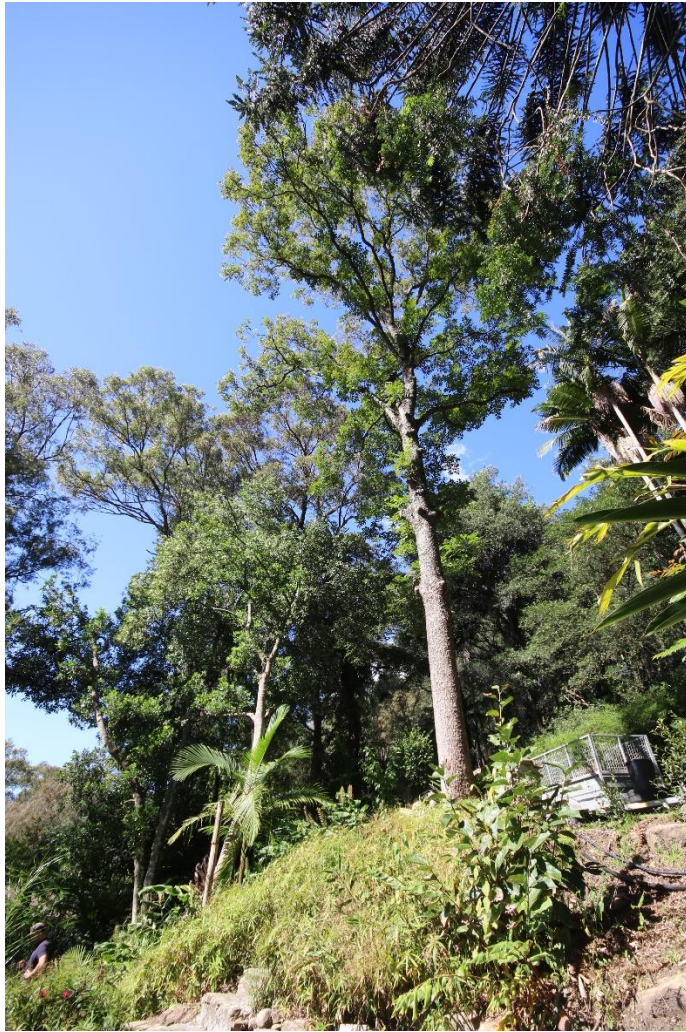
Plate 2: Tree 5

2. Tree 5 *Melia azedarach* is showing good condition and is also located on the benched platform above the development works.

The proposed works are on the edge of the SRZ and into the TPZ – refer Annexure C.

The extent of encroachment has been calculated at 11% of the TPZ, which is just over the threshold of 10% at which the development is considered acceptable.

In view of the topography of the site (sloping down hill from the rootplate) and the low level of encroachment, retention of this tree will be achieved.

Note for retention and protection in the TMP.

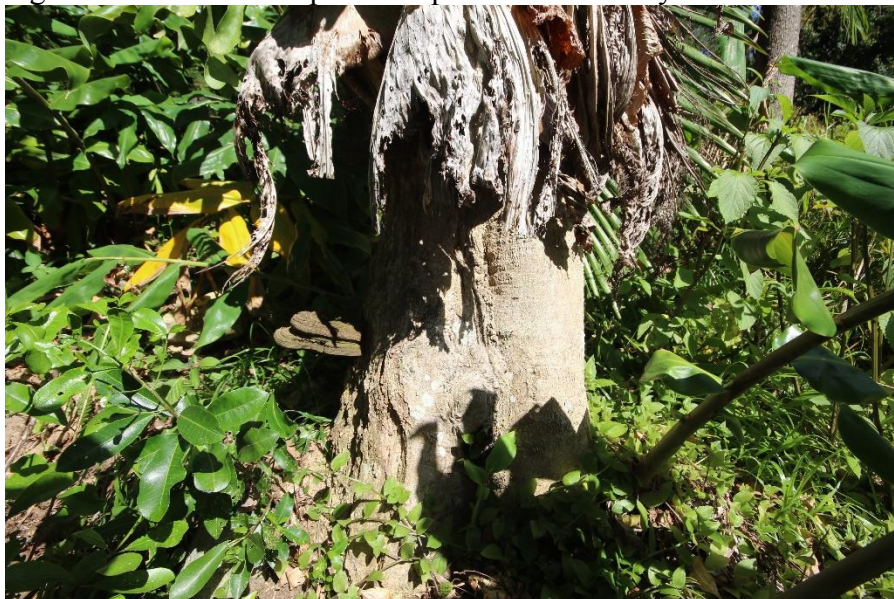
Tree 6 has a Bracket Fungus growing from its lower trunk that rendered this tree as a structurally defective tree due to the loss of internal structure from the actions of the hyphae consuming the lignin (white rot fungi) – refer plate 2. Removal is supported regardless of the development impacts from a safety factor.

Plate 3: Bracket fungi in trunk of Tree 6.

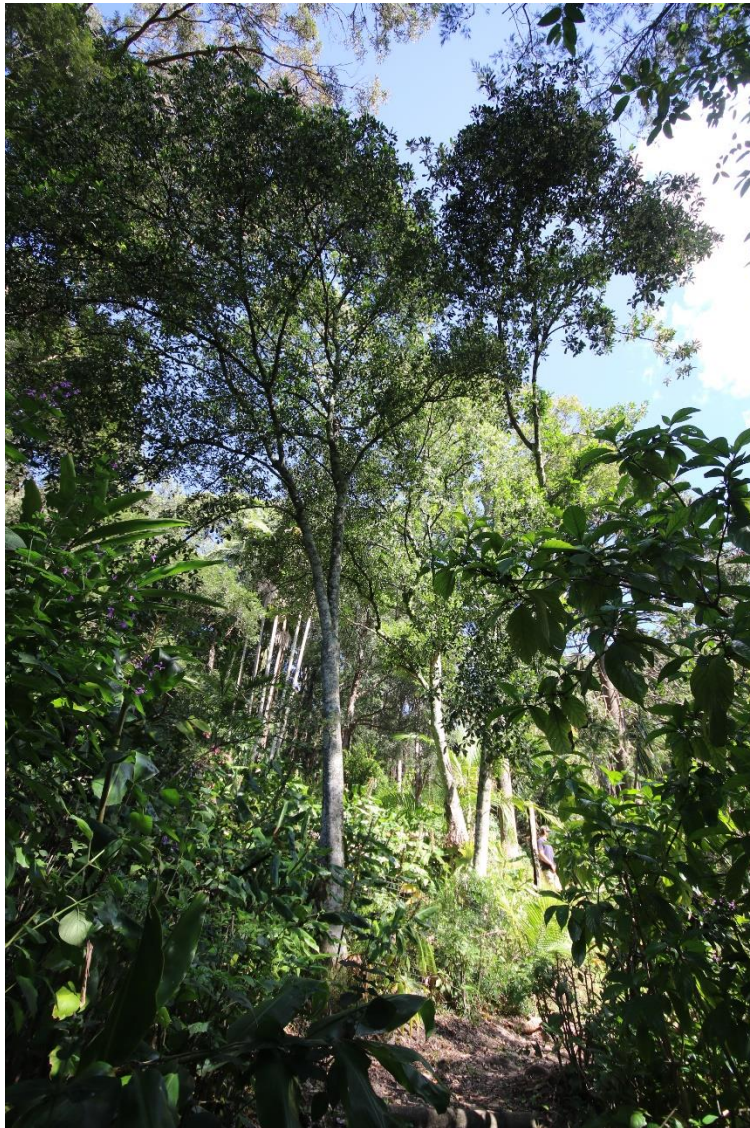
Tree 7 has suffered storm damage and has lost its natural form – refer plate 4.

This tree is within the development works and will require removal. Removal is supported as this tree will not regain its form and size and shouldn't be a restriction on the proposed works.

Tree 8 is showing good form and condition, however being within the proposed development (refer Annexure C), removal is required – refer plate 4.

Plate 4: tree 8 with 7 behind.

Note these trees for removal in the TMP.

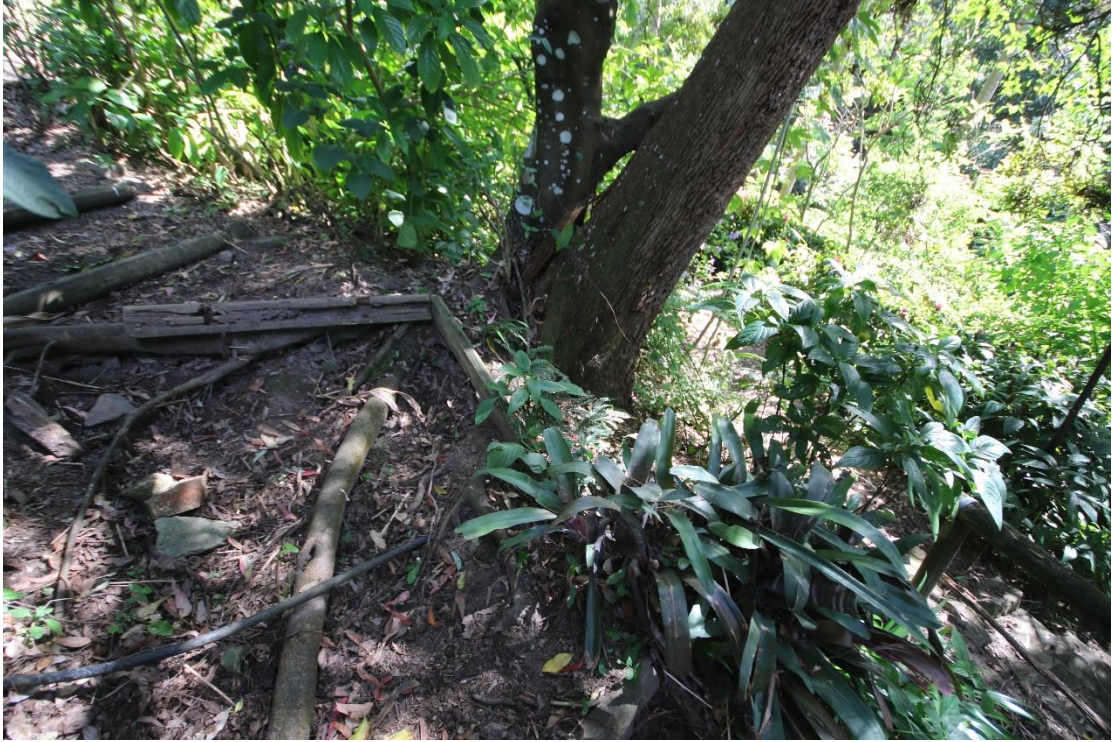
4. Tree 9 *Ficus coronata* and tree 10 *Allocasuarina littoralis* are in the process of failing as the root plate has been heaved and the trunk of tree 10 is fracturing – refer plates 5 & 6.

Plate 5: root plates of Trees 9 & 10 heaved on the tension side.

The removal of these dangerous trees is highly recommended despite the potential development impacts.

Note for removal in the TMP.

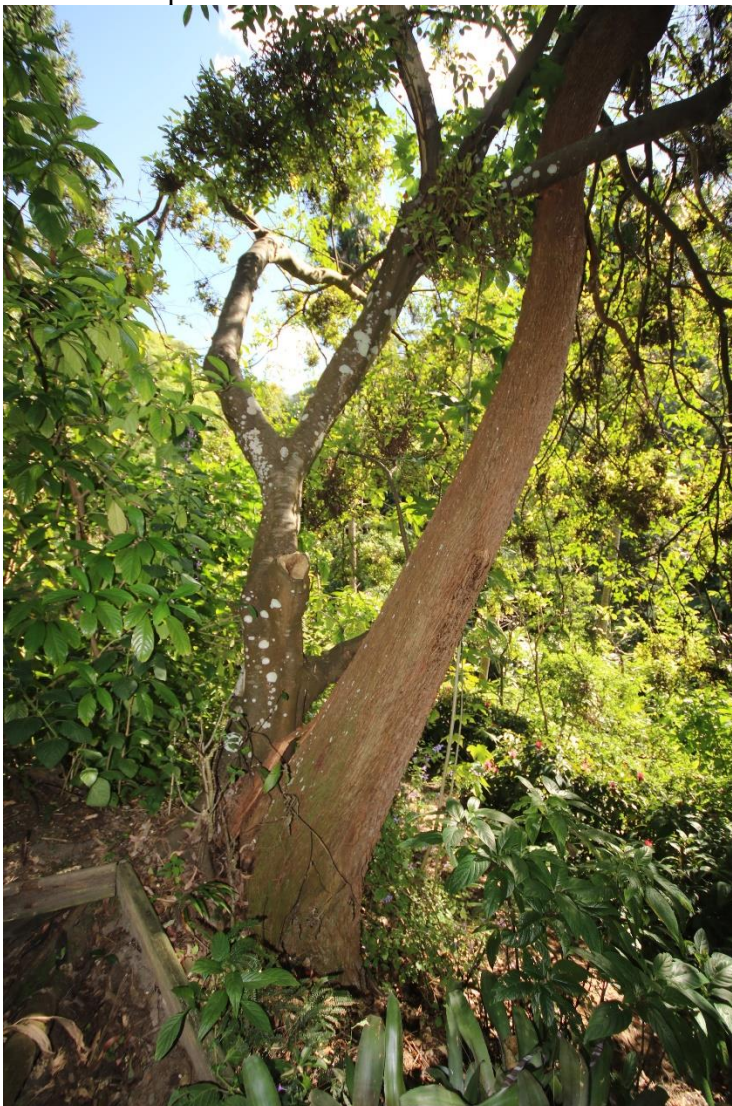
Plate 6: Fracture trunk of Tree 10.
