RISK ANALYSIS & MANAGEMENT FOR BUILDING CERTIFICATE AT 11 GILWINGA DRIVE BAYVIEW

19th January, 2016 Page 1

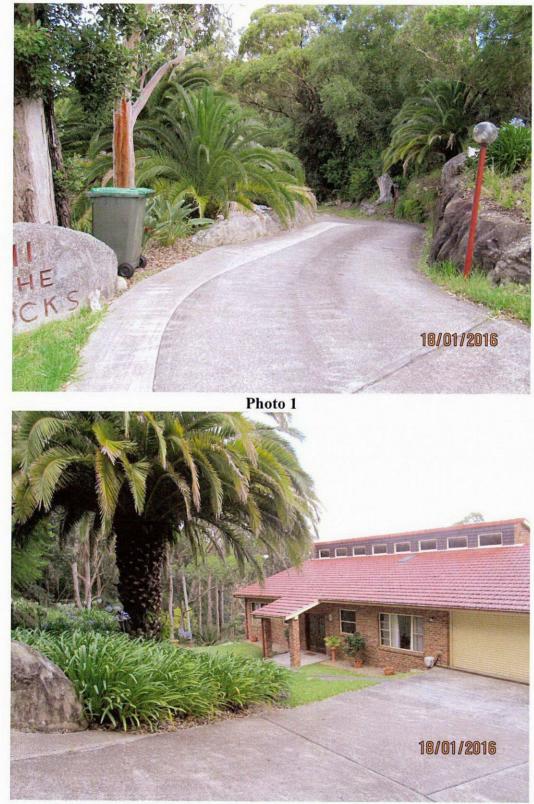
Photo 2

2.3 From the road frontage a long concrete driveway descends the slope providing access to a garage as part of the main residence (Photos 1 & 2). Abundant large sandstone floaters and outcropping bedrock is situated across the upper portion of the block (Photos 3 & 4). The floaters are situated in stable positions in the slope. A large gently sloping lawn extends from the front of the residence (Photo 5). Stable rock stack walls support portions of the lawn area and garden beds at the southern and eastern sides of the residence (Photos 4, 6 & 7). Stable rock stack walls extend around the north eastern corner of the residence (Photo 8). A large concrete swimming pool is situated on the northern side of the residence and is founded directly on exposed sandstone outcrop and well-constructed sandstone stack rock walls (Photo 9). The slope below the house and pool is comprised of natural bushland (Photo 10). The topography of the slope is controlled by the shallow underlying and exposed sandstone bedrock (Photo 11). A gently sloping lawn covered fill extends along the western side of the residence and is supported by stable sandstone stack rock walls (Photo 12 & 13). A drainage channel extends along the western boundary (Photo 13).

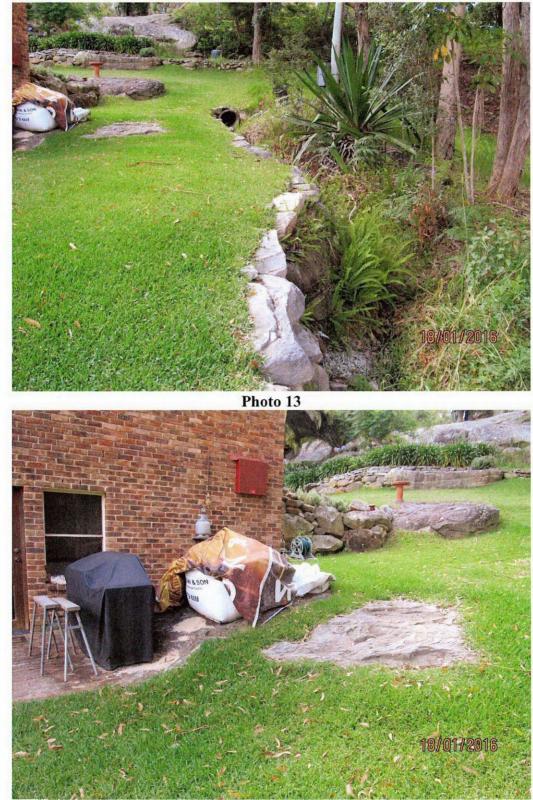
Photo 14

2.4 The two-storey brick residence is in excellent condition. It's supporting walls and piers show no evidence of significant cracking or ground movement. In places the foundations can be seen to be founded directly on the underlying sandstone bedrock. (Photos 14 & 15).
