29th January 2025

Addendum B: Arboricultural Impact Assessment Report – 60 Hudson Parade, Clareville, NSW

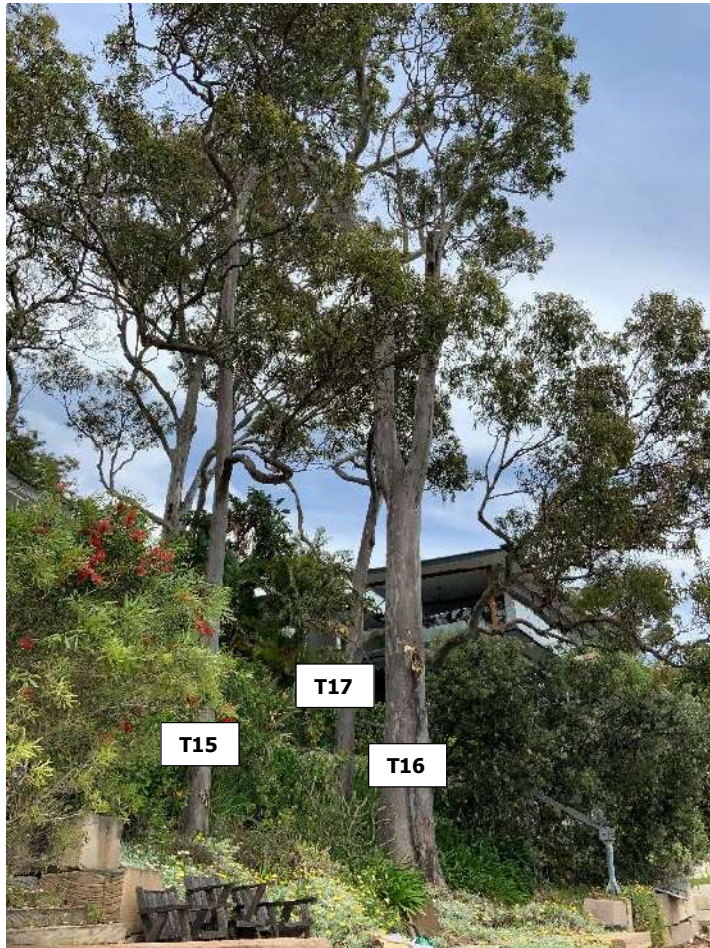
**1: Trees T15, T16 & T17**

Tree 15 (*Corymbia maculata* - Spotted Gum) is a mature specimen in good health and structural condition. The tree has a Useful Life Expectancy (ULE) of 15-40 years and has been allocated a Retention Category of Consider for Retention.

Tree T16 (*Corymbia maculata* - Spotted Gum) is a mature specimen in good health and poor structural condition. The tree has a Useful Life Expectancy (ULE) of <5 years and has been allocated a Retention Category of Priority for Removal.

As part of the tree assessment undertaken for the Development Application (DA) for the whole site, internal diagnostic testing of the trunk of Tree T16 was undertaken using a Resistograph, and resonance sounding of the first order branches was undertaken using a nylon mallet. Test results determined that a continuous column of decay is likely present that links the cavities in the trunk and western first order branch. When interpreting the Resistograph test results in accordance with the t/R ratio model<sup>1</sup>, decay at two of the four points tested in the trunk exceeded the minimum 'safe' ratio of healthy tissue to decayed tissue/hollowness.

Where the trunk of a tree becomes more than two thirds hollow the potential for torsional fracturing and cross-sectional flattening of the trunk significantly increases, particularly during high winds<sup>2</sup>. Based on the test results the tree's ULE was estimated at <5 years, and the tree was allocated a Retention Category of Priority for Removal (refer AIA Report: Appendix C - Internal Diagnostic Testing Results).

Tree T17 (*Corymbia maculata* - Spotted Gum) is a mature specimen in fair health and poor structural condition, based on the upper crown of the tree having either died back or failed due to storm damage. The 'crown' of the tree comprises of two first order branches only. The tree has a ULE of 5-15 years and has been allocated a Retention Category of Consider for Removal.

It should be noted that the extensive internal decay identified within the trunk of Tree T16 will continue to develop. Repeat internal diagnostic testing at the same testing location as previous is recommended in April 2025 (36 months after the initial test) to monitor the rate of spread of decay. Tree management recommendations (where required) should be based on the test results.

The supplied plans show Tree T17 falls within the footprint of the proposed boatshed and is therefore proposed for removal.

Tree T17 is proposed for removal. Approved tree removal works shall be undertaken by a qualified Arborist (minimum AQF level 3) covered by adequate public liability insurance. Arborists and ground staff shall comply with the *Work Cover Code of Practice for the Amenity Tree Industry*.

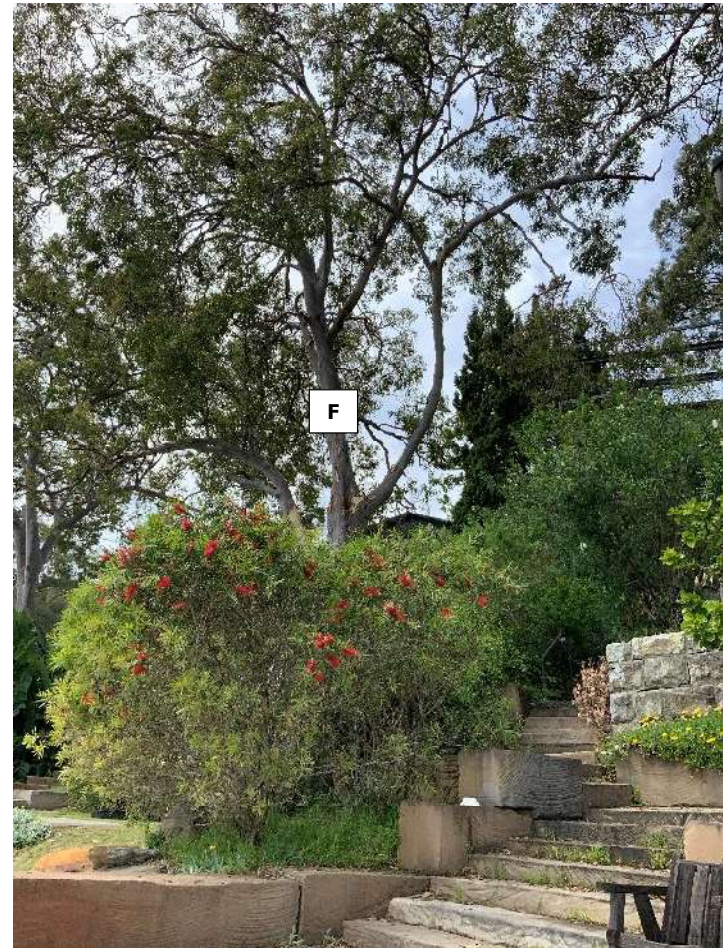
**2: Tree F**

Tree F (*Corymbia maculata* - Spotted Gum) is a large, mature specimen which is in good health and has moderate landscape value. Therefore, it is proposed to locate the boatshed in the southwestern section of the site, which will impact trees of lesser quality and value than Tree F.

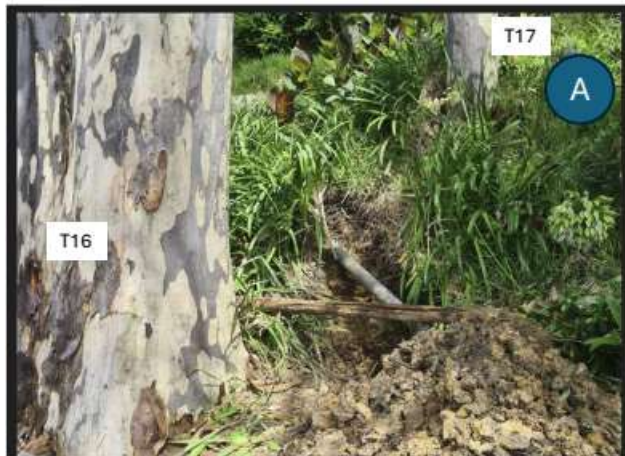
The root mapping trench was excavated by hand to a maximum depth of 800mm (bottom of proposed slab). Two (2) roots of 60mm and 70mm diameter were located within the trench. Although roots in the SRZ are important in providing stability to a tree's root plate, the pruning of these two relatively small diameter roots should not have a significant impact on the stability of Tree T16. These roots should be pruned by the Project Arborist at the time of Boatshed construction.

A trench of 2500 mm was dug up to a depth of 800 mm, revealing two tree roots  
 Root 1 of T16 (probably potentially T17)  
 Root 2 of T17 (tree to be removed)  
 A grey pipe filled with soil was across the trench)

Excavation works and the pruning of the two (2) roots identified by root mapping investigations in the SRZ of Tree T16 shall be supervised/undertaken by the Project Arborist.

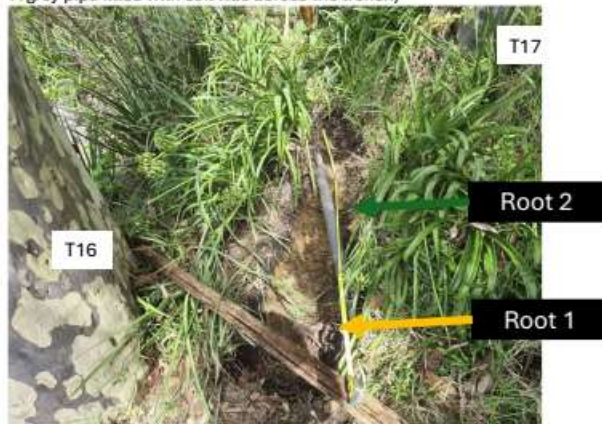
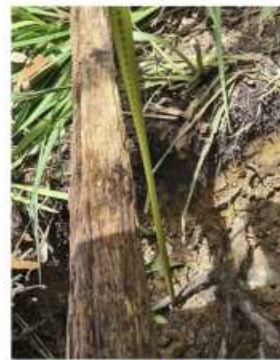
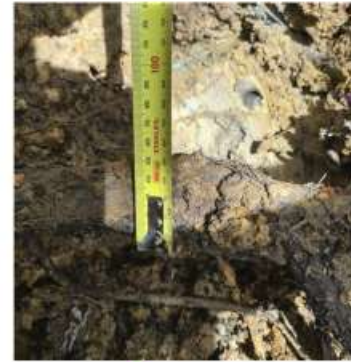
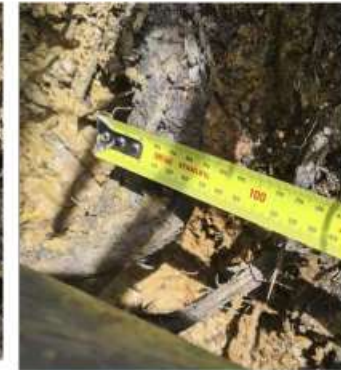
Tree root 1 of T16  
 (potentially also of T17)  
 Thickness: ca 60 mm  
 Depth: ca 800 mm

Tree root 2 of T17  
 Thickness: ca 60-70 mm  
 To be removed
