## ARBORICULTURAL IMPACT REPORT

#### 101 WOODLAND STREET BALGOWLAH HEIGHTS NSW

#### PREPARED FOR BEECRAFT PTY LTD

16<sup>TH</sup> JUNE 2020

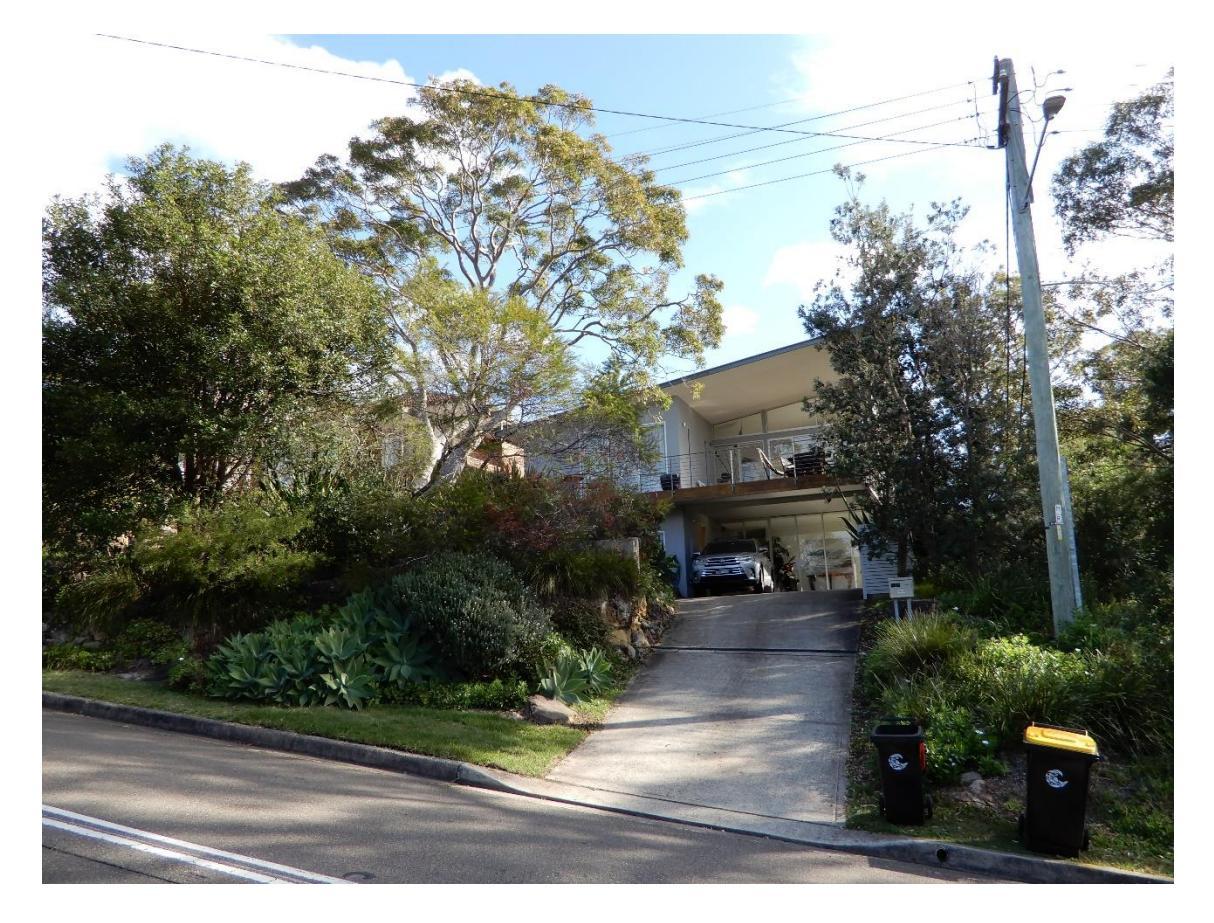
The tree is located adjacent to the southern boundary in the front garden of the site. The location and context of the tree in the front garden is illustrated in the photograph on the cover page of this report.

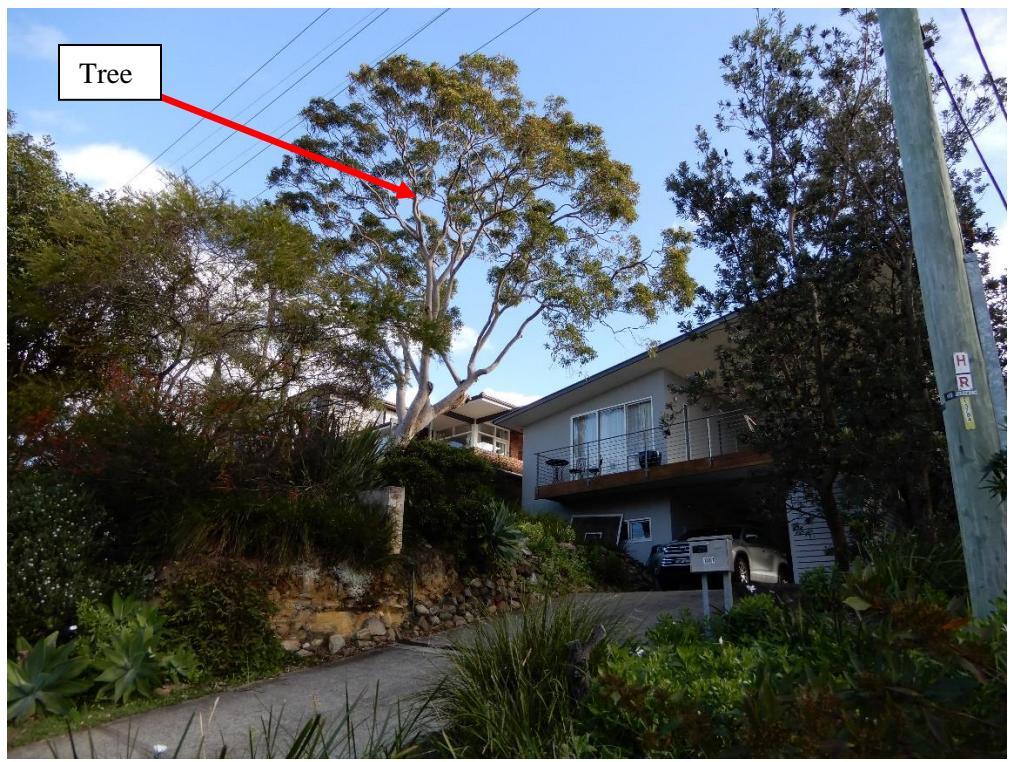
Photograph 1: Illustrating the location and context of the tree.

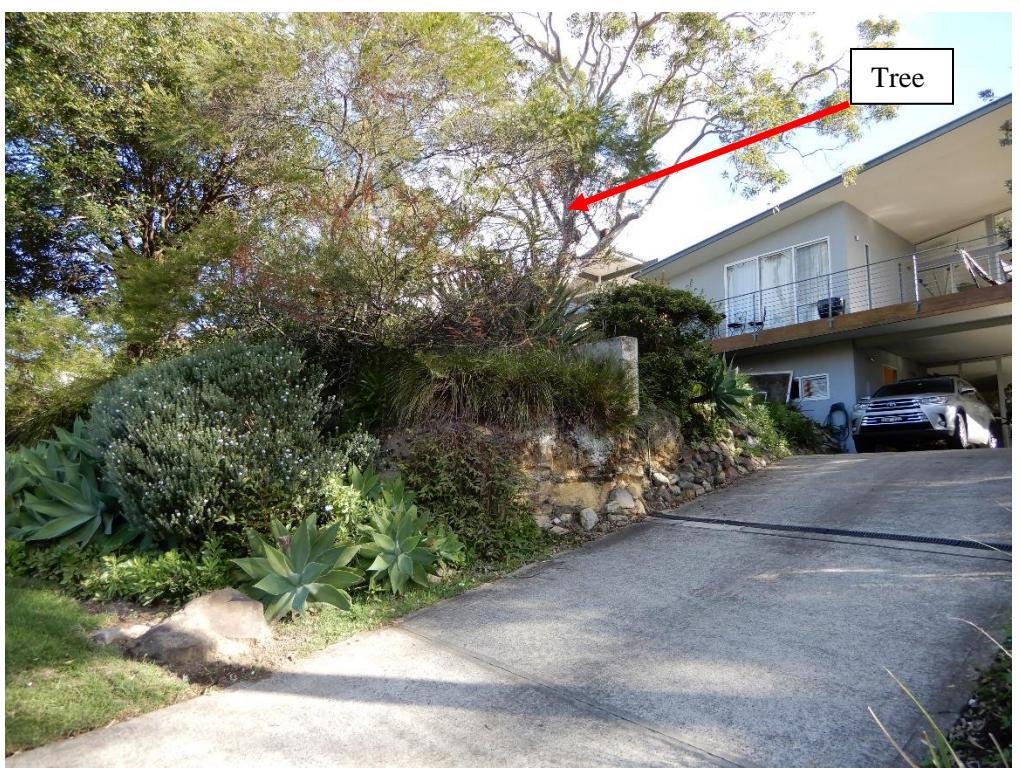
Photograph 2: Illustrating the tree and existing driveway.

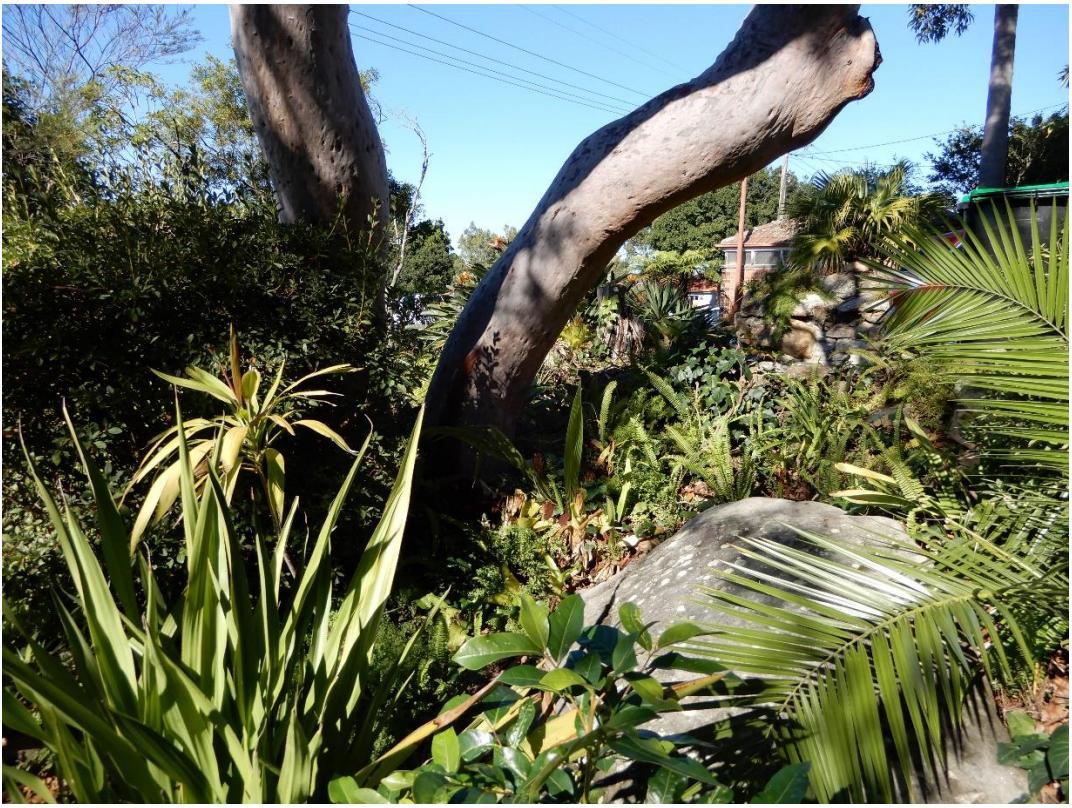
Photograph 3: Illustrating a closer view of tree location and context.

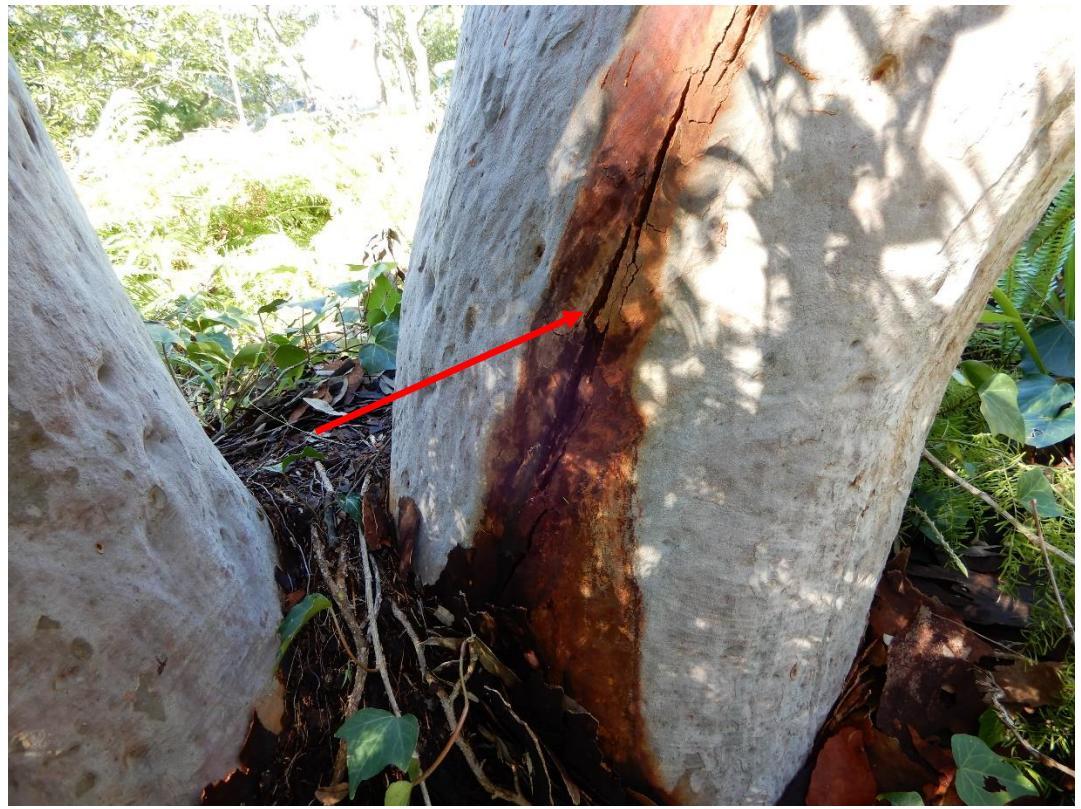
There is evidence of minor cracking in the sapwood of the lower trunk of the SW leader but this is not considered significant. The tree currently appears stable with no visual evidence of instability. The tree exhibits sound branch attachment with no visual evidence of significant past branch failures.

Photograph 4: Illustrating minor cracks in the lower tissue of the SW leader.

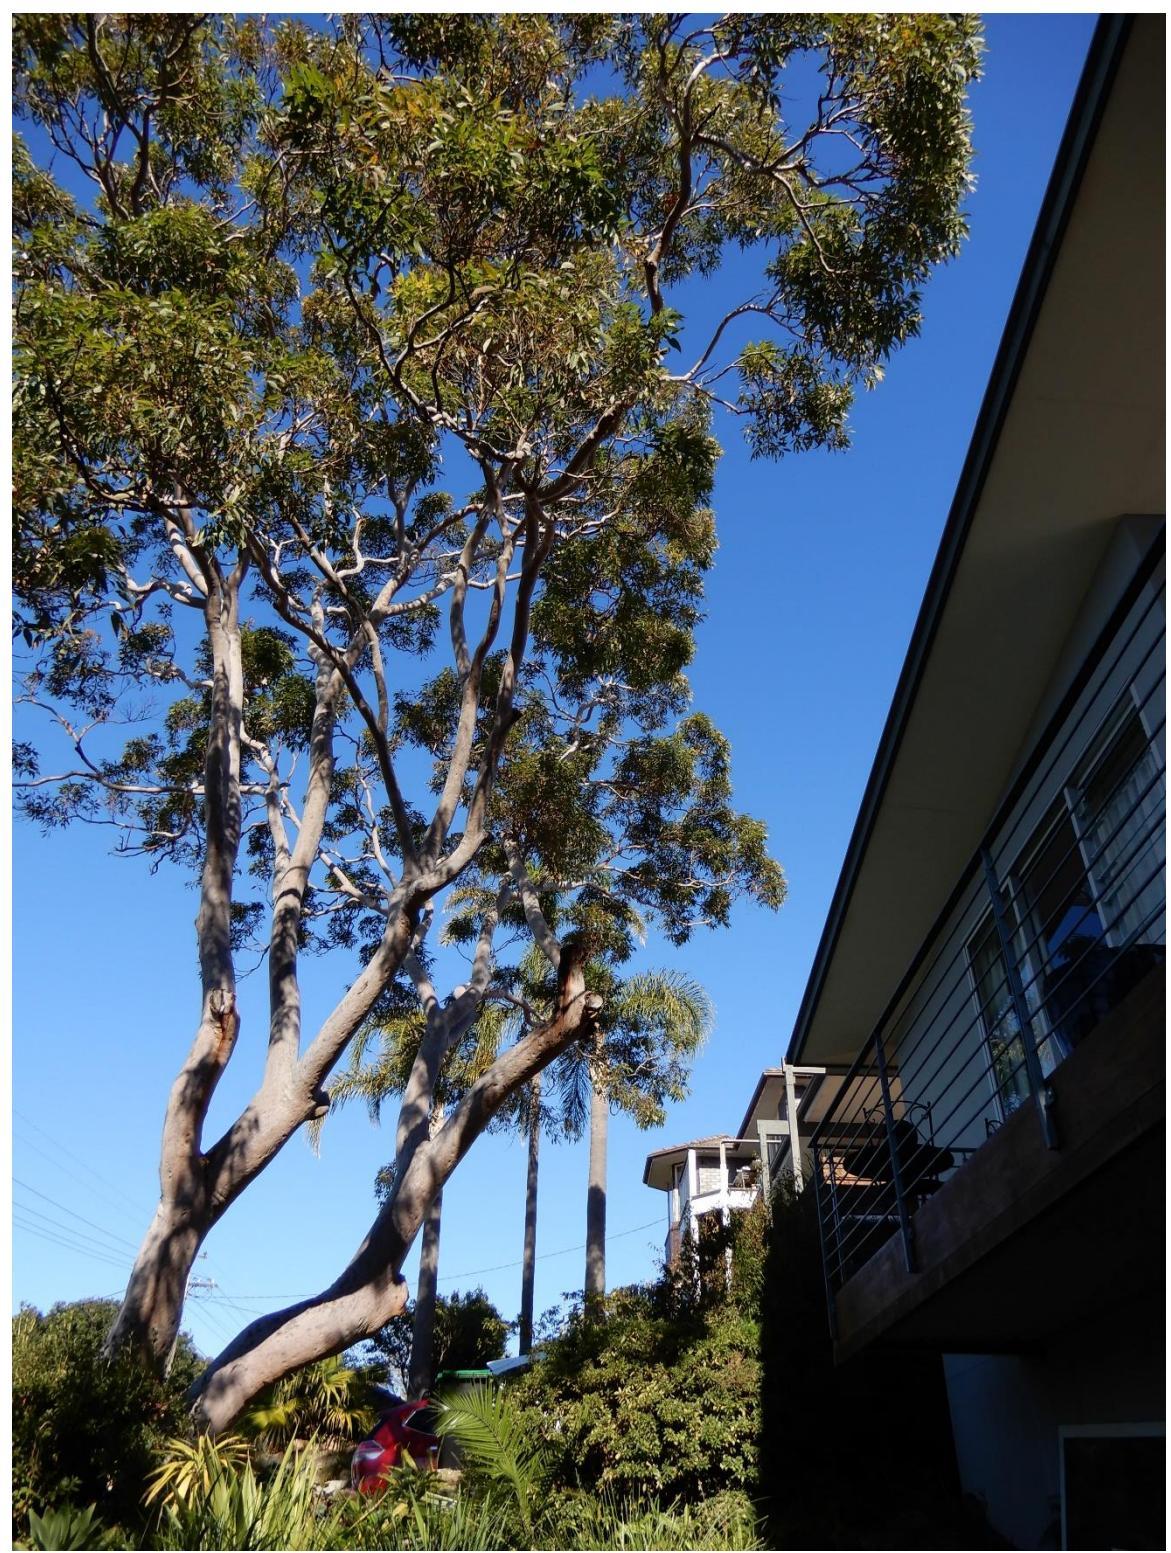
The tree has an upright trunk and the majority of its canopy is on a north x south axis due to past pruning to provide clearance from the dwelling to the west and overhead electricity lines to the east.

Low to mid canopy branches have been pruned in the past to approximately 5 metres above ground level on the west side for clearance from the dwelling and on the east side for clearance from OH electricity wires.

Photograph 5: Illustrating the north-south orientation of the crown due to past pruning to provide clearance from the dwelling to the west and overhead electricity lines to the east.

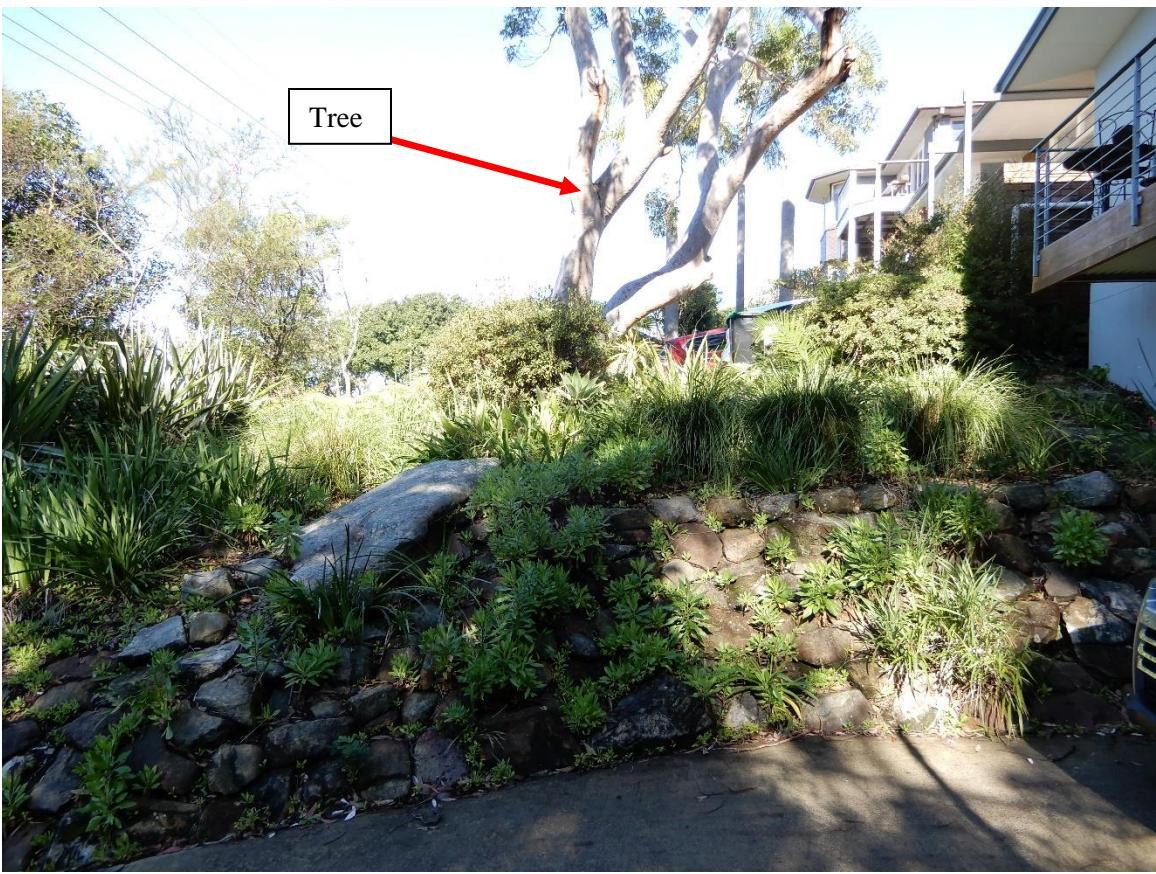
Photograph 6: Illustrating the past cut for the existing driveway.
