Tree Report

Westfield Warringah Mall

For DEM Australia Pty Ltd

June 2013

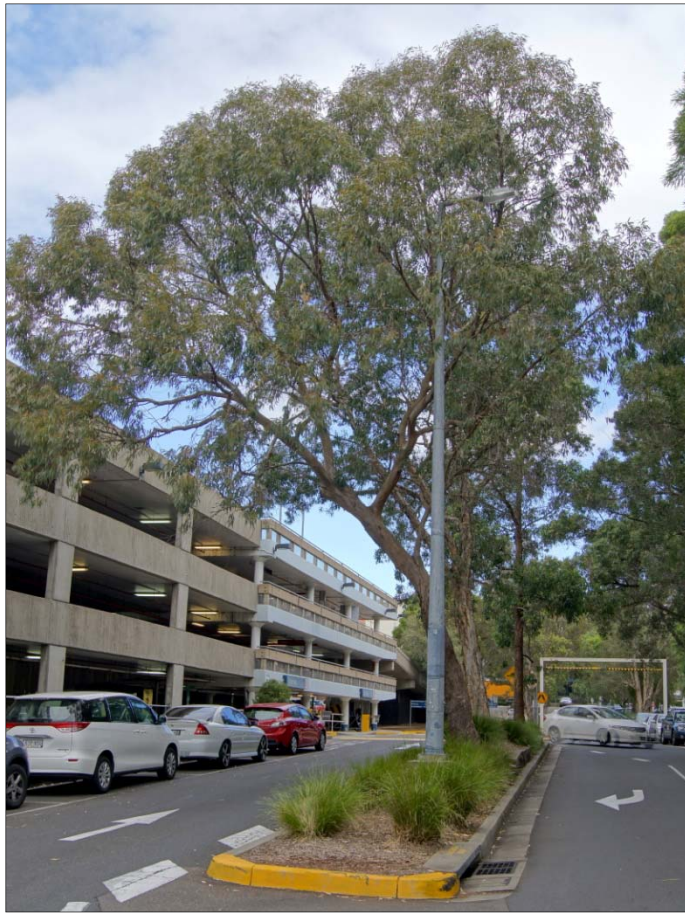
Tree 14 *Eucalyptus tereticornis* (Forest Red Gum) and Tree 15 *Melaleuca quinquenervia* (Broad-leaved Paperbark) are in a central raised bed surrounded by retaining walls; Tree 14 is leaning and may be unstable. Tree 15 is in poor structural condition due to a weak junction in the trunk. These trees would be retained although Tree 15 may be affected by the construction of a ramp to the south of the trunk.

Tree 16 *Eucalyptus microcorys* (Tallowwood) is a fair specimen although the root system is confined by kerbs to either side.

Plate 3: Tree 14 *Eucalyptus tereticornis* (Forest Red Gum), Tree 15 *Melaleuca quinquenervia* (Broad-leaved Paperbark) and at rear Tree 16 *Eucalyptus microcorys* (Tallowwood)

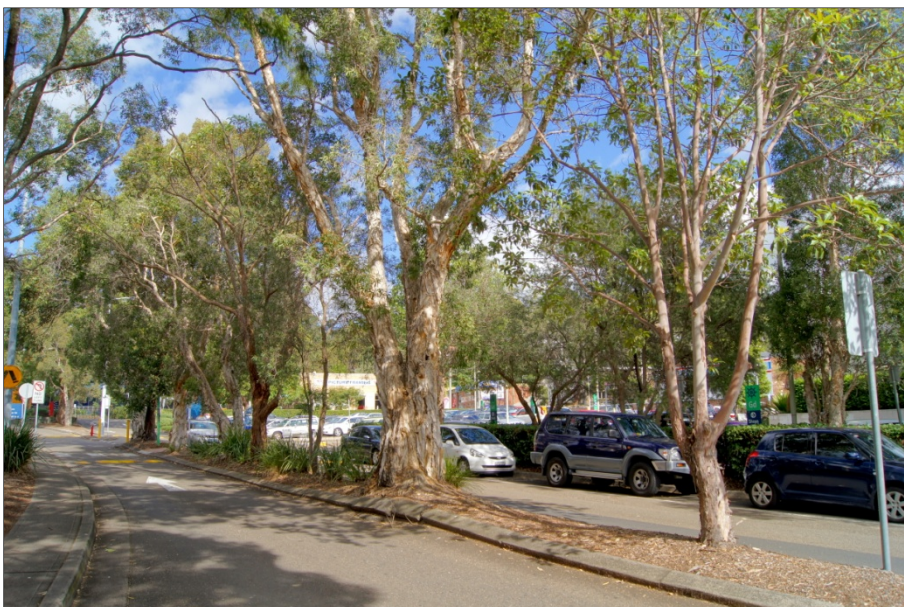
Tree 17 *Melaleuca quinquenervia* (Broad-leaved Paperbark) and Tree 26 *Lophostemon confertus* (Brushbox) are stressed and have sparse leaf coverage.

Tree 27 *Melaleuca quinquenervia* (Broad-leaved Paperbark) is a very large specimen which is causing damage to the kerb due to root activity.

Tree 27a *Callistemon viminalis* (Weeping Bottlebrush) is poor and suppressed.

Tree 28 *Eucalyptus robusta* (Swamp Mahogany) has advanced crown dieback and is declining.

Tree 29 *Melaleuca quinquenervia* (Broad-leaved Paperbark) has a weak junction near the base and the root system is likely to cause damage in the near future.

Tree 30 *Melaleuca quinquenervia* (Broad-leaved Paperbark) is likely to cause damage in the near future.

Plate 6: right to left
Tree 26 *Lophostemon confertus*
(Brushbox), Tree 27 *Melaleuca quinquenervia*
(Broad-leaved Paperbark), Tree 27a
Callistemon viminalis
(Weeping Bottlebrush), Tree
28 *Eucalyptus robusta* (Swamp
Mahogany), Trees 29 and 30
Melaleuca quinquenervia
(Broad-leaved Paperbark)

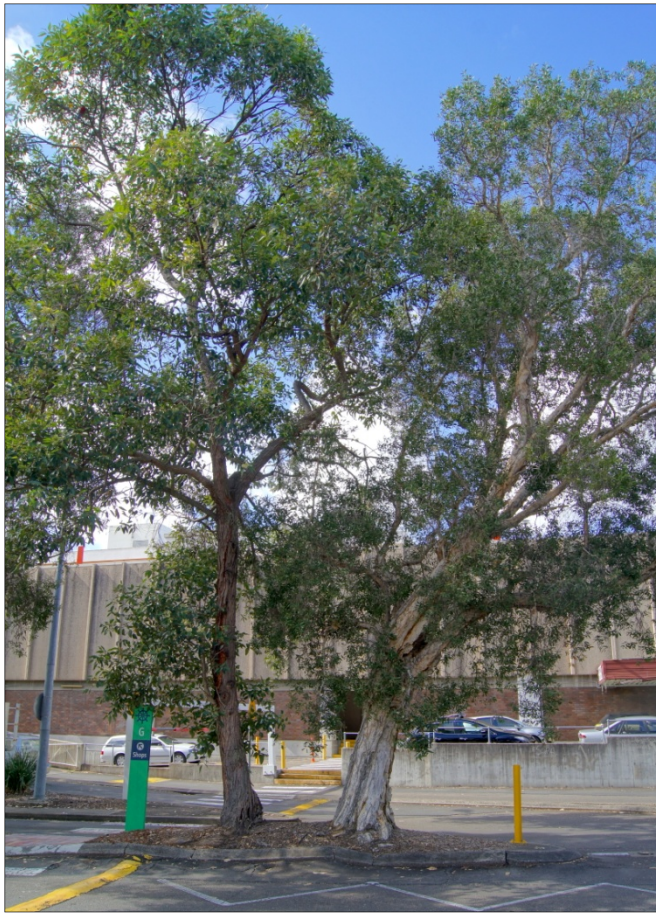
Tree 31 *Eucalyptus robusta* (Swamp Mahogany) has major surface roots which have been deformed by the adjacent kerbs. Damage is likely in the near future.

Tree 32 *Melaleuca quinquenervia* (Broad-leaved Paperbark) has already caused damage to the kerb and the road surface. Additional damage is likely in the future.

Plate 7: left to right
Tree 31 *Eucalyptus robusta*
(Swamp Mahogany) and Tree
32 *Melaleuca quinquenervia*
(Broad-leaved Paperbark)

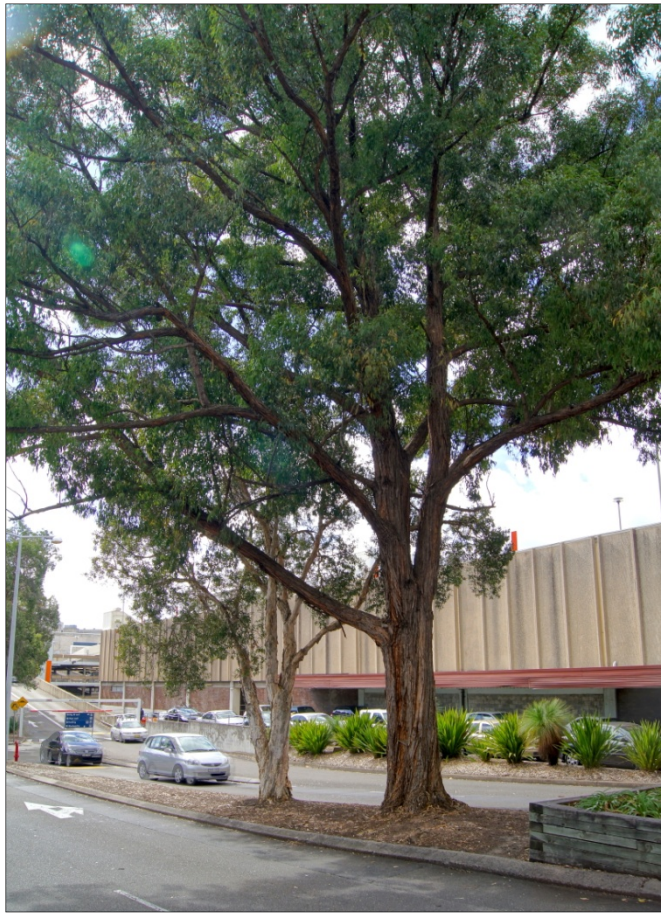
Trees 33 *Melaleuca quinquenervia* (Broad-leaved Paperbark) and Tree 34 *Eucalyptus microcorys* (Tallowwood) are close to the line of a new kerb, losing approximately 600mm and 500mm respectively to the west of the trunks. The existing kerb is approximately 1.5m from the trunks so that the additional excavation required may cause impact on the root systems. Before a decision can be made regarding the retention of these two trees, a root investigation would be required. The trees would be retained if no significant roots are found within the area. If significant roots need to be severed close to the trunk the trees may become unstable and require removal. Alternatively if significant roots are encountered it may be feasible to retain the existing kerbline in the vicinity of the trees.

Plate 9: existing kerblines near
Tree 33 *Melaleuca
quinquenervia* (Broad-leaved
Paperbark) and Tree 34
Eucalyptus microcorys
(Tallowwood)
