## **129 George Street, Avalon**

### Geotechnical Comments in Regards to New Plans

## **GEOTECHNICAL INVESTIGATION:**

New Secondary Dwelling at **129 George Street, Avalon**

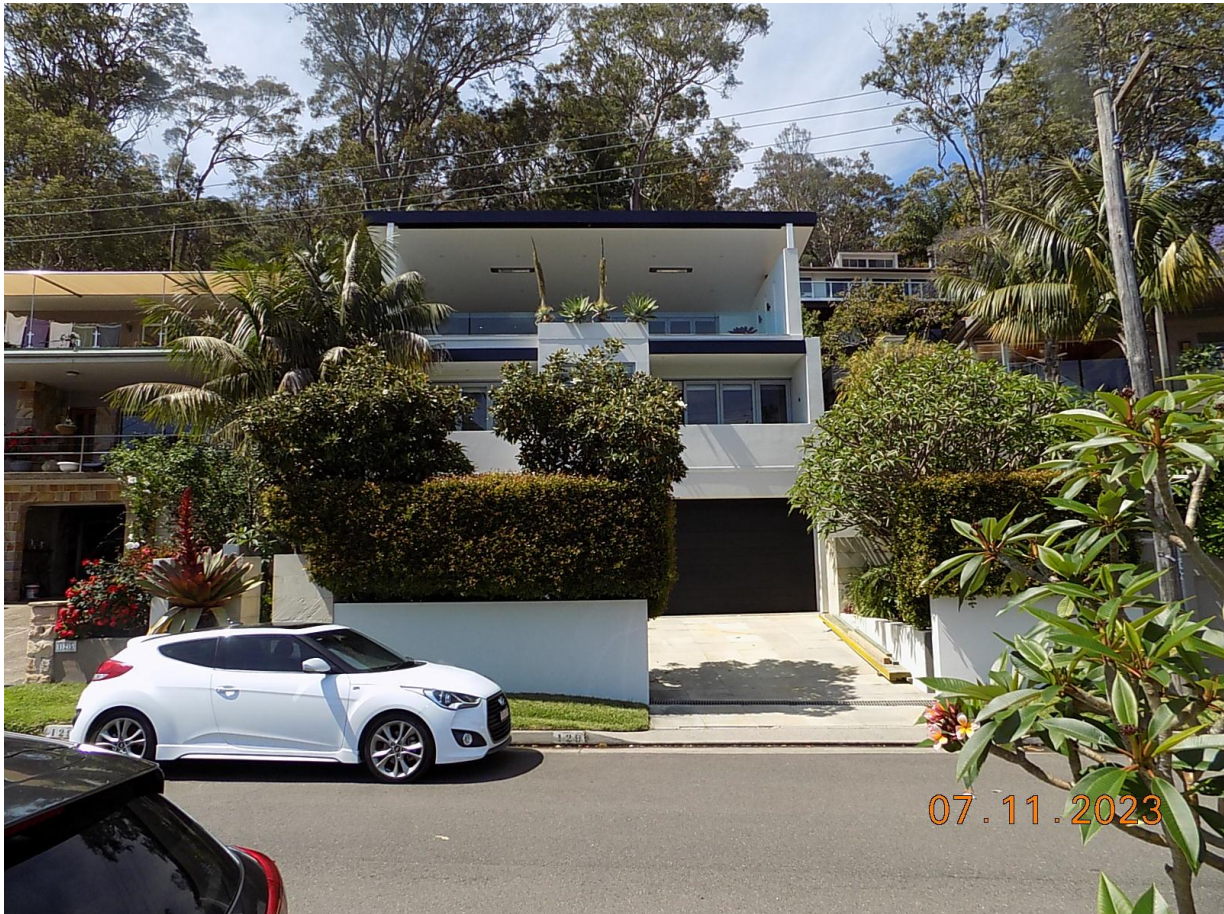
Photo 1

- 2.3** At the road frontage to George Street (Photo 1), a sandstone paved driveway runs to a garage under the downhill side of the house. Between the road frontage and the house, stable low rendered masonry retaining walls support a cut for the driveway and fill for a level lawn area (Photo 2). The part three-story house is supported on rendered masonry walls. No significant signs of movement were observed in the supporting walls. A pool has been cut into the slope above the house (Photo 3). The water level indicates no ground movement has occurred in the shell of the pool since its construction. A stable sandstone clad concrete retaining wall reaching up to ~2.6m

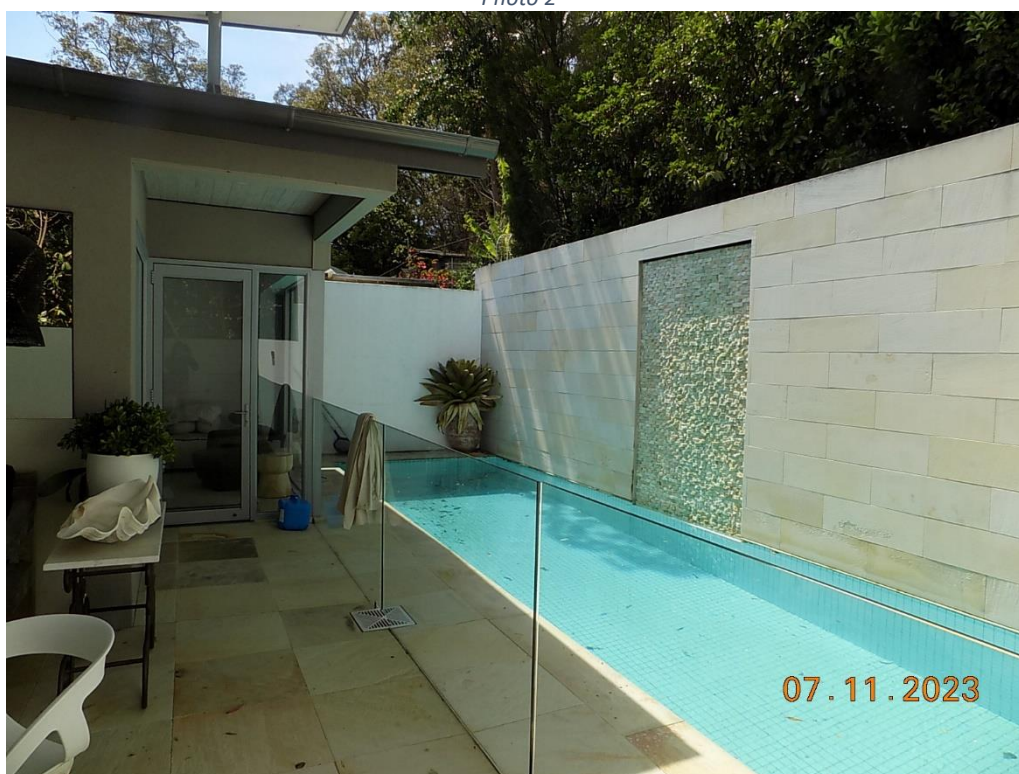
Photo 3

supports the cut for the pool area (Photo 3). A stable low timber retaining wall supports the natural slope immediately above the cut for the pool (Photo 4). A partially constructed pool pavilion remains on the uphill slope (Photo 5) and is supported on concrete piers. Sandstone boulders are scattered across the moderate slope in the middle of the property (Photo 6). These rocks are partially embedded into the slope and are considered to be in stable positions. Competent Medium Strength Sandstone outcrops and underlies the remainder of the steep slope to the Cabarita Road frontage (Photo 7). The outcropping portions of rock were observed to be free from significant geological defects that could affect their stability.

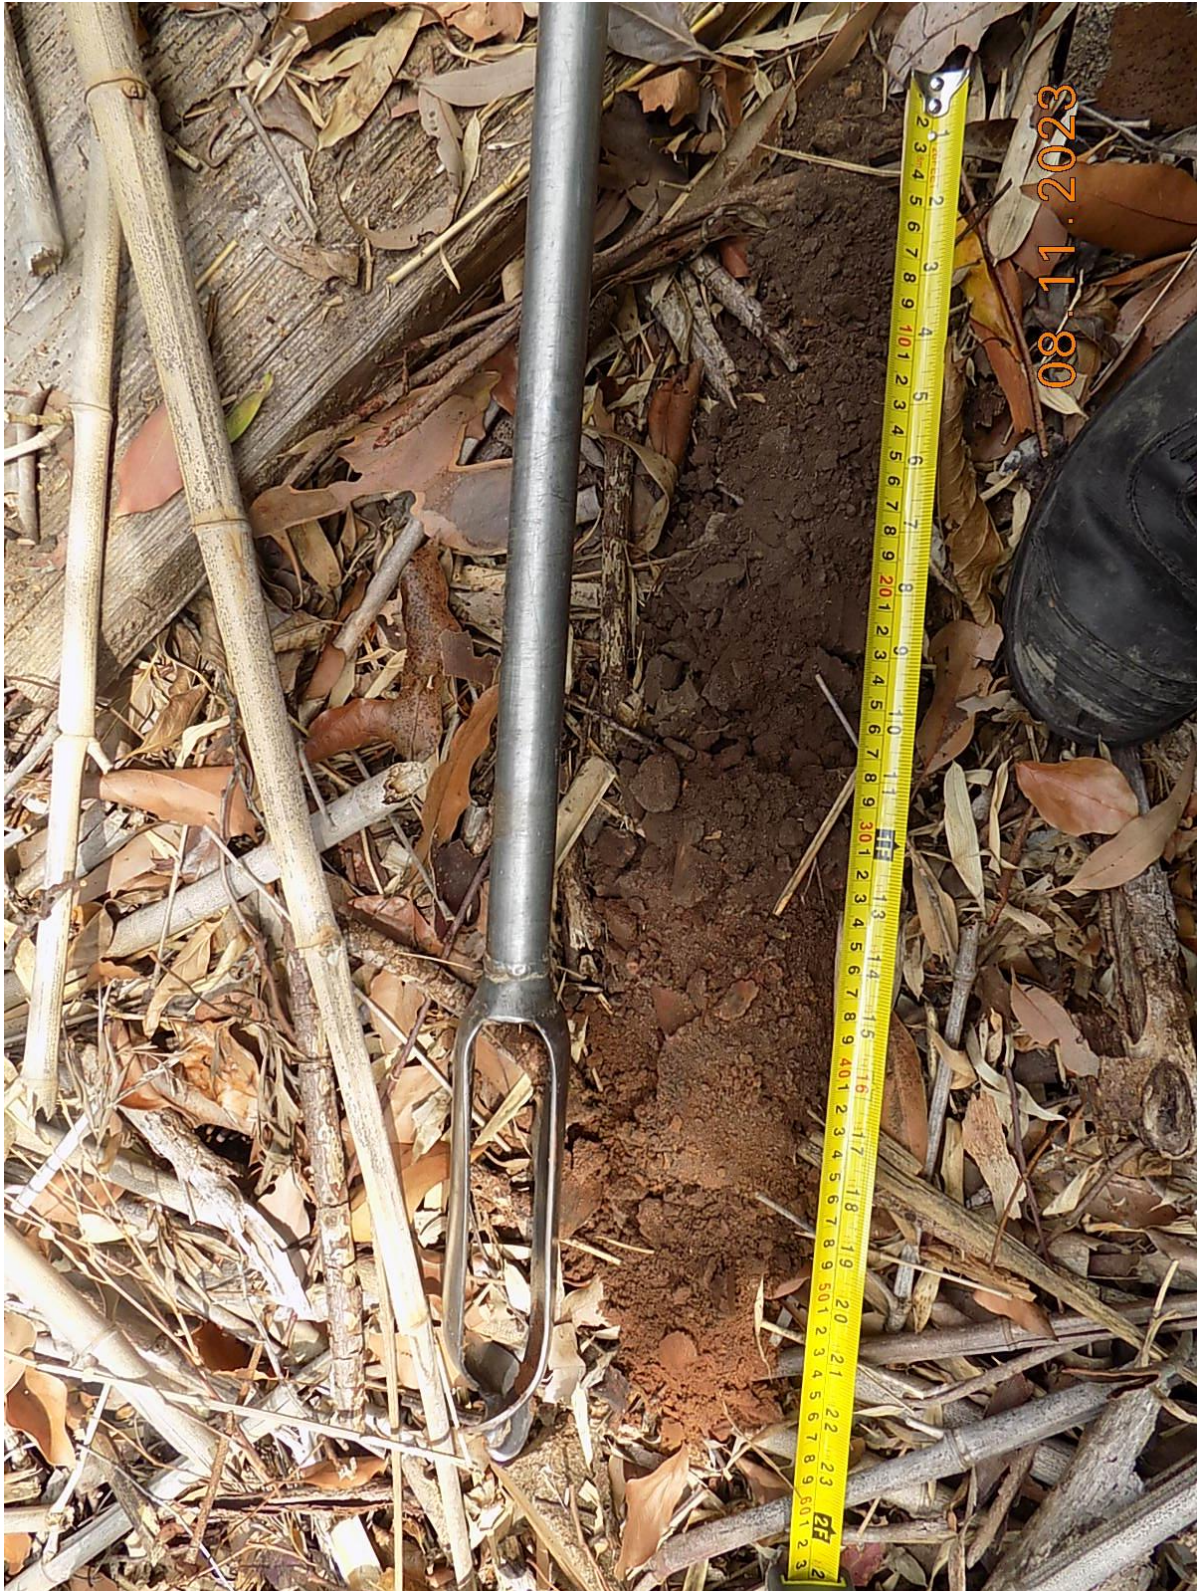
Photo 8 – AH1 - downhole is top to bottom

## AUGER HOLE 1 (~RL29.9) – AH1 (Photo 8)

Depth (m)	Material Encountered
0.0 to 0.3	<b>TOPSOIL</b> , brown, Dense, dry, medium grained.
0.3 to 0.6	<b>SANDY TOPSOIL</b> , brown-maroon, Very Dense, dry, medium grained.

Refusal @ 0.6m in Very Dense Sandy Topsoil. No water table encountered.

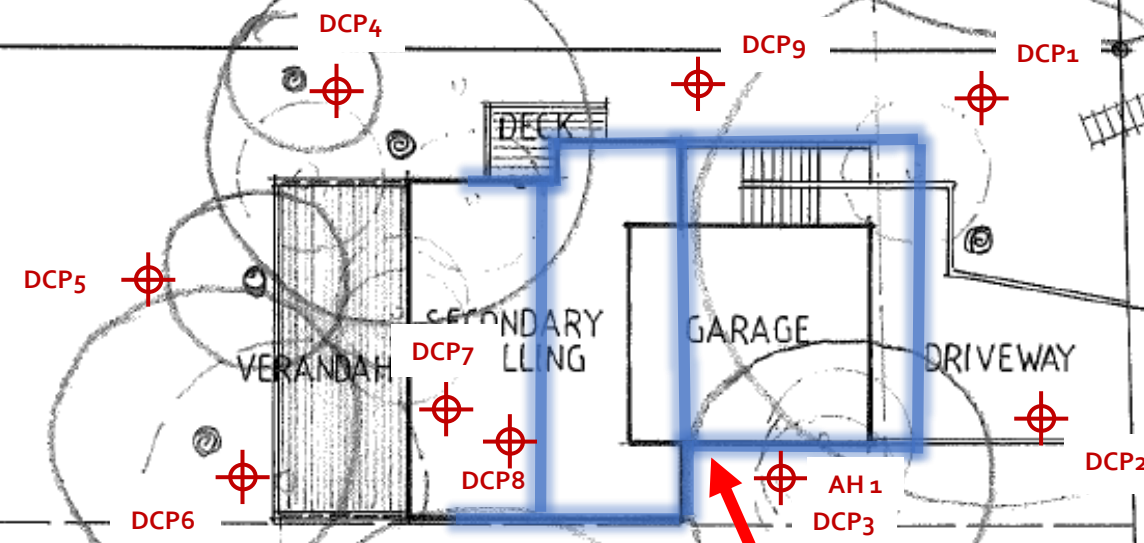
Minimum extent of required shoring shown in blue

Due to the steep grade of the slope at the location of the proposed development and the proximity of the excavation to the W common boundary, all cut faces through topsoil and clay will need to be temporarily or permanently supported prior to the commencement of the excavation, or during the excavation process in a staged manner, so cut batters are not left unsupported. Suitable temporary support includes the installation of bulka bags until retaining walls are in place. See the site plan attached for the minimum extent of the required shoring in blue. The support will need to be designed / approved by the structural engineer.
