87 Alexandra Crescent, Bayview

Comments on Updates to Plans

GEOTECHNICAL INVESTIGATION:

Alterations and Additions at **87 Alexandra Crescent, Bayview.**

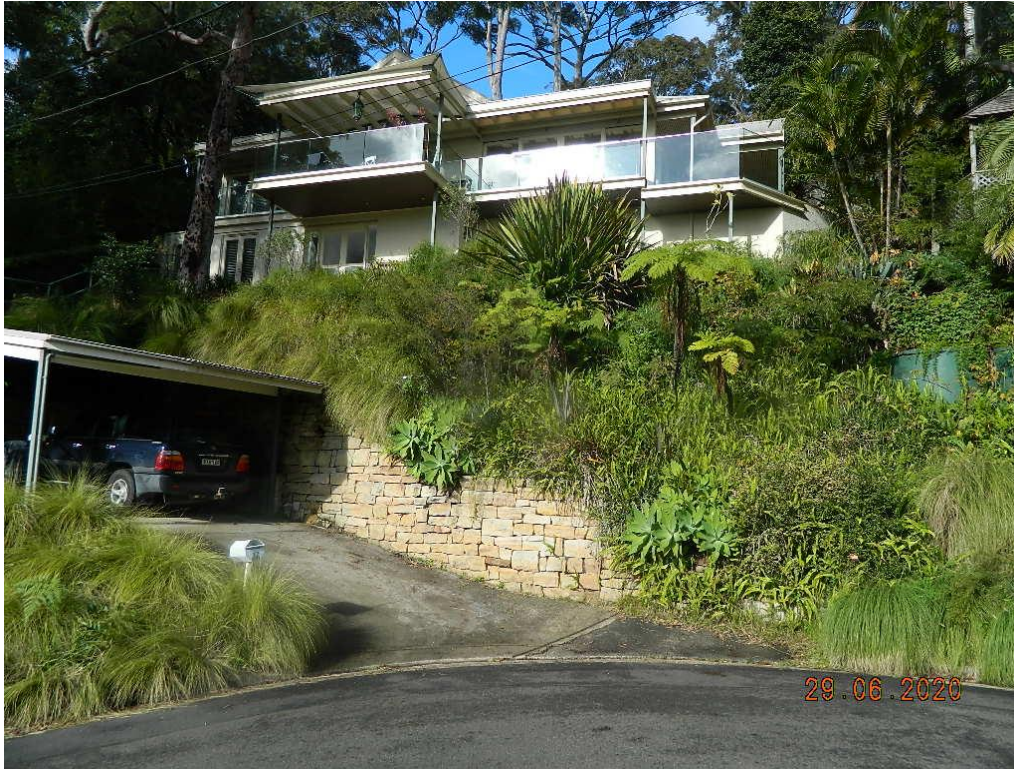
Photo 1

2.3 At the road frontage a concrete driveway runs to a carport cut into the slope (Photo 1). The cut is supported by sandstone block, brick and concrete block retaining walls up to ~3.4m high (Photos 1 to 3). The highest portion of the sandstone block wall is supported by a brick wall in front of the base of the retaining wall (Photo 2). The retaining walls are considered to be stable. Between the carport and the house is a steep and thickly vegetated slope (Photo 1). The part three storey rendered brick and weatherboard clad house is supported by brick walls and brick piers Photos (1 & 4). The supporting walls and piers stand vertical and show no significant signs of movement (Photo 5). Uphill of the house a cut in the slope provides a level platform for the house. The cut is supported by concrete block and sandstone flagging retaining walls up to ~2.7m high. (Photos 6 & 7). The W portion of the concrete block retaining wall is tilting at up to ~4° from vertical. See 'Section 16 Ongoing Maintenance'. A Medium Strength Sandstone bedrock cliff face up to ~7m outcrops above the cut for the house (Photo 8). A portion of the cliff face is undercut by up to ~4.4m (Photo 9). The undercut is considered stable. No geotechnical hazards were observed on the neighbouring properties that could impact on the subject property as seen from the street and subject property.

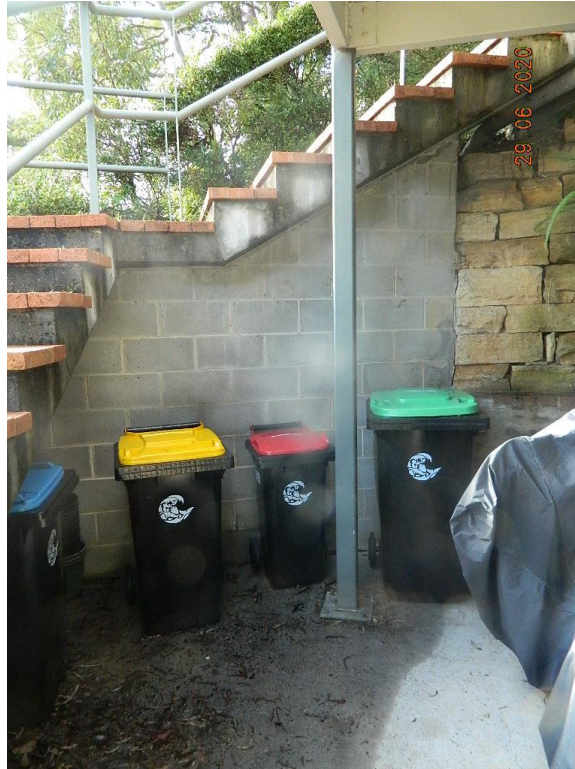
Photo 3

The excavation requires the demolition of part of the existing sandstone block, brick and concrete block retaining walls (Photo 3).

The existing retaining walls (Photo 3) are to be demolished from the top down as the excavation is progressed.

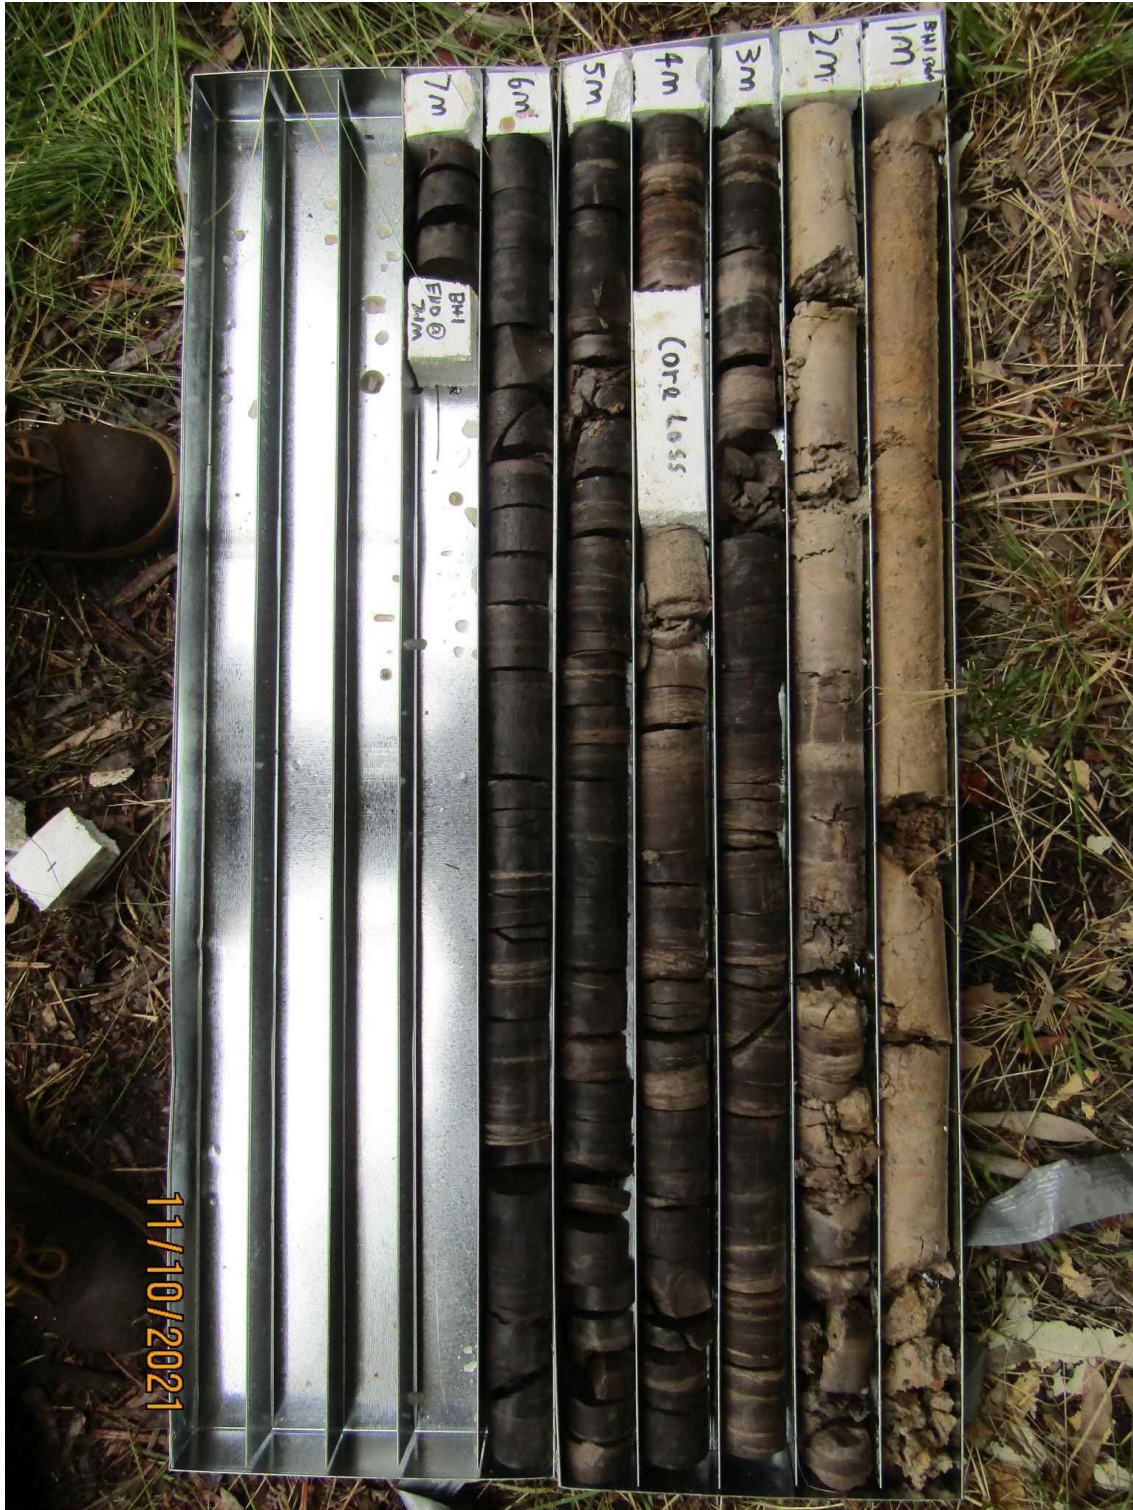
Photo 11: BH1

BORE HOLE 1 (~RL72.9) – BH1 (Photo 11)

1.0 to 2.2	CLAY , brown orange and grey, stiff.
2.2 to 2.4	EXTREMELY LOW STRENGTH SHALE , grey.
2.4 to 3.0	VERY LOW STRENGTH SHALE , grey and black/dark brown.
3.0 to 4.14	LOW STRENGTH SHALE , black/dark brown, grey and orange, parting at variable intervals of between 2cm to 13cm.
4.14 to 4.31	CORE LOSS.
4.31 to 7.1	LOW STRENGTH SHALE , black/dark brown and grey, with grey sandstone laminite, parting at variable intervals of between 2cm to 12cm.

End of hole @ 7.1m in Low Strength Shale. No watertable encountered.

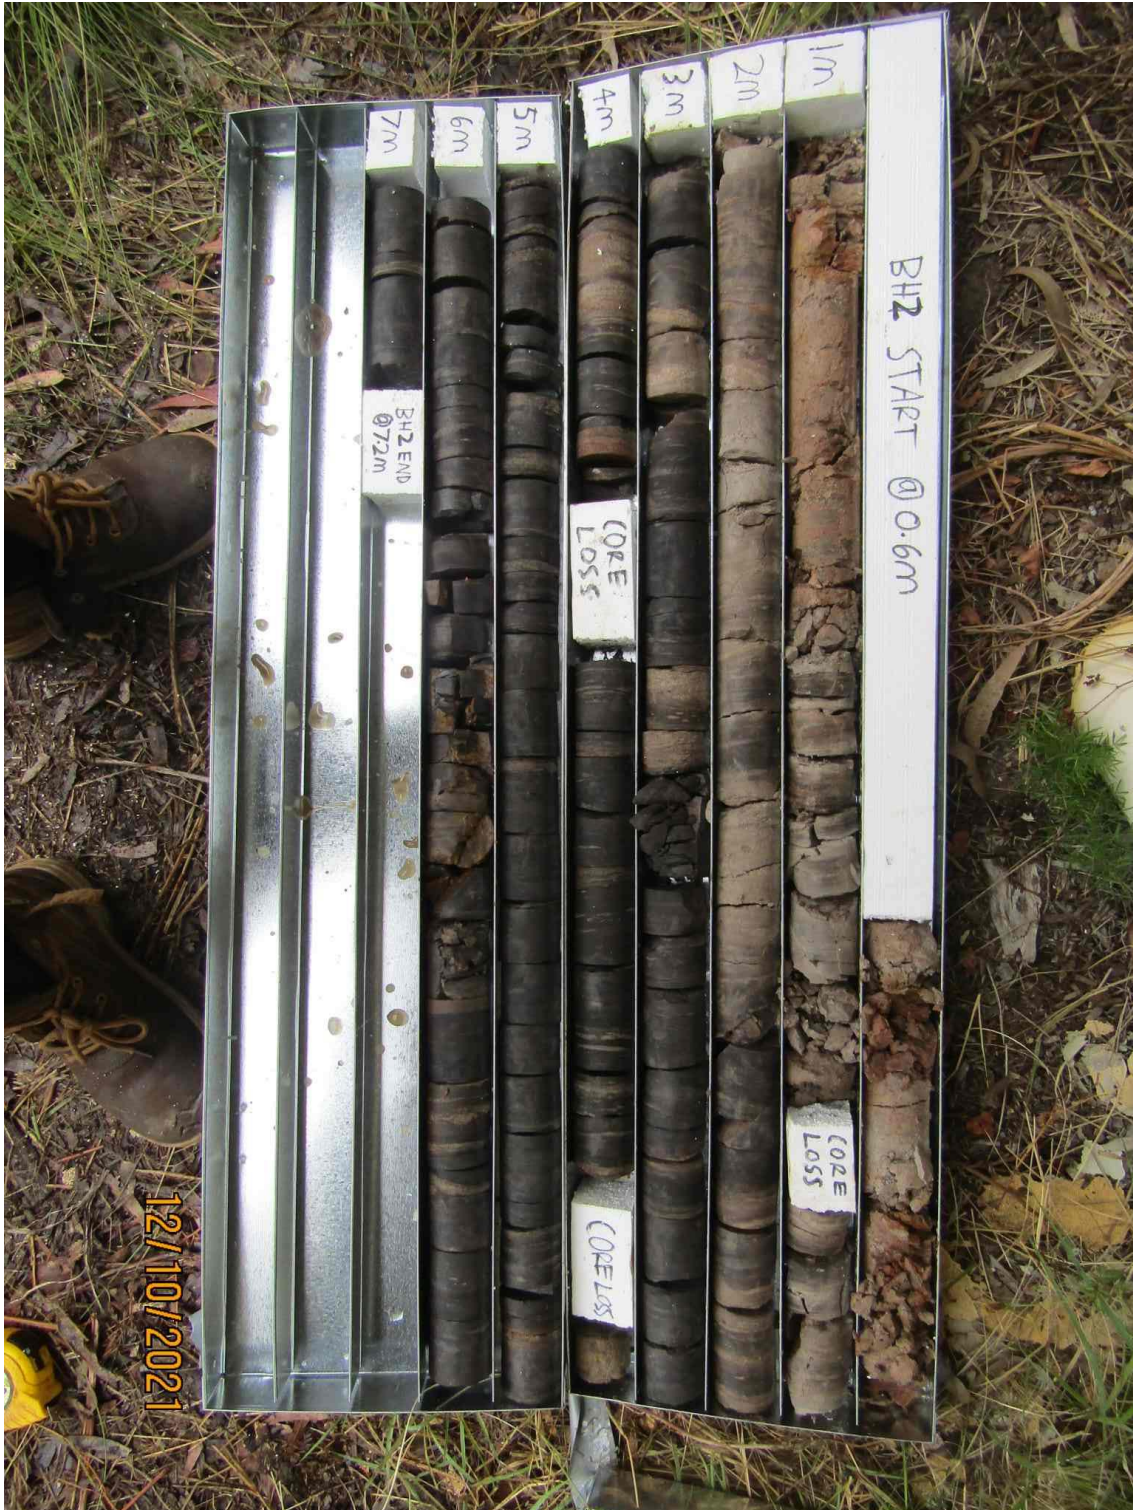
Photo 12: BH2

BORE HOLE 2 (~RL73.0) – BH2 (Photo 12)

0.6 to 1.3	EXTREMELY LOW STRENGTH SHALE , grey, brown and orange.
1.3 to 1.76	VERY LOW STRENGTH SHALE , grey and black/dark brown.
1.76 to 1.83	CORE LOSS.
1.83 to 2.7	VERY LOW STRENGTH SHALE , grey, black/dark brown and orange, with thin grey sandstone laminite, parting at variable intervals of between 4cm to 12cm.
2.7 to 4.28	LOW STRENGTH SHALE , black/dark brown, grey and orange, parting at variable intervals of between 4cm to 12cm.
4.28 to 4.39	CORE LOSS.
4.39 to 4.84	LOW STRENGTH SHALE , black/dark brown and grey, parting at variable intervals of between 2cm to 8cm.
4.84 to 4.94	CORE LOSS.
4.94 to 7.2	LOW STRENGTH SHALE , black/dark brown, grey and orange, with thin grey sandstone laminite, parting at variable intervals of between 2cm to 8cm.

End of hole @ 7.2m in Low Strength Shale. No watertable encountered.
