GEOTECHNICAL INVESTIGATION REPORT

PROPOSED NEW DWELLING 30 ABERNETHY STREET, SEAFORTH NSW

> PREPARED FOR ADAM MCDOUGALL REPORT ID: G22061SEA-R01F

Date: 6th September 2022 **Revision No.**: 0

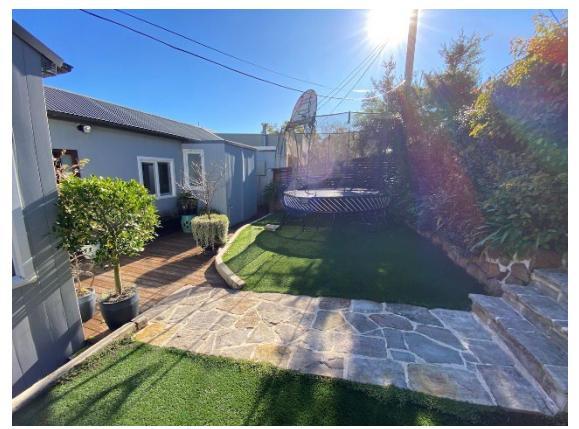
Plate 1 – Front yard of No.30, facing north.

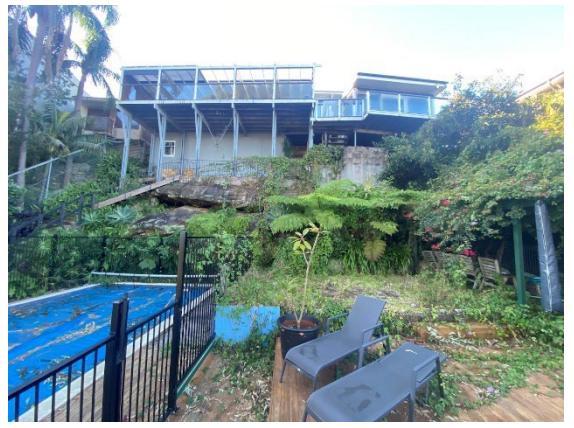
Plate 3 – Rear of the dwelling showing the central sandstone cliffline and natural benched area below, facing east.

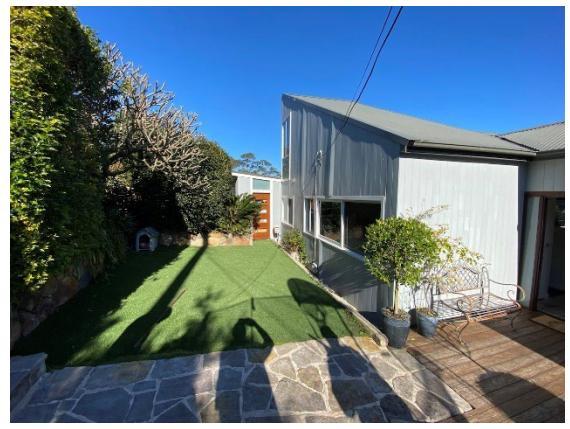
Plate 2 – Front yard of No.30, facing south.

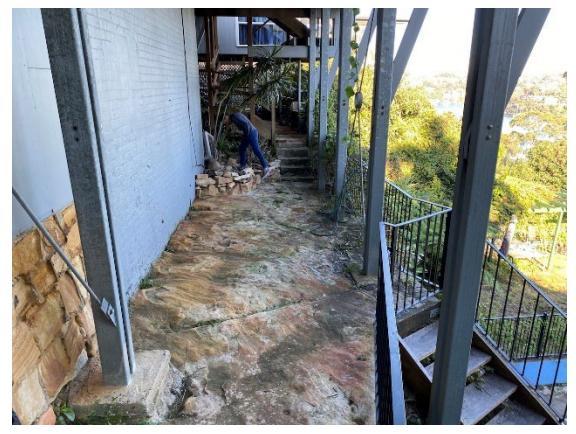
Plate 4 – Brick and steel post supports for dwelling and decking founded on crest of central cliffline.

The existing dwelling was a single storey brick and weatherboard structure founded on a brick wall and brick piers above and into the stepped sandstone cliffline. The building was in a poor condition due to termite infestation, however the structural elements such as brick walls and piers where observed appeared to be in a sound condition.

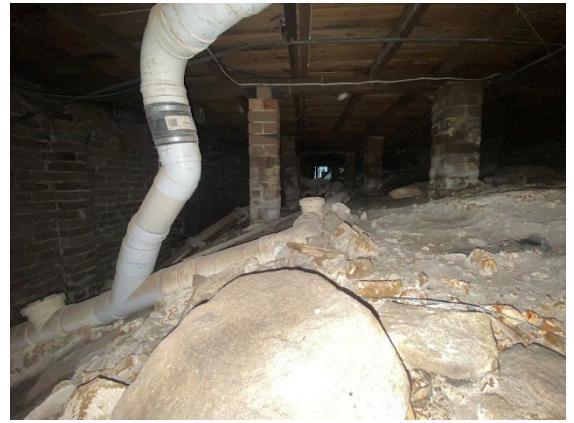
Plate 5 – Piers supporting dwelling founded directly onto upper sandstone cliffline.

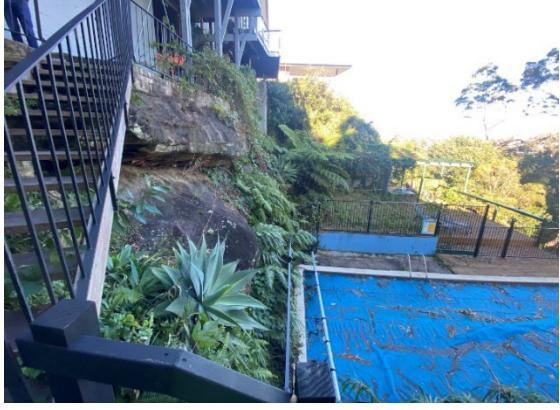
Plate 6 – Central sandstone cliffline downslope of dwelling facing south.

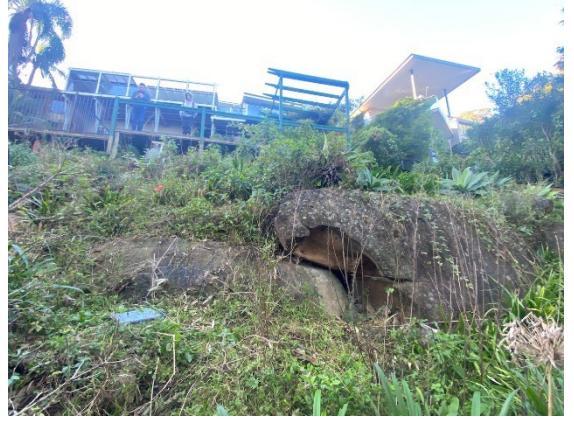
Plate 9 – Sandstone outcrop in proximity to site boundary.

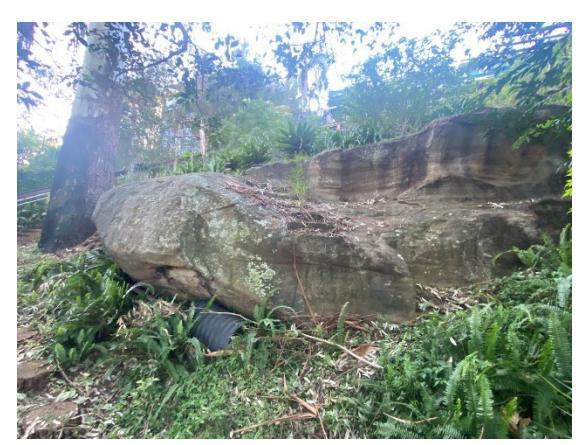
Plate 10 – Sandstone outcrop to west of site boundary.

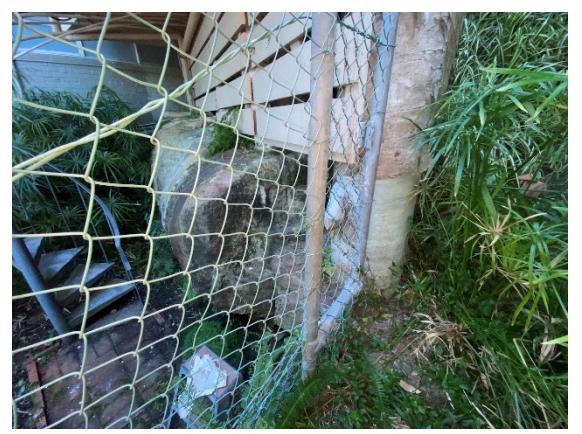
The area immediately to the north of the site forms a narrow easement that accesses both No.28 and No.32a located downslope (west) of No.30. The garage located at street within the easement belongs to No.32. Both sites are accessed by an inclinator that runs down the boundary with No.30. The single garage is supported on concrete piers that are in proximity to the site boundary. The founding condition of the garage piers was not determined during the investigation.

Plate 11 – View of concrete pier supporting No.32 garage located on the northern boundary.

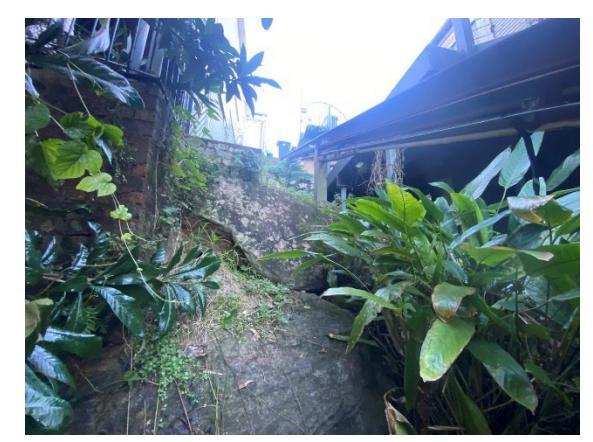
The area immediately to the south of the site also forms a narrow easement that allows access to the property located immediately downslope of No.26 and presumably is No.26a. The inclinator used to access this property runs down this easement. The upper section of the inclinator has been directly founded onto the outcropping sandstone clifflines that continue from No.30 southwards into No.26. The slope beneath the shared carport for No.26/No.26a? has been excavated into the sandstone bedrock to a height of about 2.0m to create a storage area. The excavation extends to the boundary with No.30 with the concrete carport for No.26 currently supported on concrete piers.

Plate 12 – View of inclinator founded on insitu detached sandstone boulder within easement located along the southern boundary.

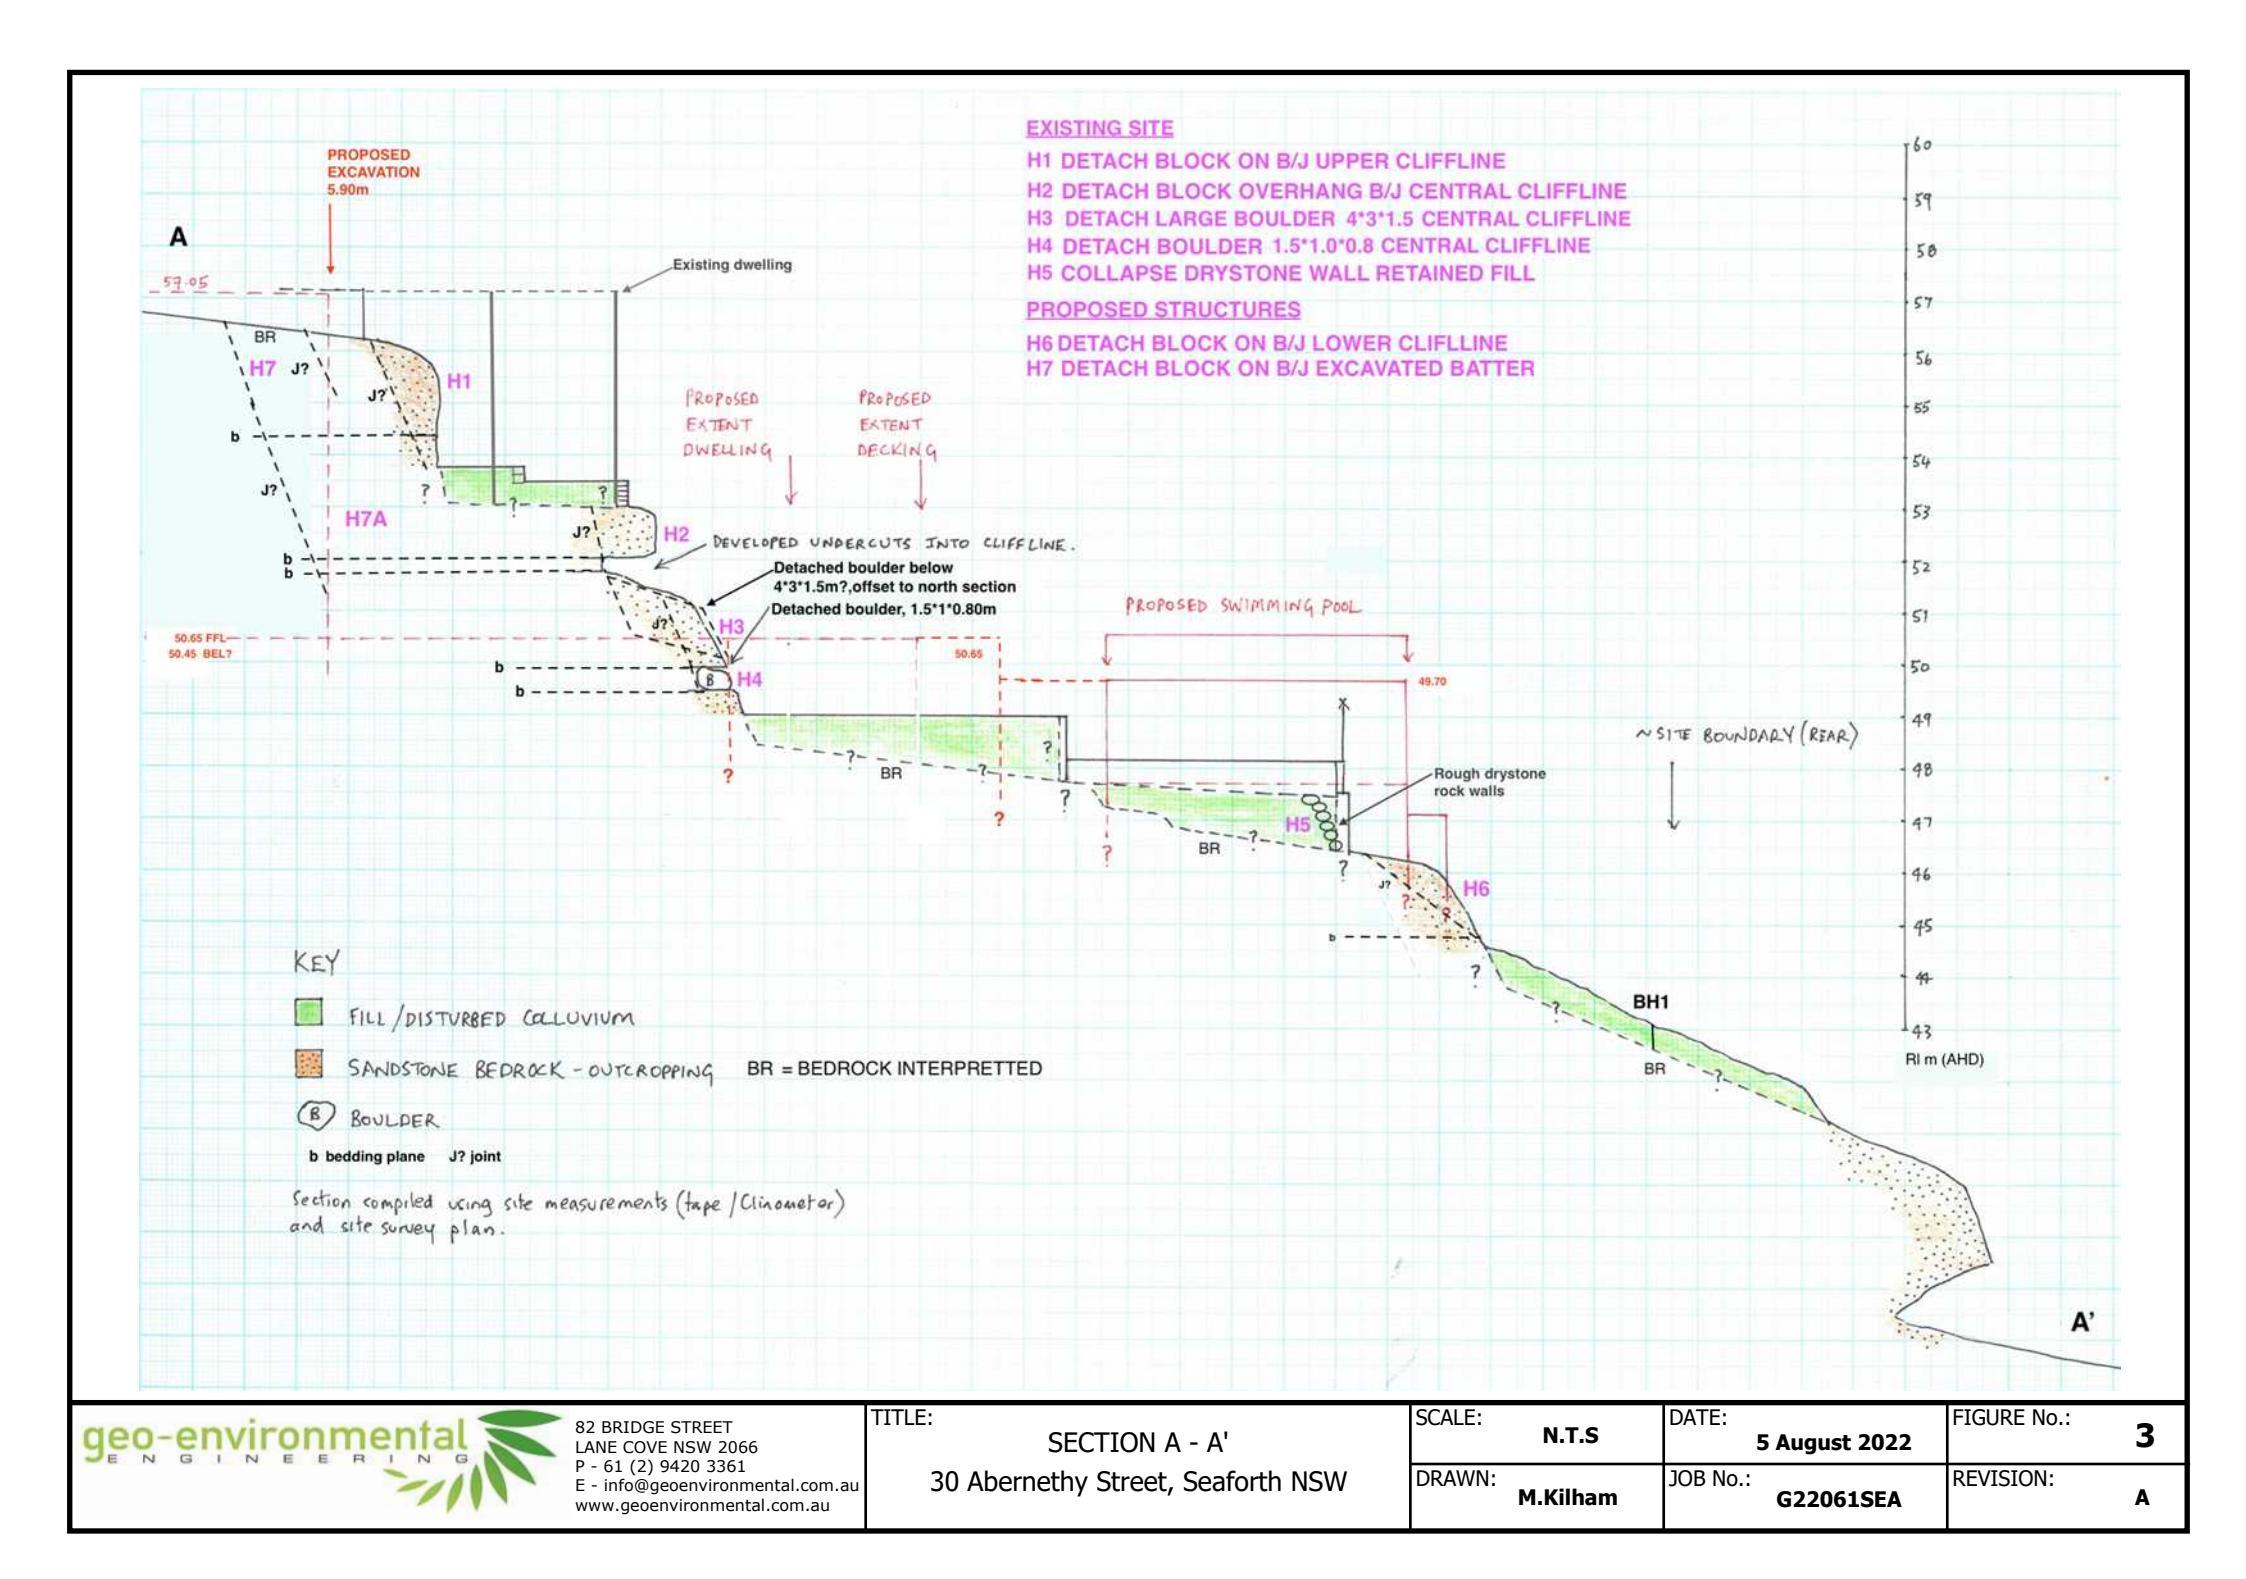
- Hazard 1: Detach block from bedding/jointing from upper cliffline, (4*1*1.5).
 Mechanism: Failure along weathered back joint.
- Hazard 2: Detach block from developed overhang, (3*1*0.7).
 Mechanism: Failure along weathered back joint.
- Hazard 3: Detached boulder slide, (4*3*1.5).
 Mechanism: Weathering, rainfall event.
- Hazard 4: Detached boulder slide, (1.5*1*0.8).
 Mechanism: Weathering, rainfall event.
- Hazard 5: Failure drystone wall retaining fill, (2*1*1 = 2m³).
 Mechanism: Saturation of retained fill.
- Hazard 6: Detach block on bedding/jointing, (3*0.8*0.8).
 Mechanism: Failure along weathered back joint.
- Hazard 7: Detach block on bedding/jointing from excavated batter, (4*2*1.5).
 Mechanism: Failure along weathered back joint.
- 4.2.2 SLOPE RISK ASSESSMENT RESULTS
