H2O Consulting Group Pty Ltd

Marine Habitat Survey: 23 and 25 – 33 Robertson Road, Scotland Island

February 7, 2018

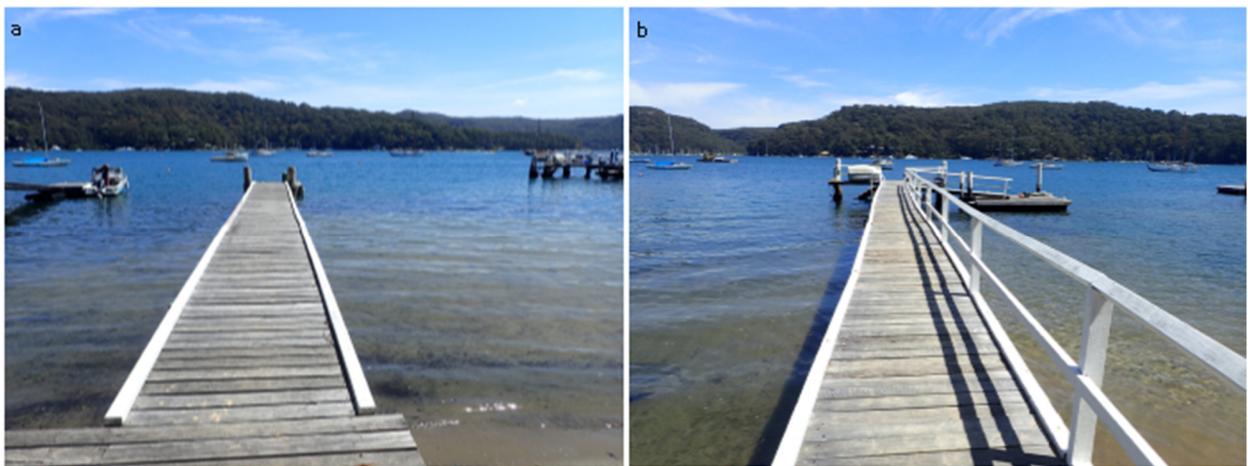
The adjoining shoreline is moderately sloping and well vegetated with a mixture of native and ornamental trees. The site includes a boatshed on both No: 23 and 25-33, each with a jetty that extends seaward to a pontoon, and an additional landing structure and seastairs on No: 25-33 (Figure 5).

Figure 5: Existing jetties for (a) No: 23 and (b) No:25-33 at the subject site.

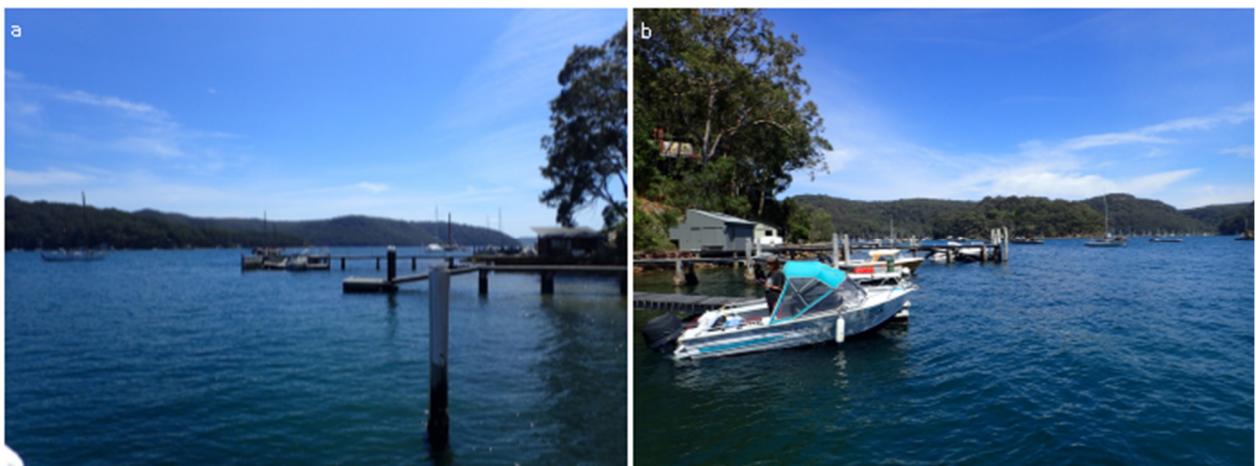
Figure 6: Neighboring waterfront structures to the (a) north and (b) south of the subject site.

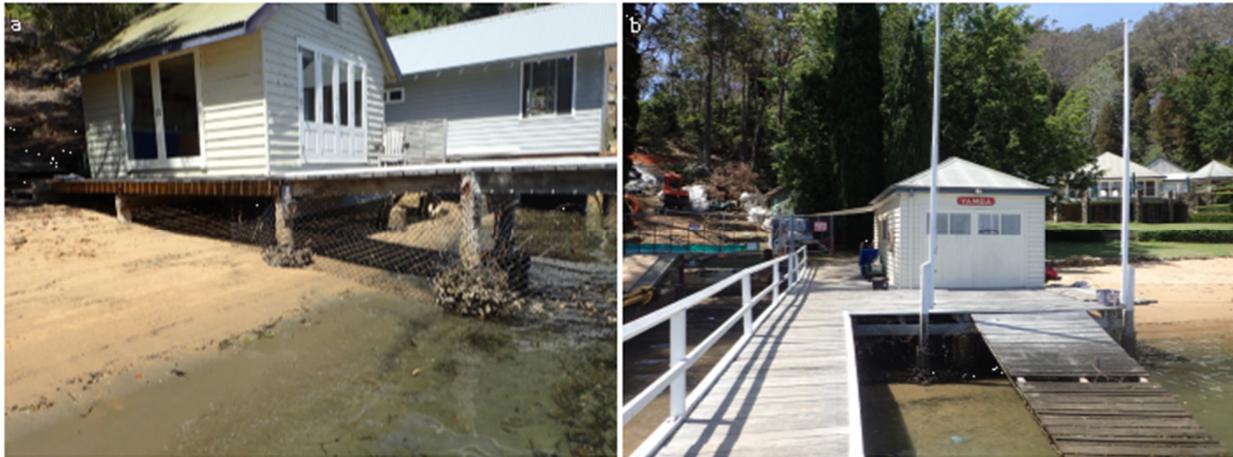
The intertidal zone was predominantly a protected sandy beach and extended 10-15 m from the shoreline. Hard substrate was limited to artificial structures provided by the pylons and piers for the existing water front structures, meshing under the jetties, and a small area of sea wall at the northern end of the site (Figure 7). These structures were dominated by Sydney rock oysters (*Saccostrea glomerata*) and oyster limpets (*Patelloida mimula*).

No intertidal vegetation, other than turfing algae amongst oysters was present.

Figure 7: Typical intertidal habitat around the boatsheds at (a) No: 23 and (b) No: 25-33, within the study area.

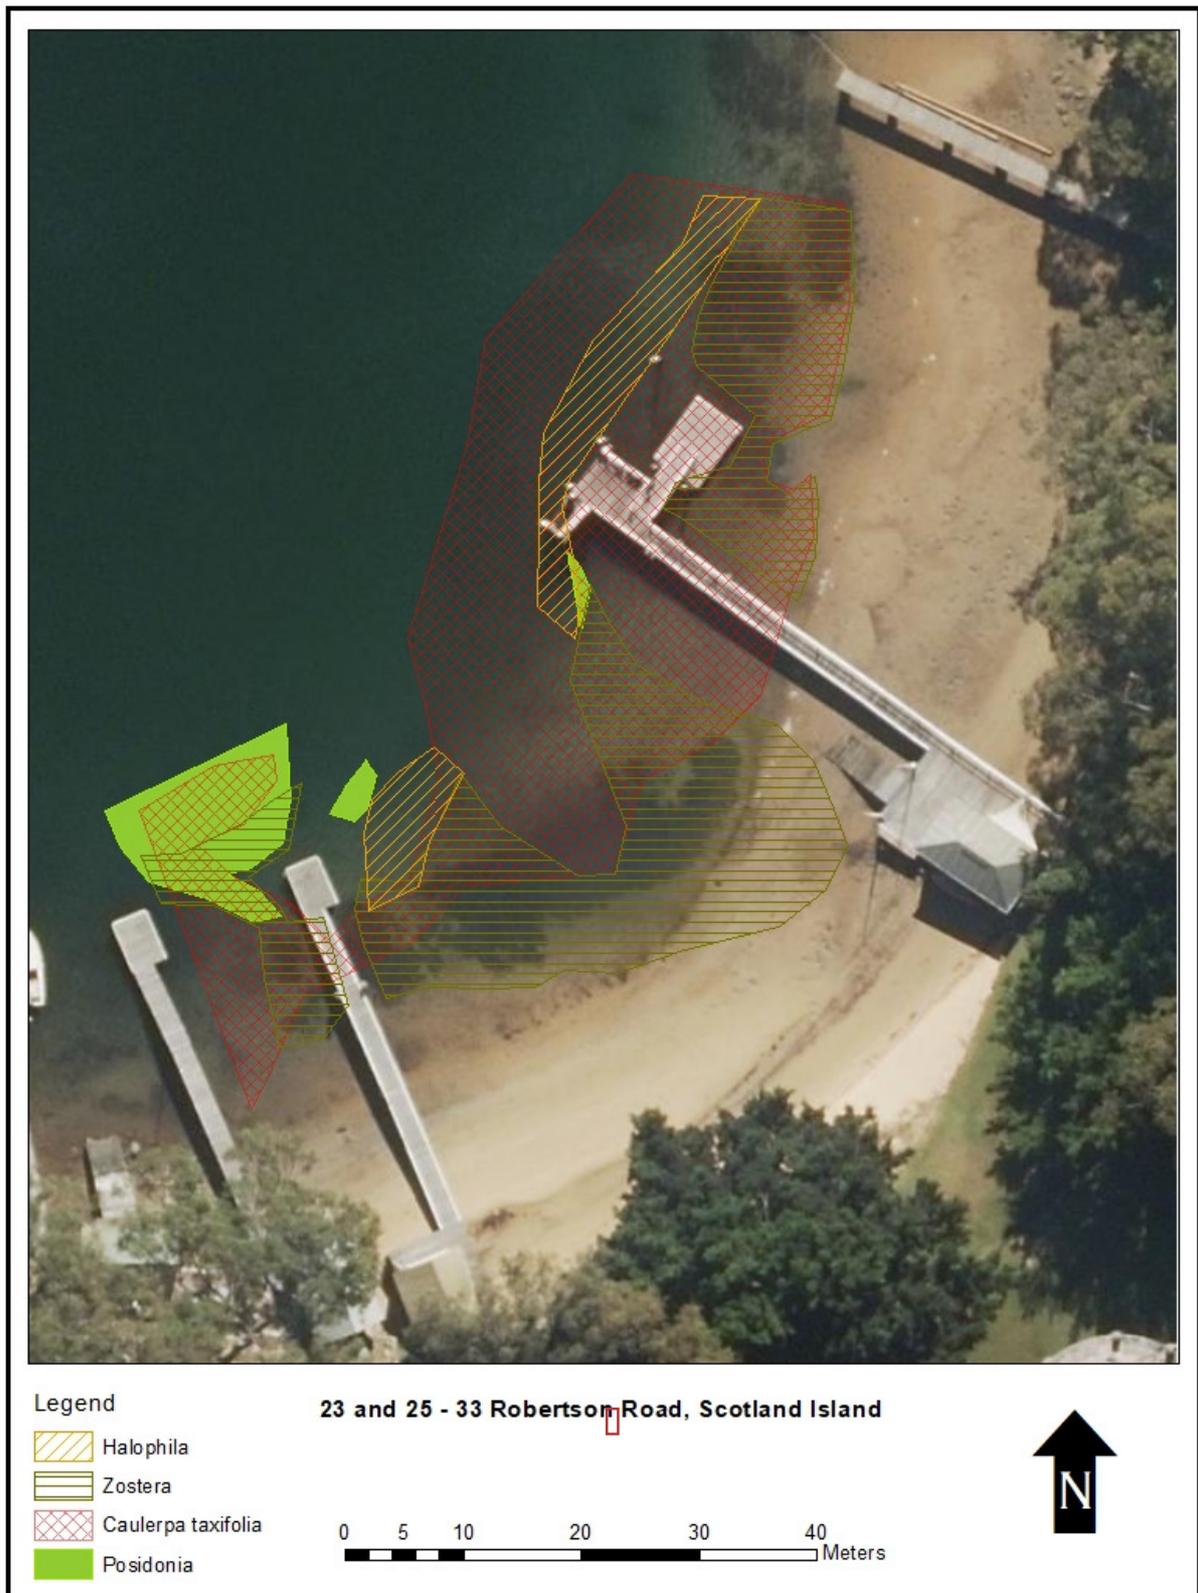
The subtidal habitat consisted of sandy sediments with seagrasses and the green alga *Caulerpa taxifolia* (Figure 8). Seagrasses included beds of *Zostera capricorni* in shallower areas. The *Z. capricorni* was growing in good health, high density and with long leaf lengths to 30 cm in some places, while in poorer health, lower density and in competition with *C. taxifolia* in other places (Figure 9). In deeper areas, the seagrass *Halophila ovalis* was more common, typically growing along the 2 to 3m depth contour and seaward of the *Z. capricorni*. The *H. ovalis* at the subject site was also in typically good health, but very variable densities that ranged from low to medium and a patchy distribution, and also was competing with *C. taxifolia* in places (Figure 10). There were also some remnant beds of *Posidonia australis* present in the study area, these appeared to be typically restricted to the southern end of the subject site, on the southern side of the pontoon for No: 23 (approximately 3 m from) and typically growing seaward in medium density into deeper water (Figure 11). There were also some small patches of medium density *P. australis* growing 3 m north west of the pontoon for No: 23 and 2m south of the seastairs for No:25-33 (Figure 8). The *P. australis* at the subject site was typically growing in association with other seagrasses, and in competition with *C. taxifolia*.

Figure 8: Map of benthic habitat in the study area.

The endangered seagrass community *P. australis* was present at the subject site (Figure 8). Although it was predominately restricted to deeper areas on the southern side of the site. In other areas it appears to have been displaced by *C. taxifolia* and potentially other seagrass species, which are earlier colonizers. The *P. australis* at the subject site was in good health growing with moderate density and leaf lengths to 40 cm (Figure 11).

The invasive green alga *C. taxifolia* was very abundant at the subject site and appeared to extend into deeper water (+5m depth) on the northern side of the subject site (Figure 8). In many areas it was growing in high density forming monocultures and appearing to displace/ restrict the spread of seagrass species. It was also noted growing amongst the meshing under the jetties and on the pylons (Figure13).

- ❖ Silt curtains be used to reduce impacts of turbidity on nearby seagrasses during works with potential to mobilize sediments.
- ❖ The works should include no excavations below the LWM. All piling should be done by driving, and structures should be lifted from the water.
- ❖ On removal of structures from the water, a seawater wash-down should be implemented to wash any cryptic mobile fauna back into the water.
- ❖ No anchoring and/or grounding of construction vessels or storing of materials on the seafloor in seagrass habitat.
- ❖ Disposal of all materials removed from the water at an appropriate landfill site. No materials removed from the water at this site should be returned to the water at other sites due to the presence of *C. taxifolia*.

- ❖ Construction equipment should be cleaned and washed down before leaving site to prevent the spread of *C. taxifolia* to new sites.

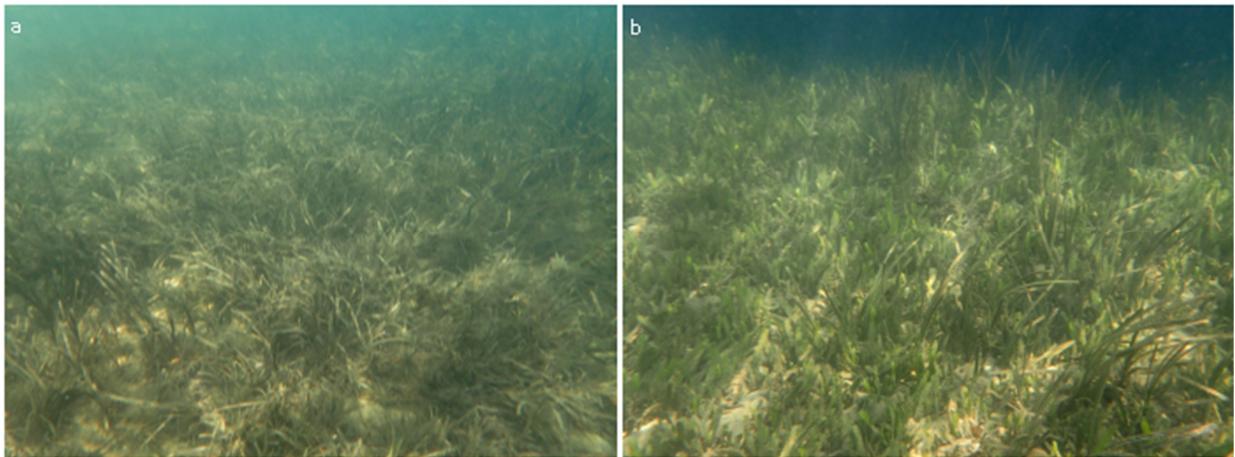
Figure 9: Seagrass *Zostera capricorni* (a) growing in high density, and (b) in lower density with *Caulerpa taxifolia*, in the study area.

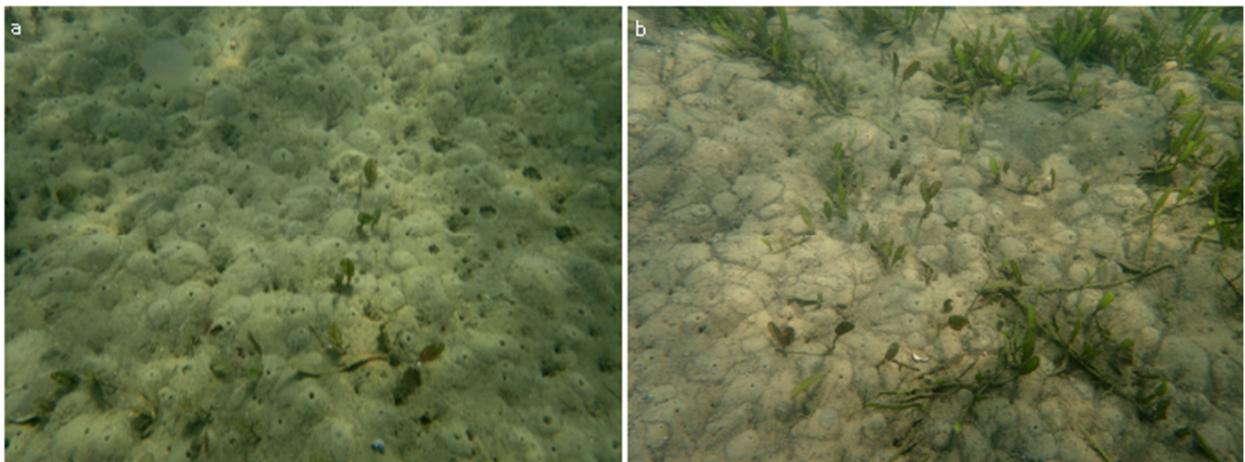
Figure 10: Seagrass *Halophila ovalis* (a) growing in low density, and (b) with *Caulerpa taxifolia*, in the study area.

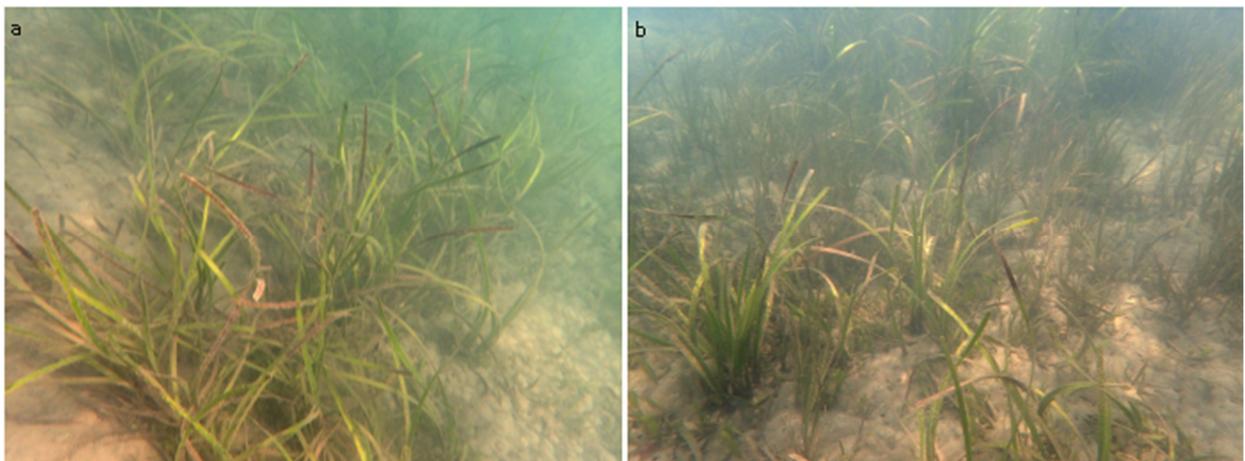
Figure 11: Seagrass *Posidonia australis* (a) growing in medium density, and (b) in lower density with *Zostera capricorni* in the study area.

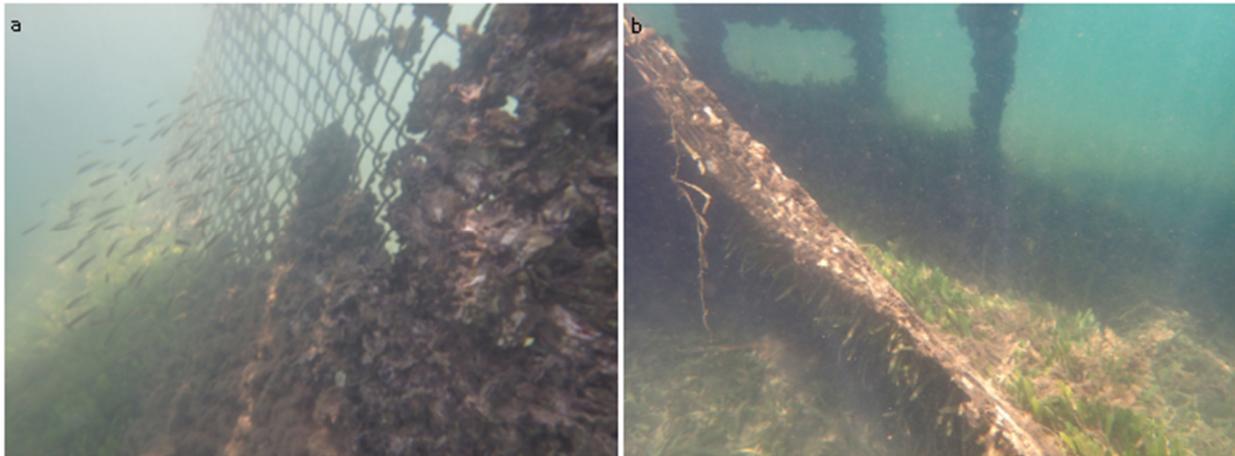
The mesh below the jetties also created additional subtidal habitat that was covered with both Oysters in shallower areas and the alga *C. taxifolia* in deeper areas (Figure 12).

Figure 12: The mesh under the jetties with (a) oysters and eastern hula fish, and (b) with *Caulerpa taxifolia*.

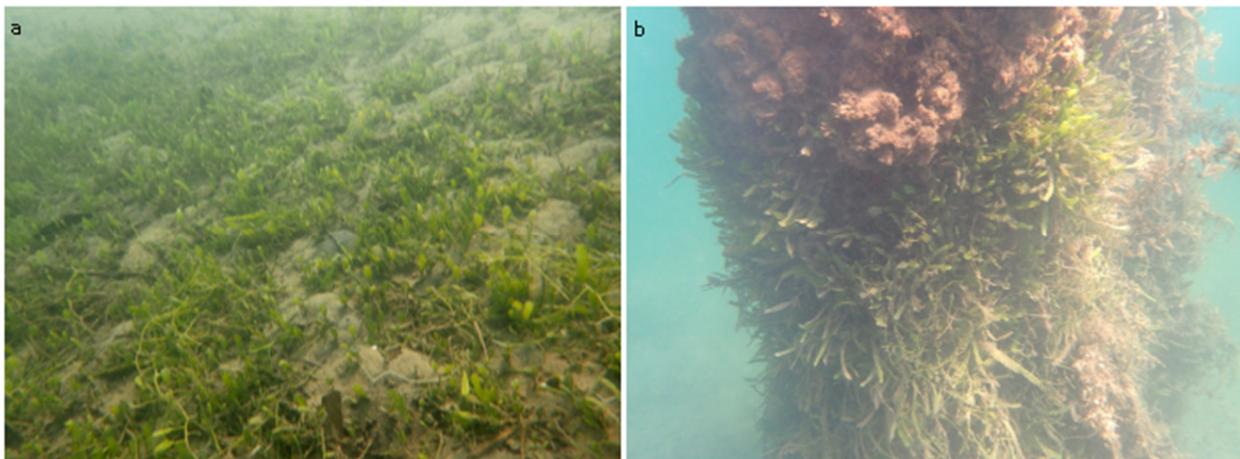
Figure 13: *Caulerpa taxifolia* (a) growing in dense monocultures, and (b) with on the pylons, in the study area.
