Patbay Pty Ltd 98 Prince Alfred Parade Newport NSW 2106 Project 85382.00 23 March 2016 85382.00.R.001.Rev0 RKL:pc

Geotechnical Assessment New Residence 81 Prince Alfred Parade, Newport

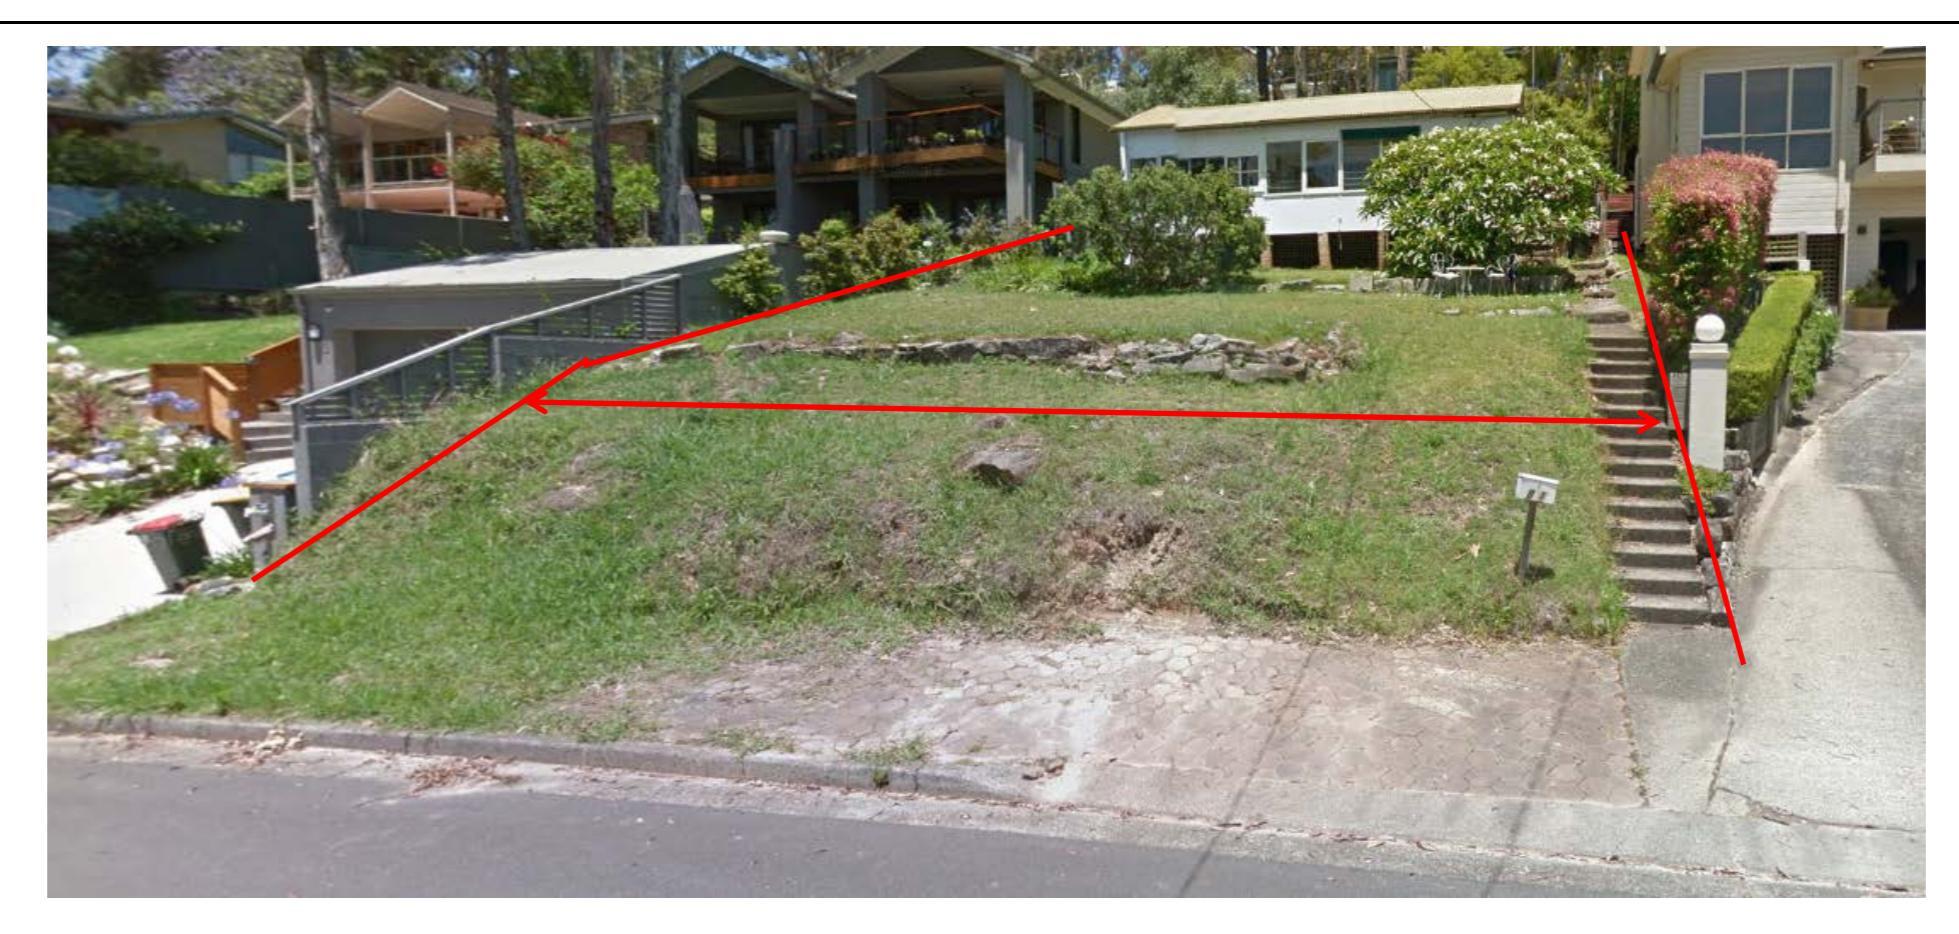
- the site slopes from south to north generally at a relatively uniform slope angle (of about 13<sup>°</sup>) from the southern boundary to the northern boundary with a steeper batter (of about 33<sup>°</sup>) to a paved parking bay and the nature strip next to the concrete street kerb.
- there is currently no on-site parking and the cottage is accessed via a set of concrete steps along the western boundary (refer to Photo 1).

Photo 1. Panorama of the site viewed towards the south. Note marked boundaries are approximate only.

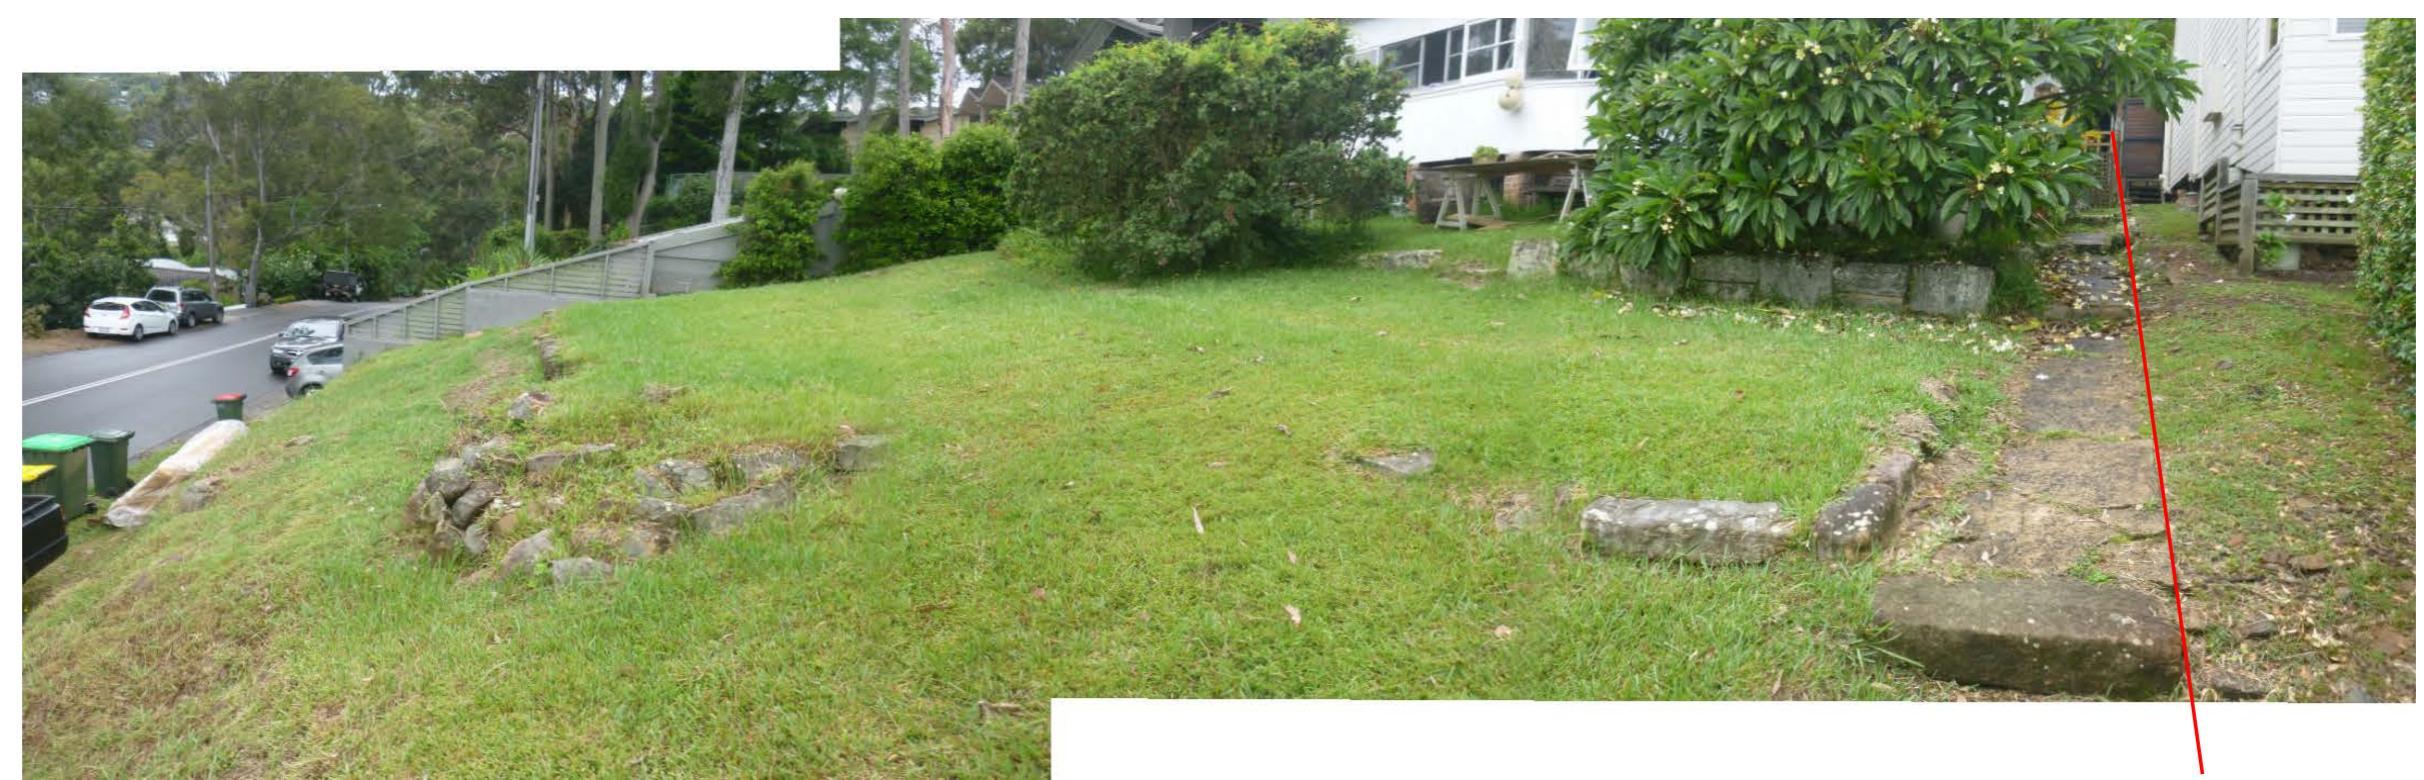
Photo 2. Panorama of the northern portion of the site viewed towards the east.

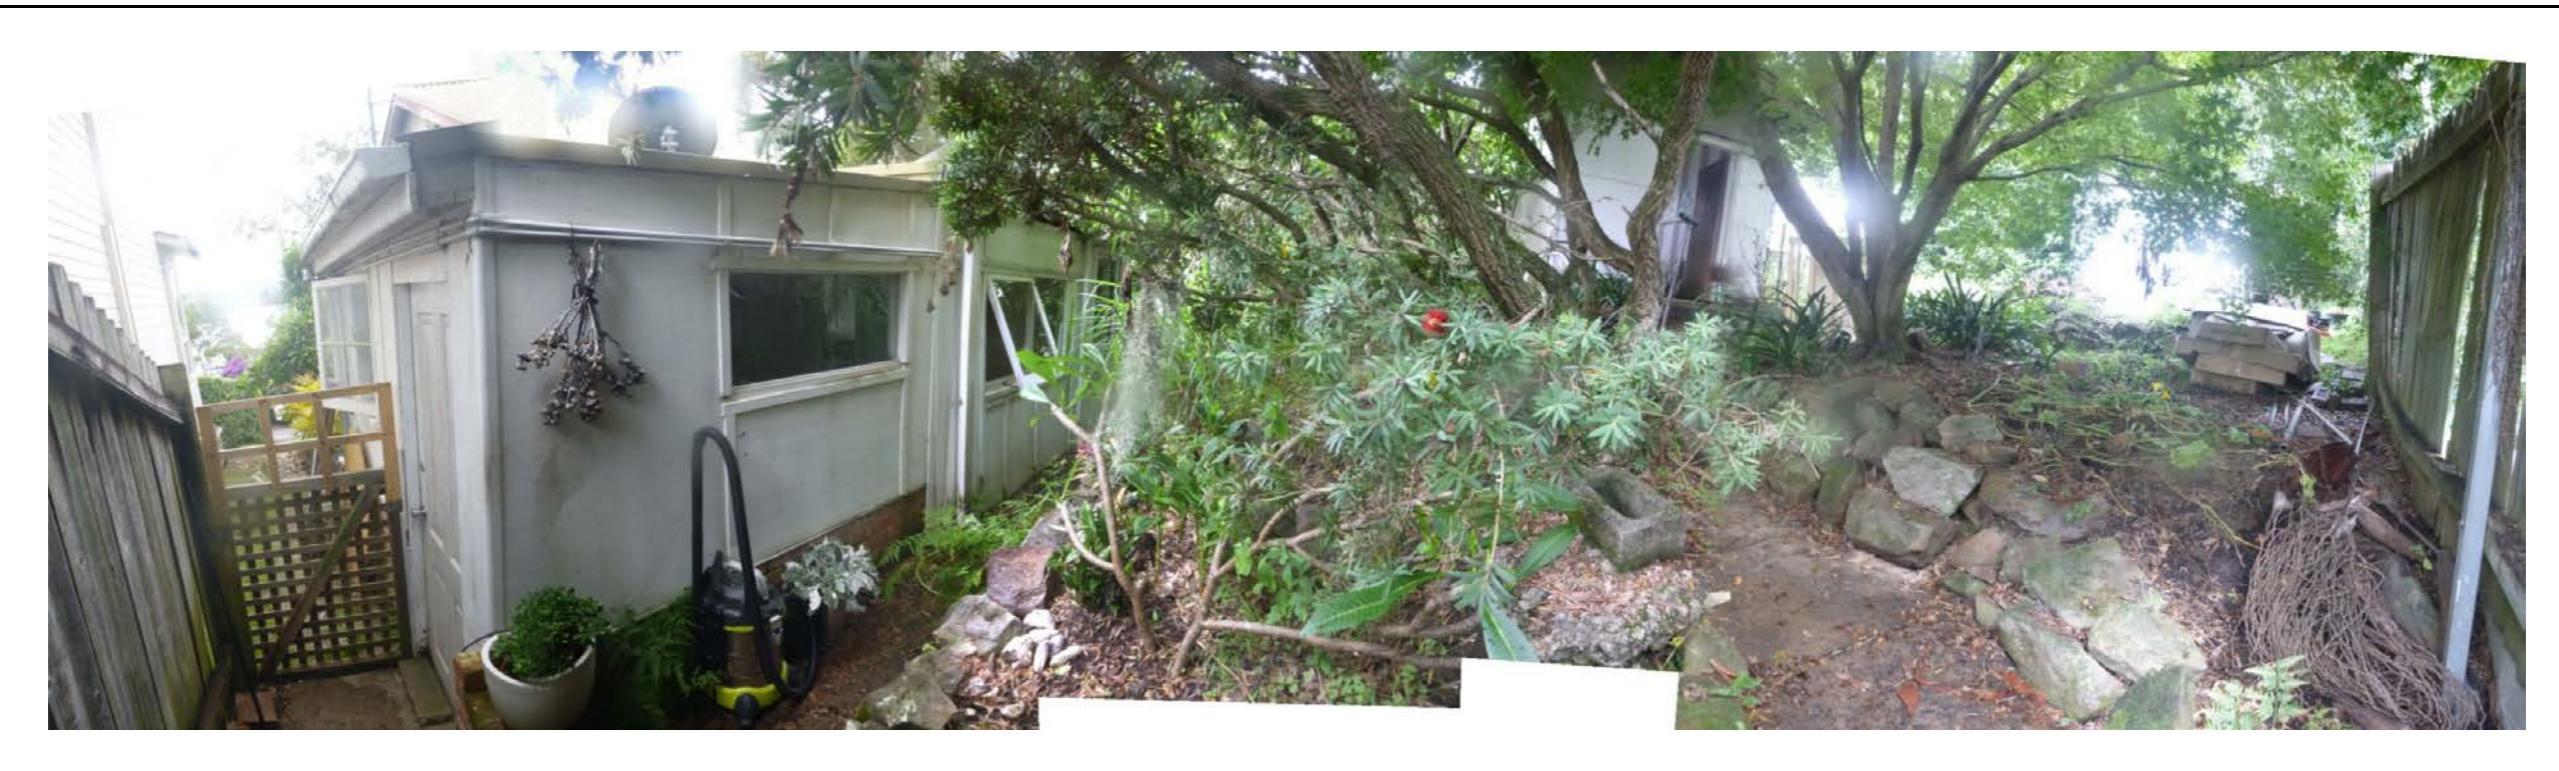
Photo 3. 180 degree panorama of the upslope side of the existing cottage viewed towards the east.

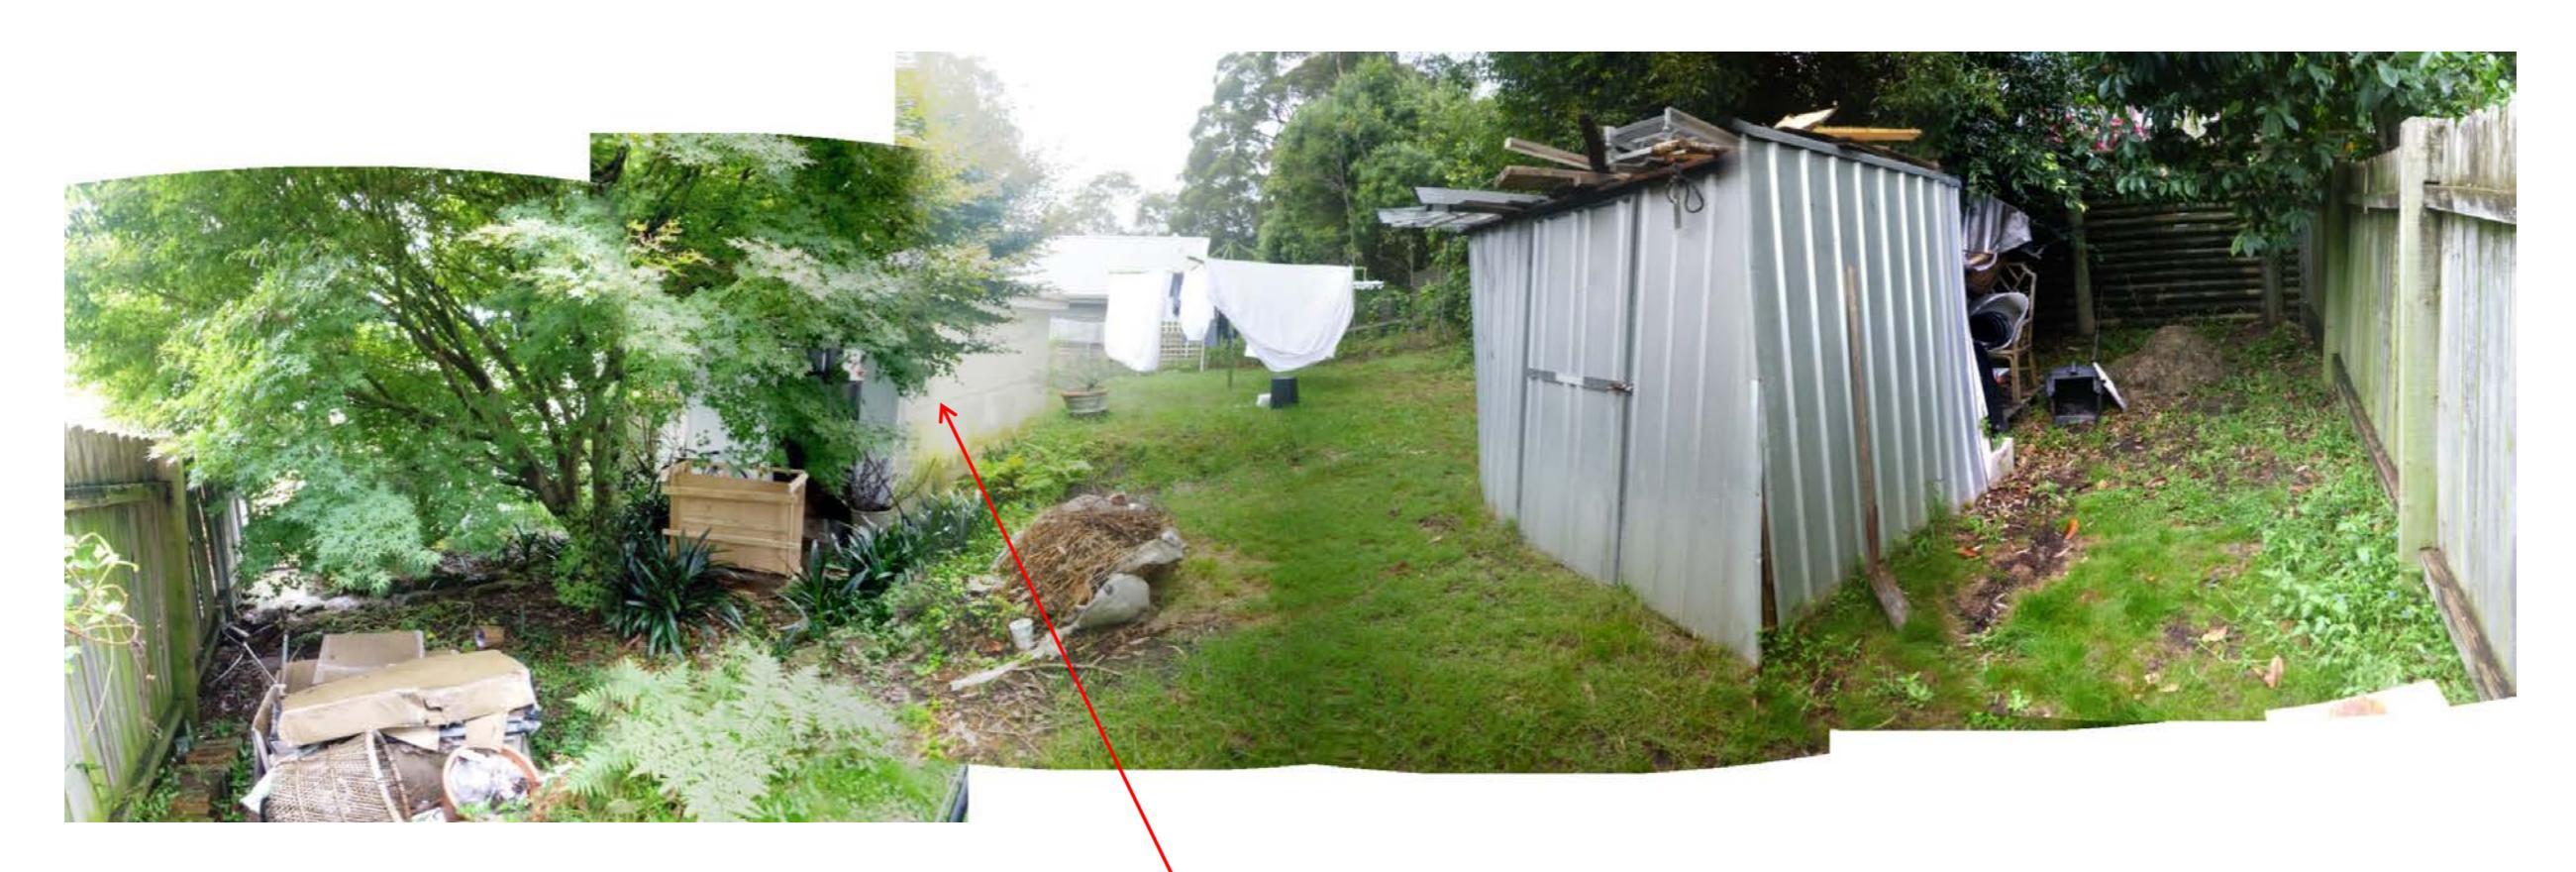
Photo 4. 180 degree panorama of the upslope side of the fibro shed, viewed towards the east .

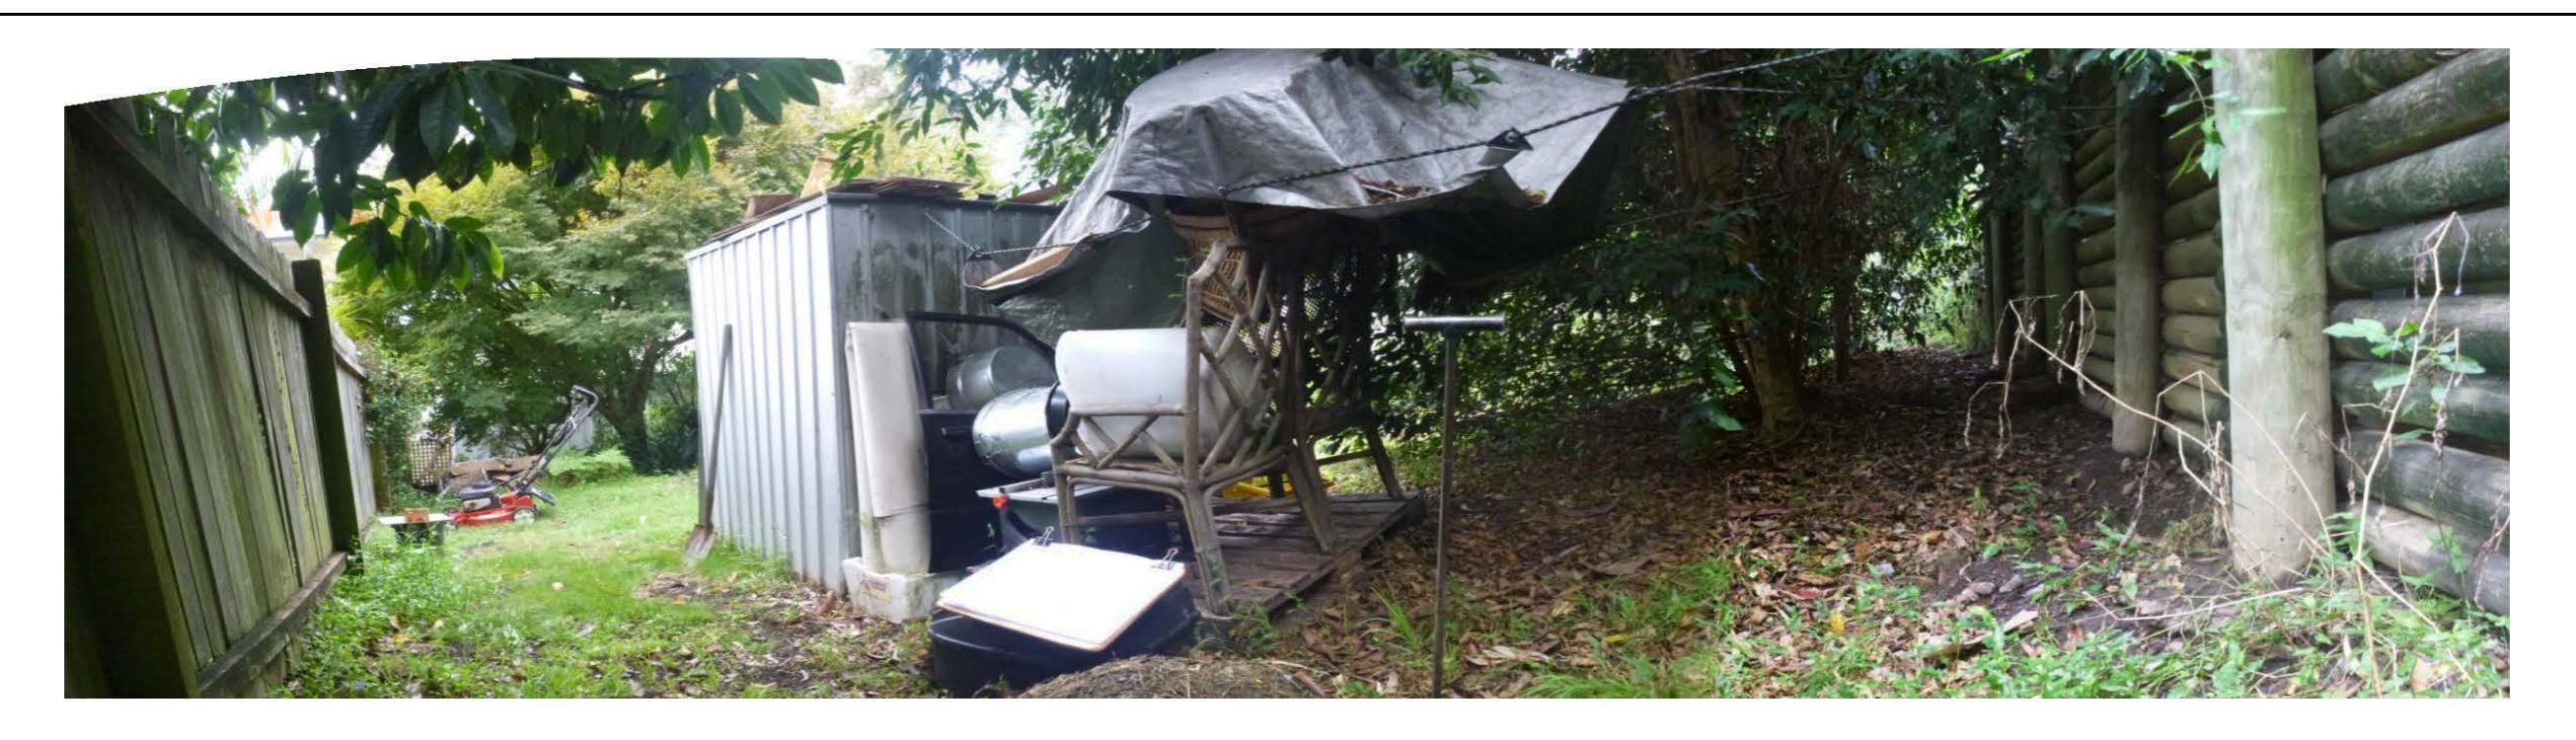
Photo 5. Upper south-western corner of the site showing southern log boundary fence.

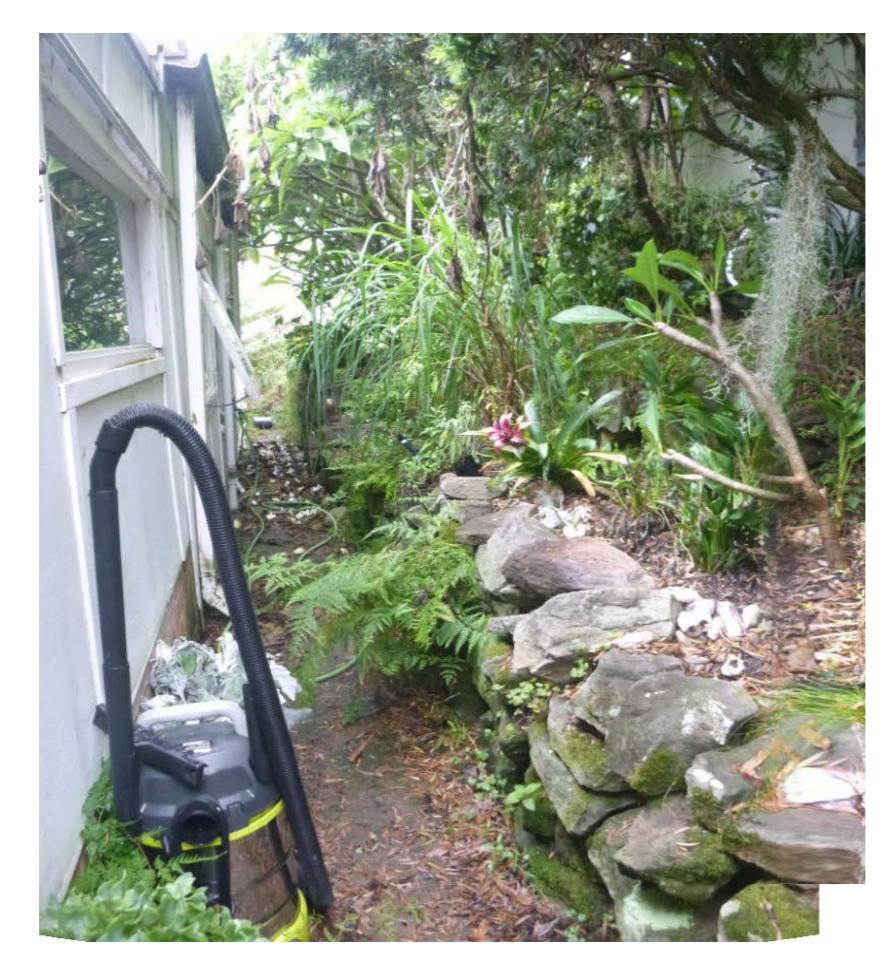
Photo 6. Stacked sandstone block wall on southern side of the cottage viewed towards the east.

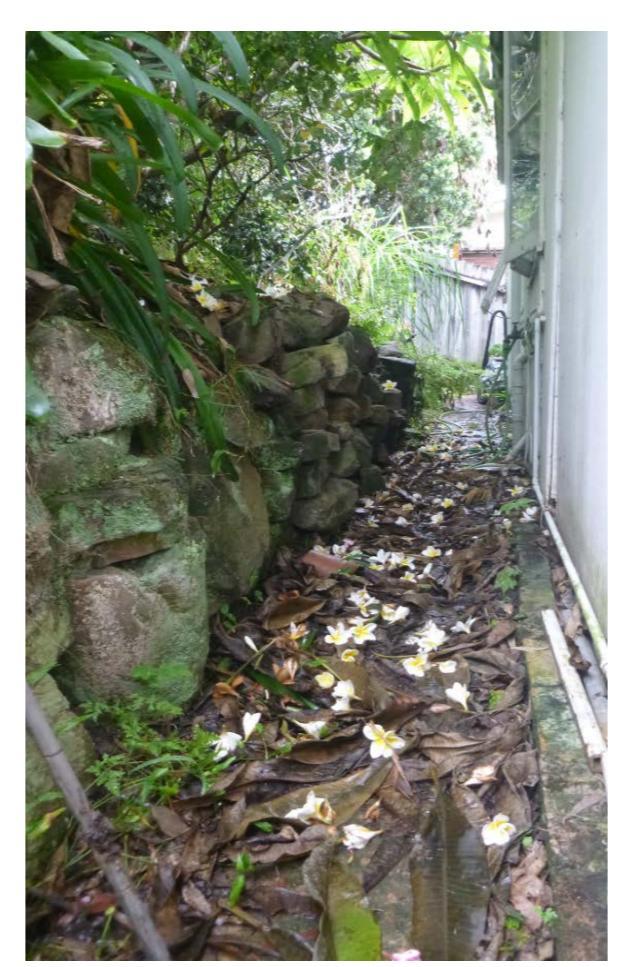
Photo 7. Stacked sandstone block wall on southern side of the cottage viewed towards the west.

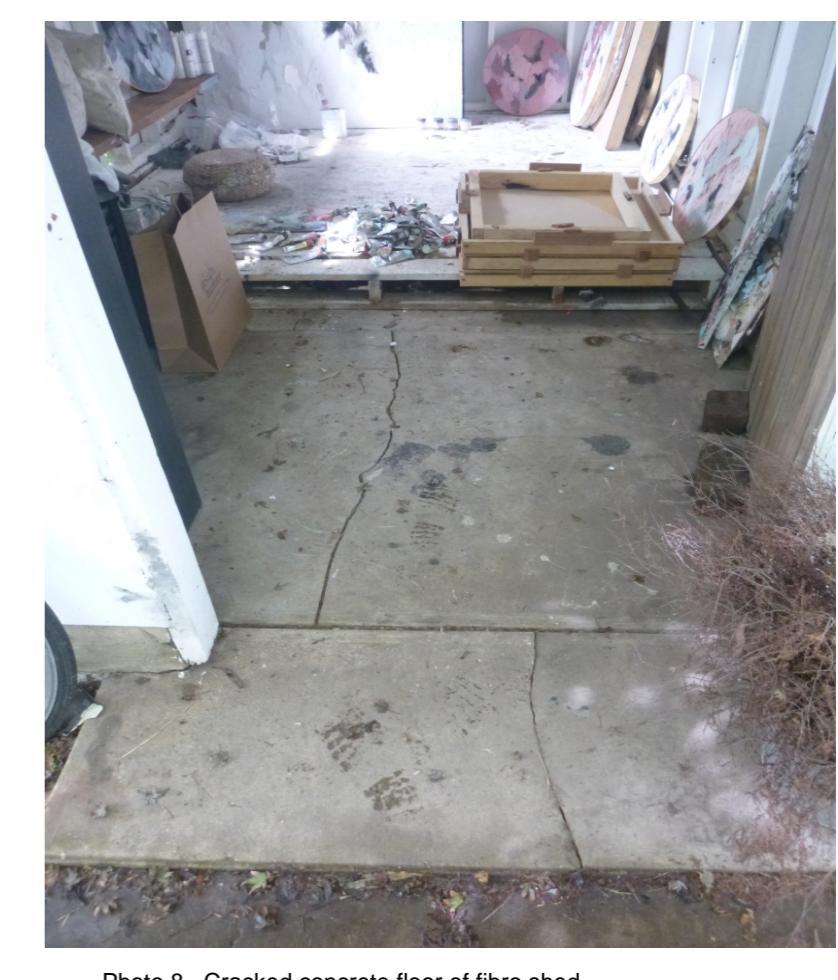
- the site is occupied by a fibro cottage and shed, both of which show signs of minor movement in the form of rotated brick piers supporting the northern side of the cottage and cracking of the concrete floor slab of the shed as well as the formation of a 30 mm gap under the northern, downslope side of the shed.

Photo 8. Cracked concrete floor of fibro shed.

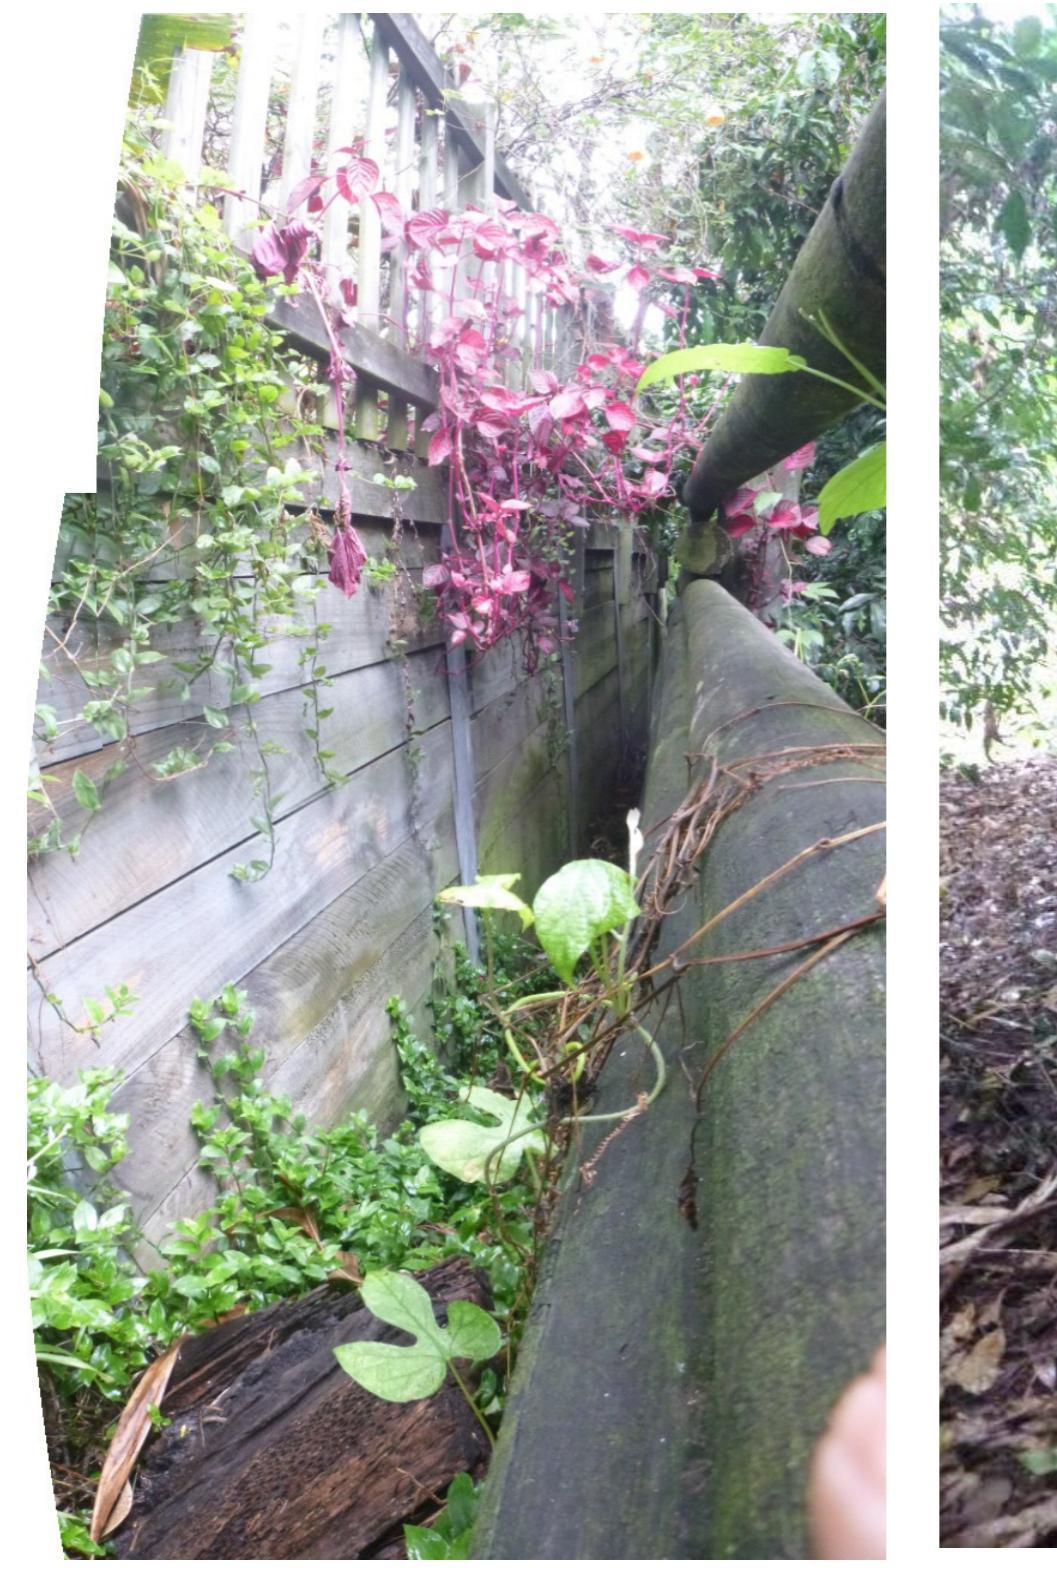
- beyond (upslope of) the southern boundary there is a (relatively) recently constructed retaining wall of galvanised steel sections with timber infill panels. The structure appears to be in sound condition but does not extend fully to the eastern boundary. Approximately 2 m of the eastern end of the southern boundary comprises a steep, unsupported batter, immediately adjacent to a large tree (refer to Drawing 1).

Photo 9. Upslope side of the southern boundary fence, showing retaining wall on upslope property.

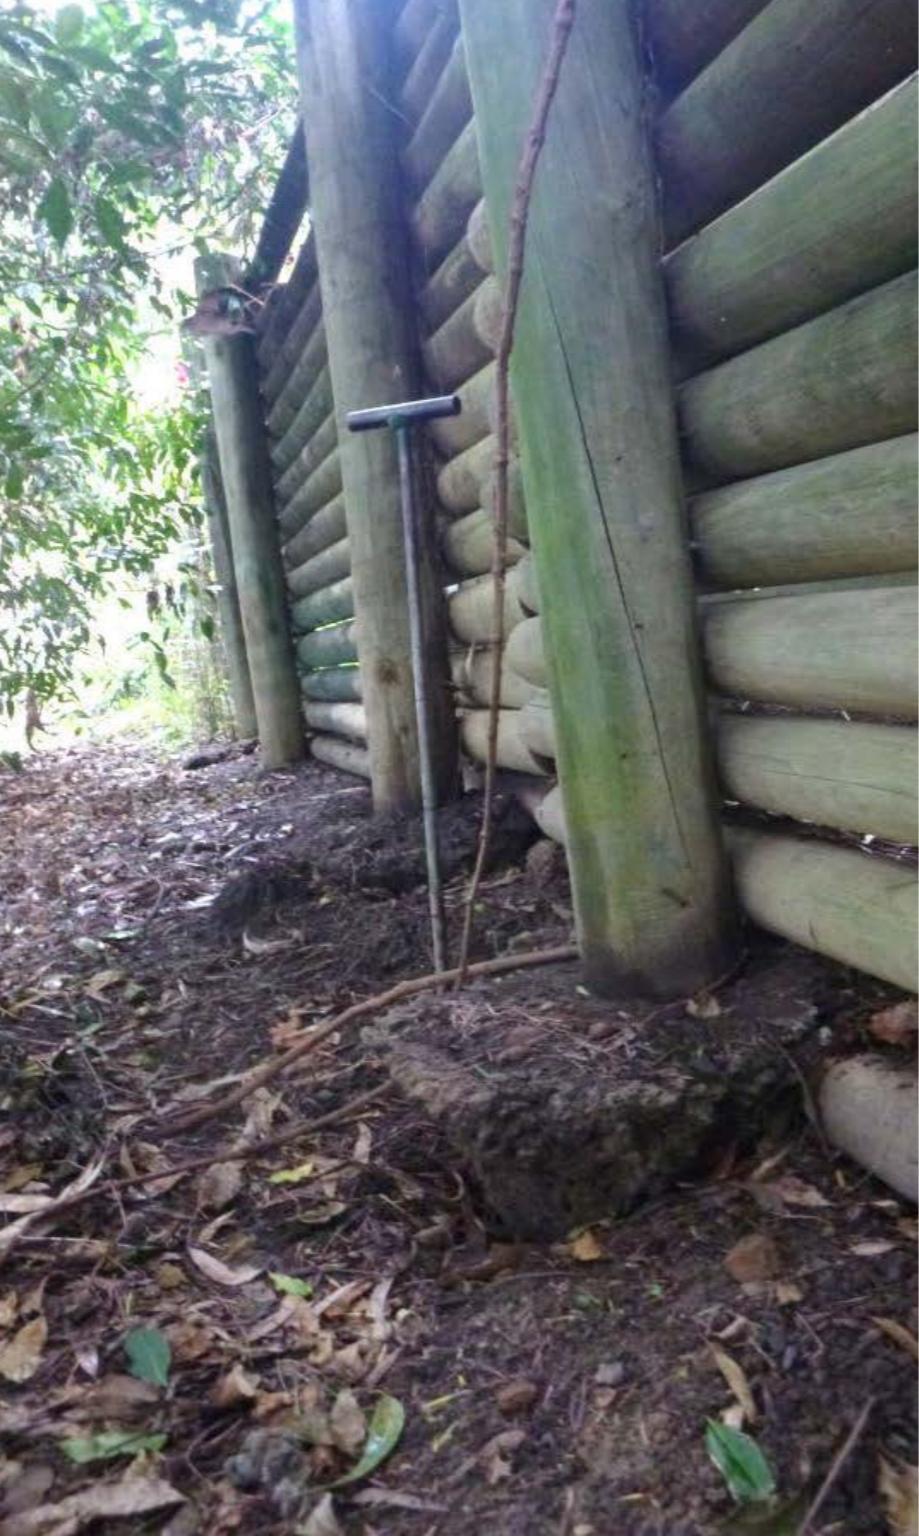
- there was no evidence of significant slope instability observed on the subject site. There was evidence of minor soil creep, rotation of the rear, southern fence, bulging of the low (less than 0.8 m high) landscaping wall and minor slumping of the roadside batter immediately adjoining the parking bay.

Photo 10. Eroded base of fence posts exposing part of the concreted "socket" of the posts. The posts and fence have rotated down slope.
