J5044 6th October, 2023 Page 1.

GEOTECHNICAL INVESTIGATION:

New Inclined Lift at 948 Barrenjoey Road, Palm Beach

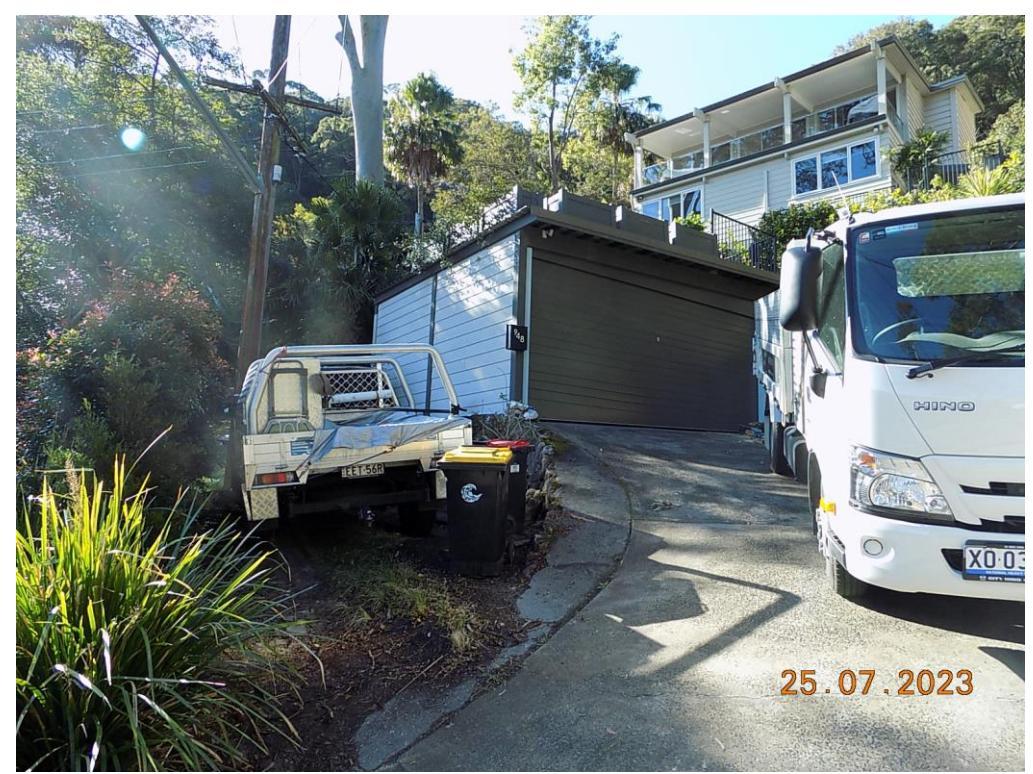
Photo 1

2.3 At the road frontage, a shared concrete driveway runs up the slope to a garage on the downhill side of the property (Photo 1). A cut and fill has been made in the slope to provide a level platform for the garage. The fill is supported by a ~1.0m high stable mortared stack rock retaining wall (Photo 2). The cut is supported by a similar wall that was in excellent condition when we were last on site in 2018. The wall was obscured by the garage structure and access was not available during the recent inspection (Photo 3). The slope between the garage and the house is terraced with a series of mortared dimensioned sandstone block, and gabion basket retaining walls reaching a maximum height of ~3.0m where the cut for the existing inclined lift on the S side of the property was made (Photos 4 to 8). To maintain ongoing stability for

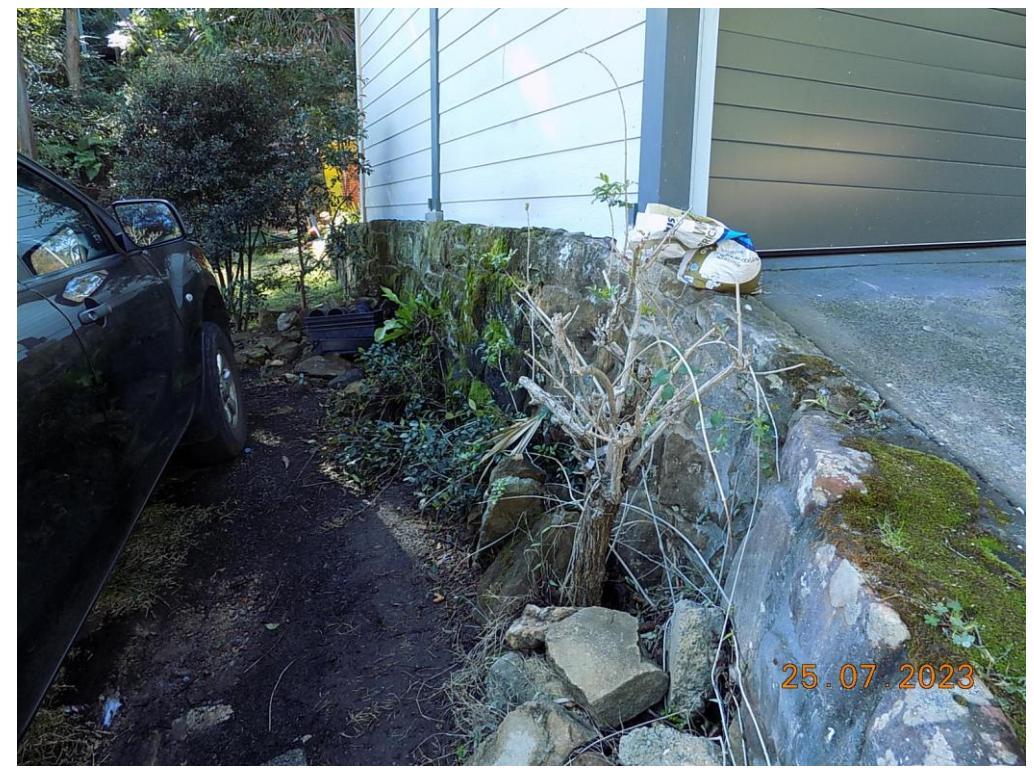
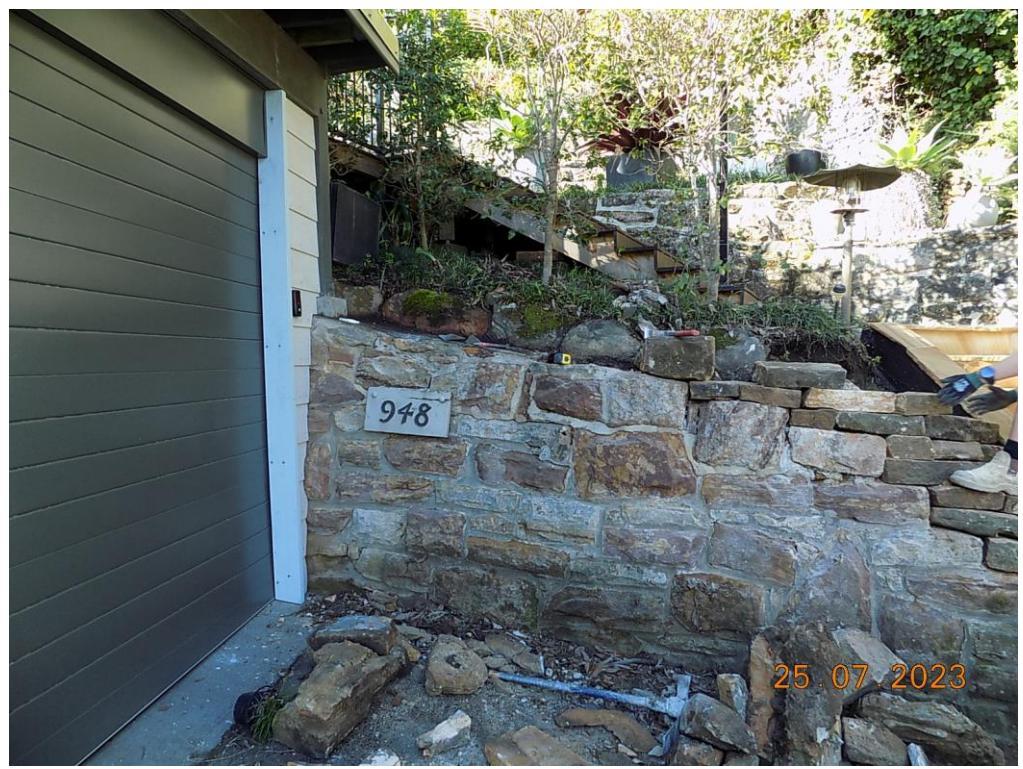
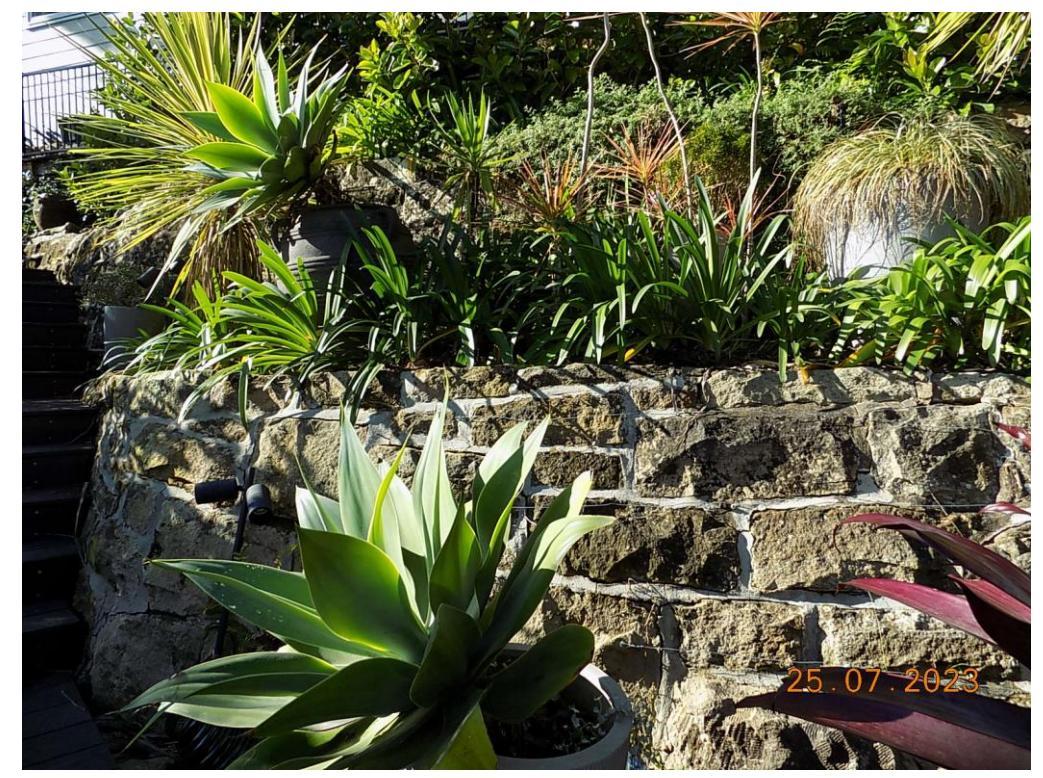
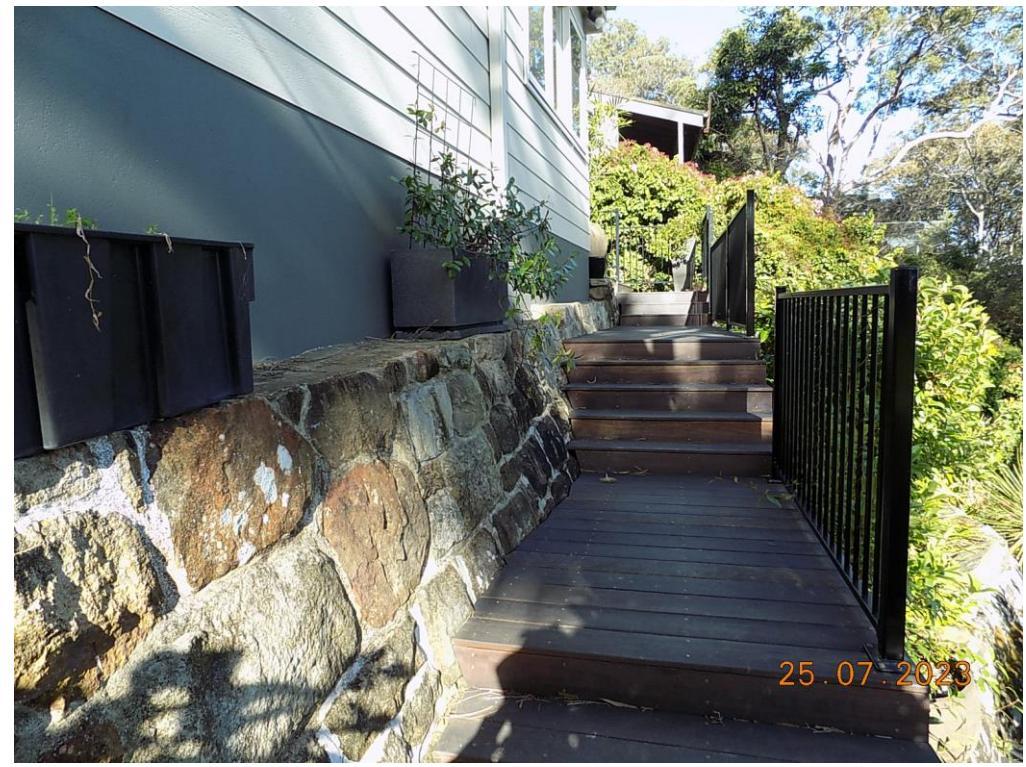
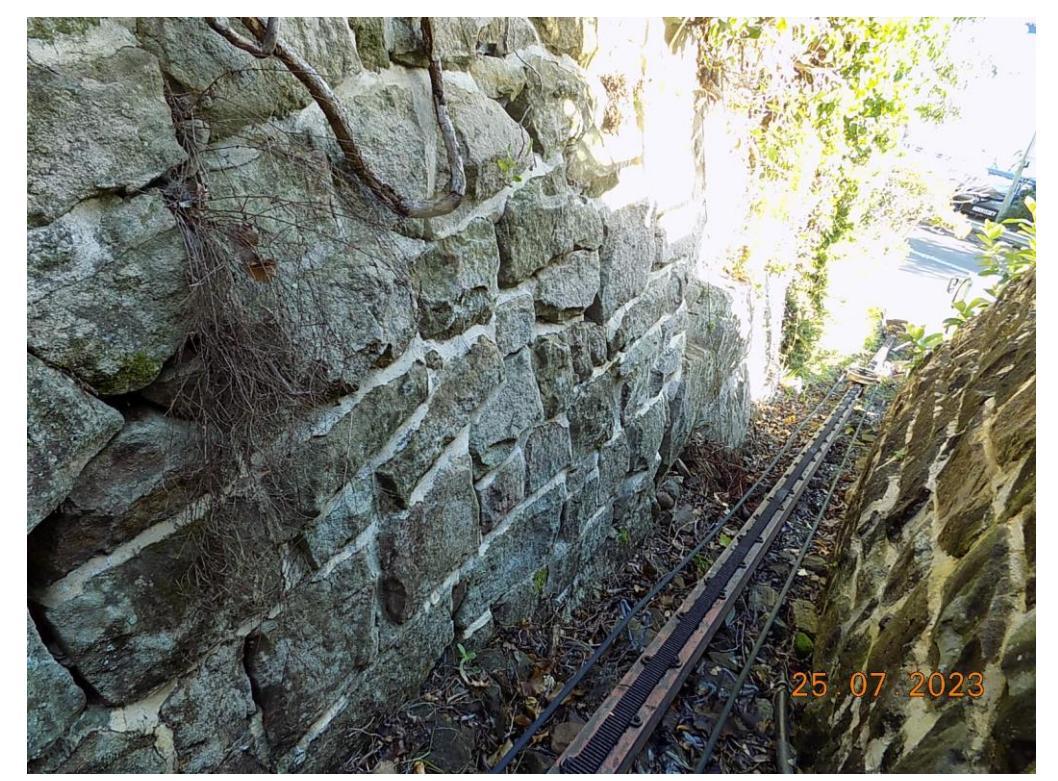
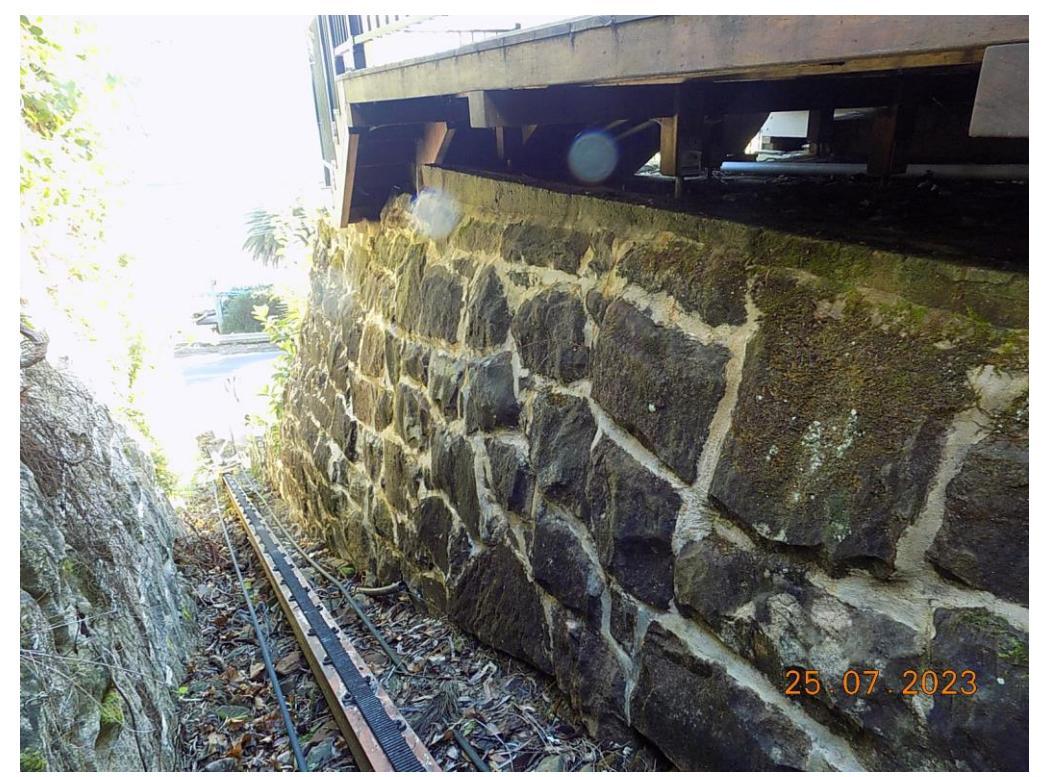
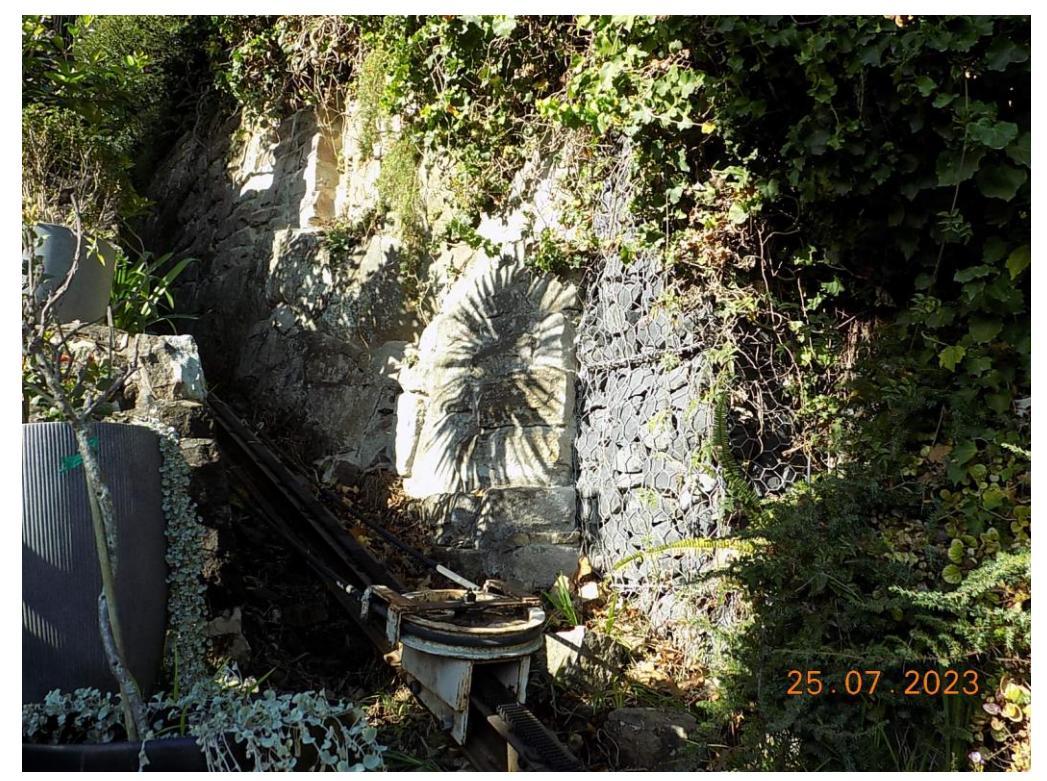
The property is extensively terraced in mortared stack rock walls (Photos 2 to 13). These walls require occasional maintenance to ensure ongoing stability in the future. As such, they are to be monitored by the owners on a biannual basis or after heavy and/or prolonged rainfall events, whichever occurs first. A photographic record of these inspections is to be kept. Should further movement occur the walls are to be remediated so they meet current engineering standards.

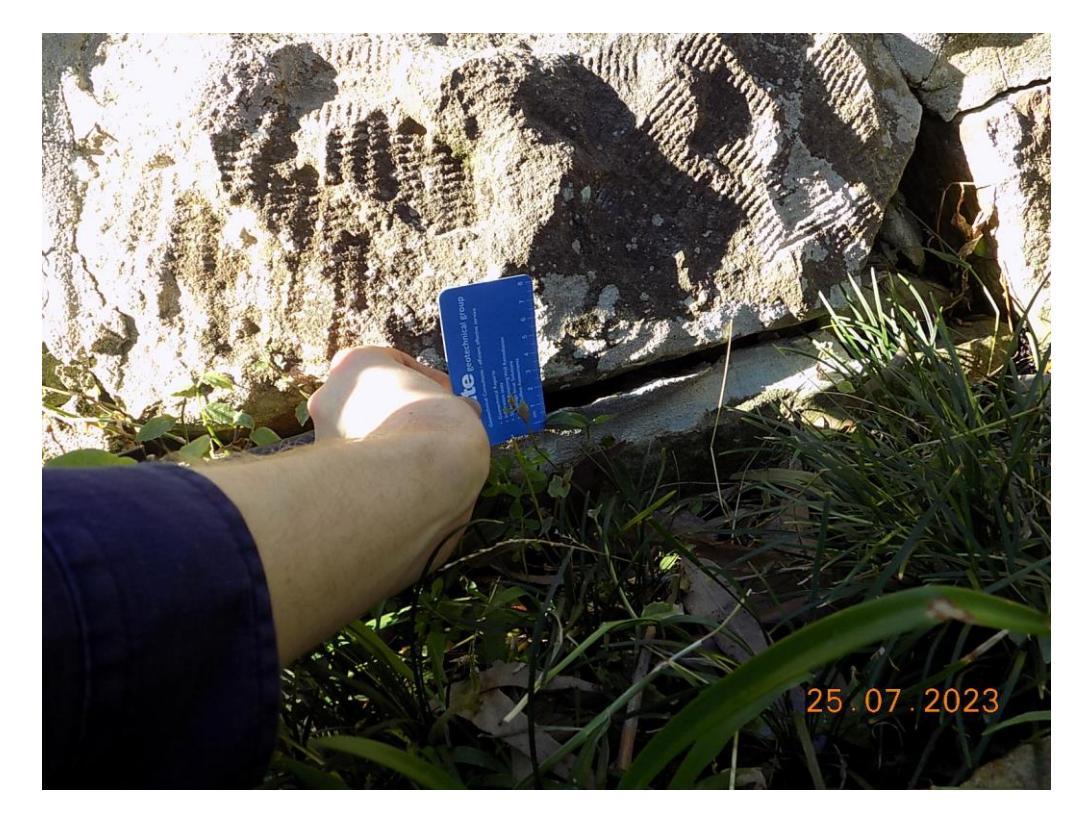
Photo 9

dimensioned sandstone walls they require occasional maintenance which may involve re-mortaring or repointing. While the mortar in some locations was observed to be failing (Photo 9), there has been no significant further movement of these walls since the last site visit. See Section 13 "Site Maintenance" for treatment of the cracking. The part two-storey rendered masonry and timber clad house is supported by rendered masonry walls (Photo 5). No significant signs of movement or cracking was observed in the external supporting walls of the house. Two dimensioned sandstone block walls terrace the slope above the house. The lower wall reaches a maximum height of \sim 2.0m, providing a level platform for the lower ground floor and supporting the deck above (Photo 10). The dimensioned sandstone wall on which this footing is founded exhibits cracking to a width of 10mm (Photo 11). See Section 13 for advice. The upper wall reaches a maximum height of ~1.0m and levels an area for a deck attached to the ground floor (Photo 12). Both walls are slightly angled back into the slope and are considered stable subject to ongoing maintenance. Low timber and dimensioned sandstone block retaining walls terrace the uphill slope, supporting fill for garden bedding (Photos 13 and 14). The remainder of the property rises steeply to the upper boundary (Photo 15), most of the vegetation here has been cleared since the previous inspection rendering the slope more susceptible to erosion, and shallow failure than it was previously. See Section 13 for advice. There were multiple instances of large and undercut sandstone joint blocks on the steep, undeveloped bush slope above the property (Photos 16 and 17). Some of these had dislodged from the natural slope, whereas others exhibited horizontal bedding and were assumed to be in situ. The undercut rocks have relatively thick cantilever arms compared to their overhang length, have likely been in place for thousands of years prior to the development of this area and do not display any significant jointing or cracking which could impact on the stability of the rock face. As such, the rock faces are currently considered to be stable. However, if these rocks were to collapse, they would likely come to rest on the slope immediately below their current location.

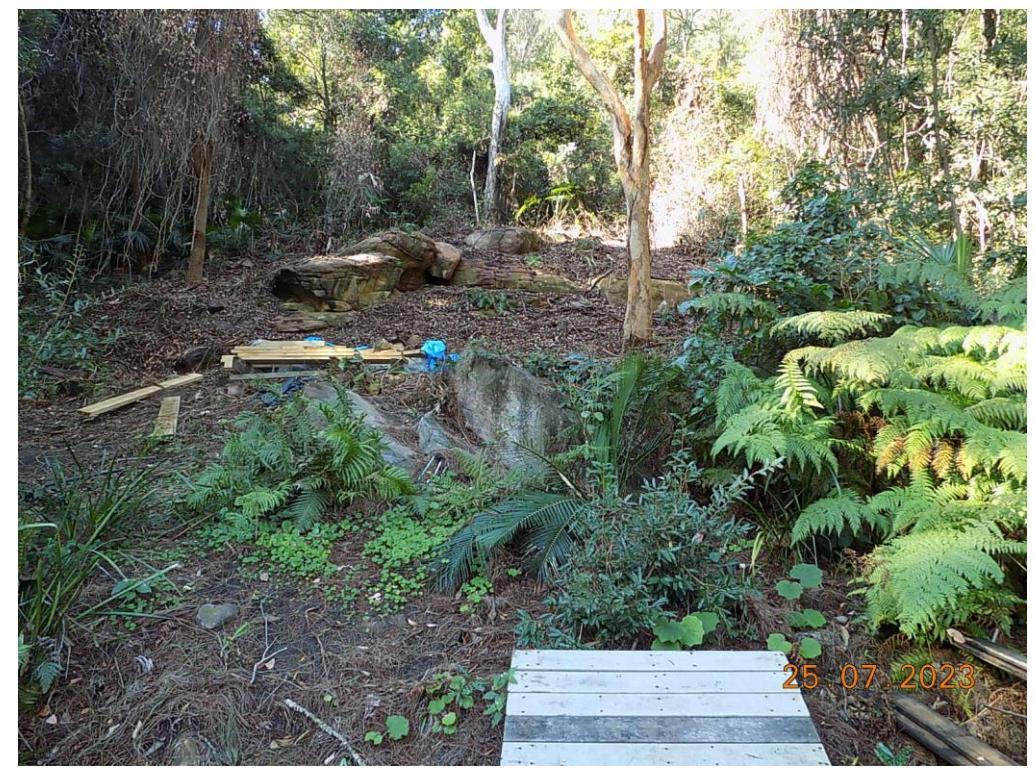
Photo 15

The steep upper portion of the property has been mostly cleared of vegetation, increasing its risk of failure (Photo 15). This slope is to be planted out with native trees, shrubs, and ground cover. The plants should be chosen for their deep root systems that will bind and anchor the natural profile. Native plants are required because they generally have deeper root systems. A well-informed horticulturalist should be able to advise on the most suitable plants for this purpose taking into account the aspect and location (steep slope).

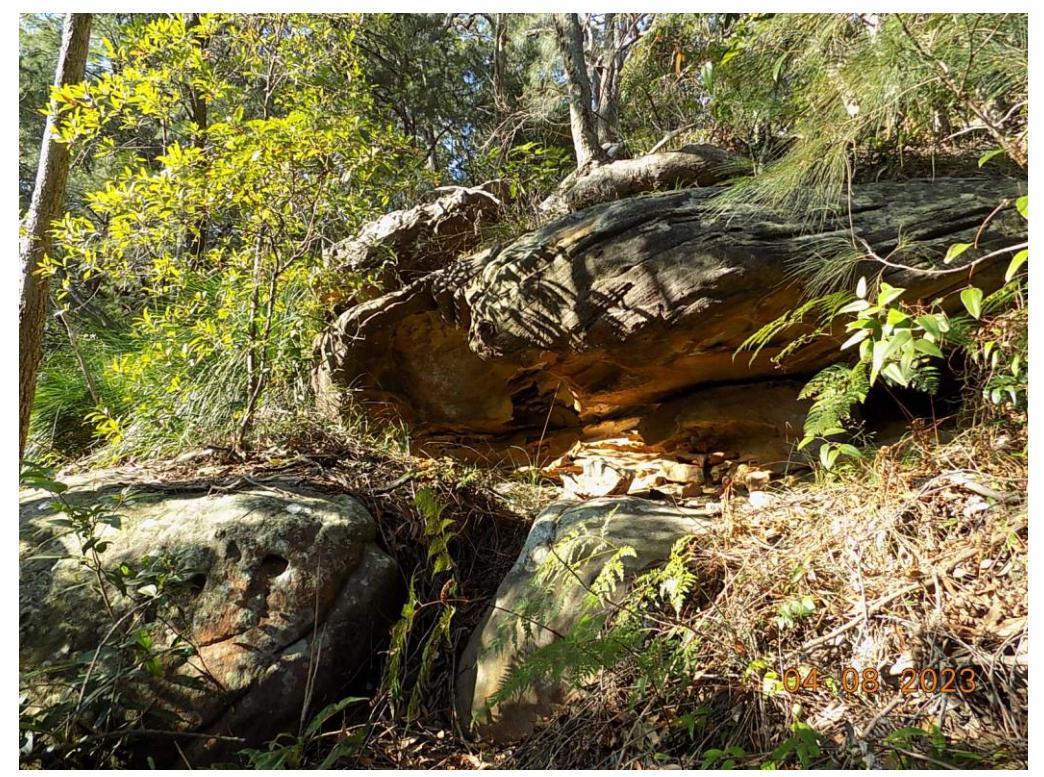
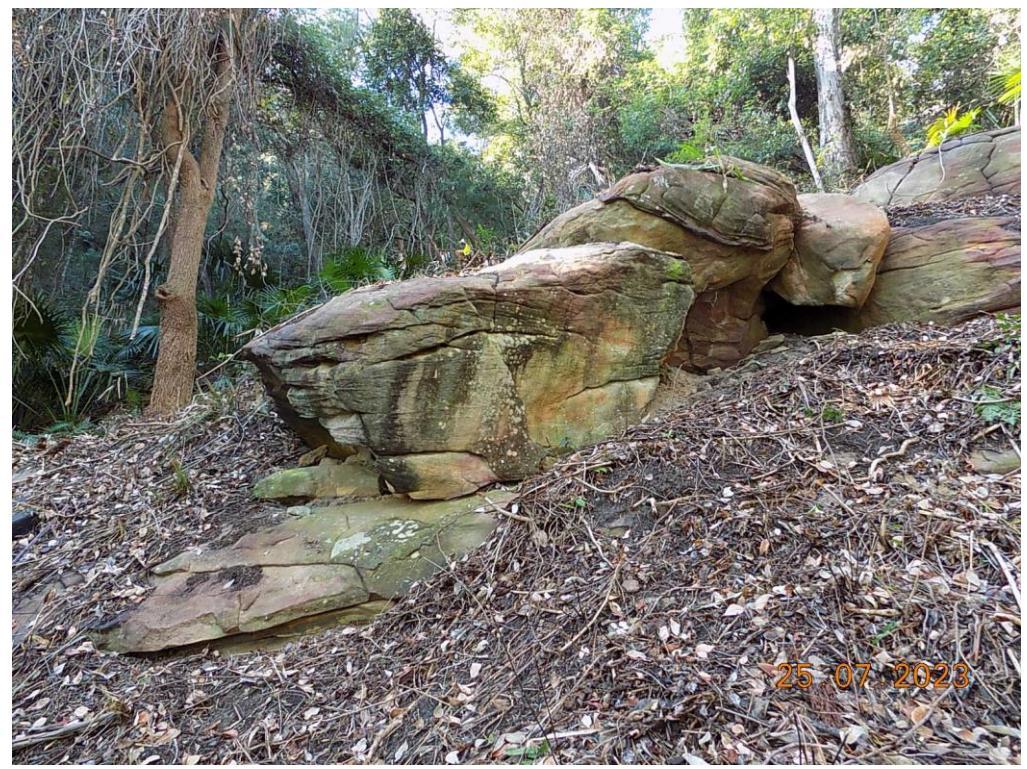
HAZARDS	Hazard Three	Hazard Four	
ТҮРЕ	The large dislodged and undercut sandstone joint blocks above and on the property falling and impacting on the subject house and/or proposed works (Photo 16 & 17).	The proposed excavation collapsing onto the work site and impacting on the subject and neighbouring property before retaining walls are in place.	
LIKELIHOOD 'Unlikely' (10 ⁻⁴)		'Possible' (10 ⁻³)	
CONSEQUENCES TO PROPERTY	'Major' (50%)	'Medium' (15%)	
RISK TO PROPERTY	'Low' (6 x 10 ⁻⁵)	'Moderate' (2 x 10 ⁻⁴)	
RISK TO LIFE	4.7 x 10 ⁻⁶ /annum	5.3 x 10 ⁻⁵ /annum	
COMMENTS	This level of risk to life and property is 'UNACCEPTABLE'. To move the risk to 'ACCEPTABLE' levels, the recommendations in Section 16 are to be followed.	This level of risk to life and property is 'UNACCEPTABLE'. To move risk to 'ACCEPTABLE' levels the recommendations in Section 13 are to be followed.

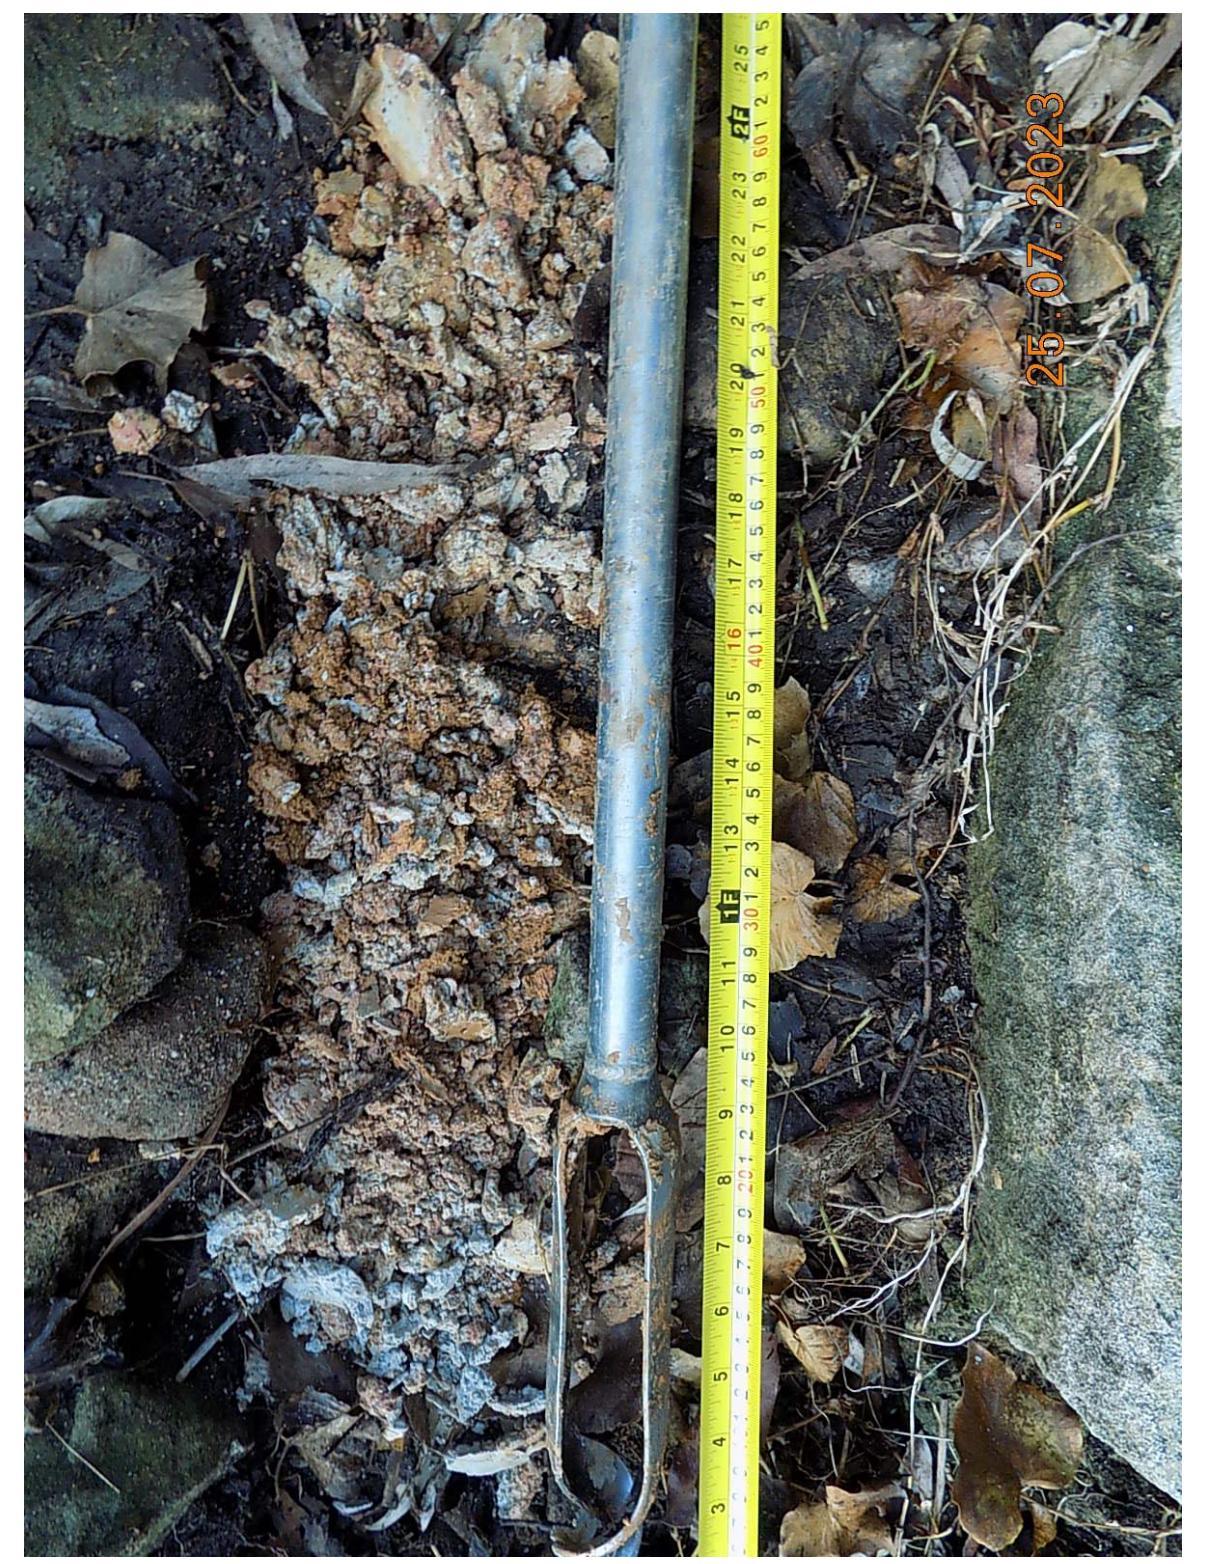
AUGER HOLE 1 (~RL28.4) – AH1 (Photo 18)

Depth (m)Material Encountered0.0 to 0.6CLAY, derived from weathered shale, mottled grey and maroon, dry,
hard.

End of test @ 0.6m in hard clay. No water table encountered.

Photo 18 AH1 – downhole is top to bottom
