J2125A. 20th February, 2020 Page 1.

18 Alexander Street, Collaroy

Comments on Updates to Plans

GEOTECHNICAL INVESTIGATION:

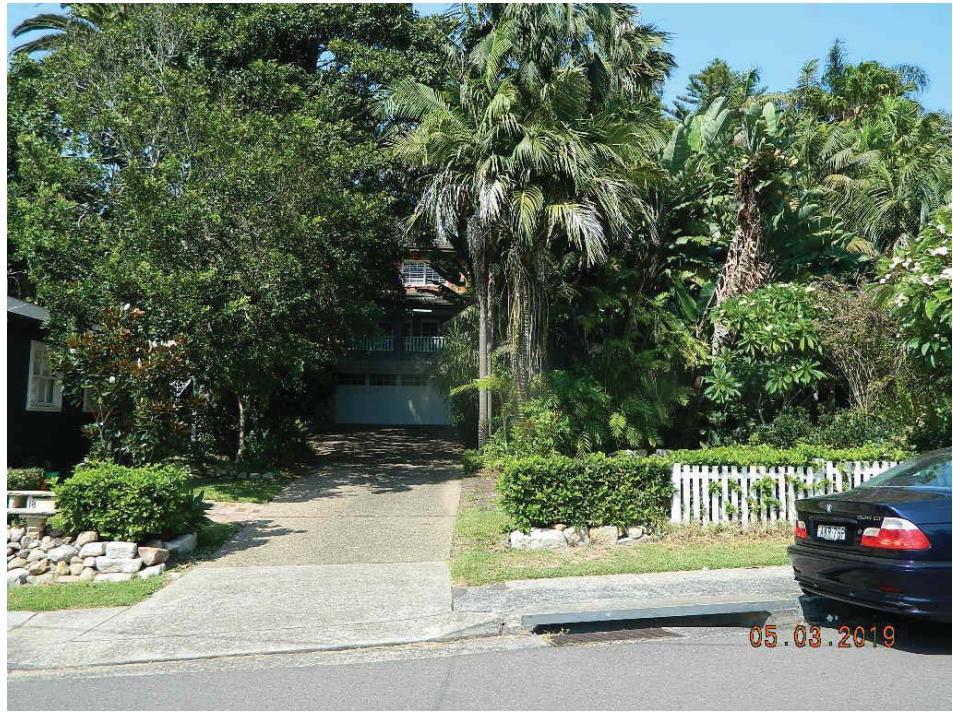
Photo 1

2.3 At the road frontage, a concrete driveway runs to a garage beneath the house (Photo 1). A free standing studio is located beside the driveway (Photo 2). A gravel driveway runs up the slope to a car parking space on the E side of the studio (Photo 3). The area between the road frontage and the house is otherwise densely vegetated (Photo 4). The majority of the part three storey brick house will be demolished as part of the proposed works (Photo 5). A stable timber retaining wall reaching a maximum height of ~1.0m terraces the

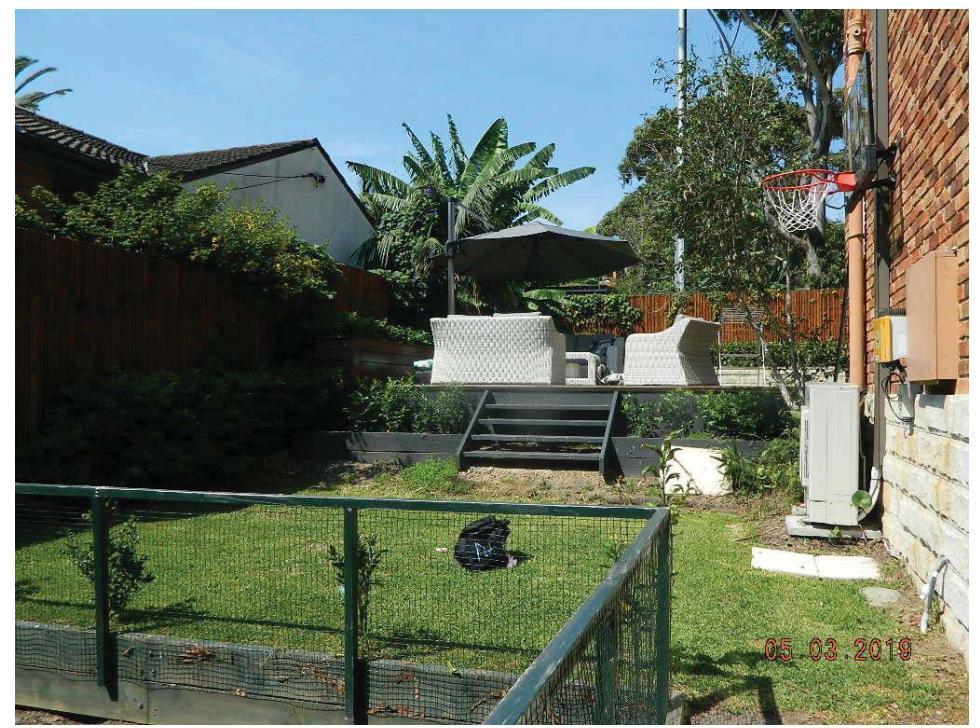
Photo 6

slope on the E side of the house. The wall retains a fill that levels a lawn area above (Photo 6). A near level lawn area rises from the uphill side of the house to a stable ~0.5m high sandstone block retaining wall along the uphill boundary (Photo 7). A recently constructed pool in the SW corner of the property is in good condition with no signs of cracking or movement in the pool shell (Photo 8). No signs of movement were observed on the grounds. The adjoining neighbouring properties were observed to be in good order as seen from the road and the subject property. No geotechnical hazards were observed on these properties that could impact on the subject property.

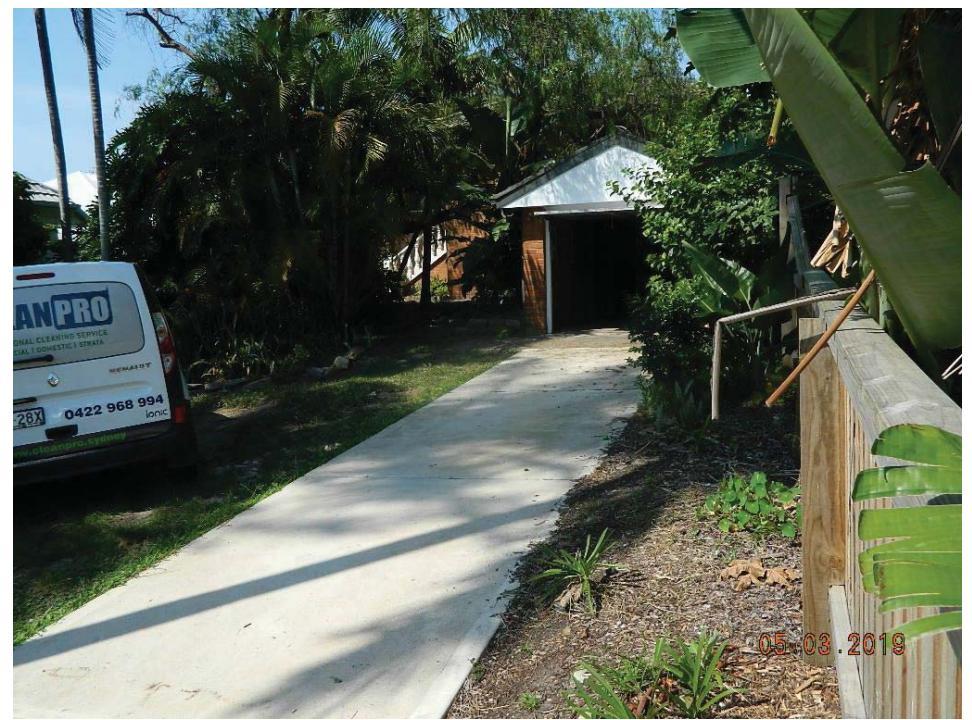
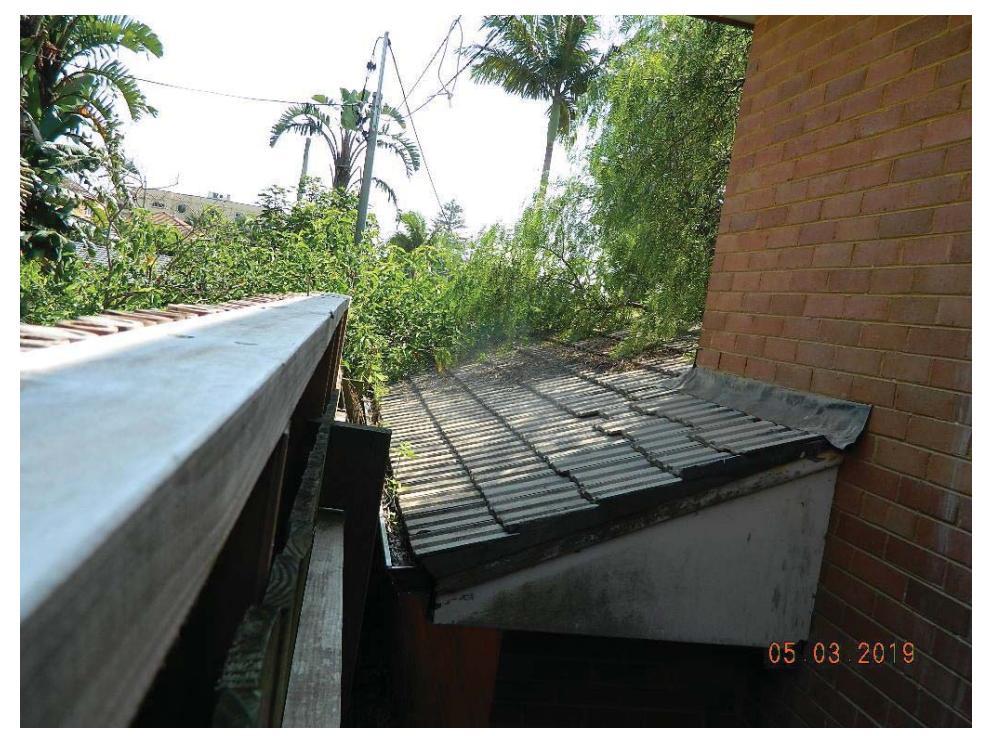
| HAZARDS | Hazard One | Hazard Two | |
|---|--|---|--|
| ТҮРЕ | The proposed excavation undercutting the neighbouring house to the E, causing failure in the supporting walls of the neighbouring house (Photos 9 & 10). | The proposed excavation collapsing onto the worksite and impacting on the E neighbouring property before retaining walls are in place. | |
| LIKELIHOOD | 'Possible' (10 ⁻³) | 'Possible' (10 ⁻³) | |
| CONSEQUENCES TO PROPERTY | 'Minor' (15%) | 'Medium' (20%) | |
| RISK TO PROPERTY | 'Moderate' (2 x 10 ⁻⁵) | 'Moderate' (2 x 10 ⁻⁴) | |
| RISK TO LIFE | 6.6 x 10 ⁻⁷ /annum | 6.8 x 10 ⁻⁴ /annum | |
| COMMENTS | This level of risk to property is ' UNACCEPTABLE' . To move the risk levels to acceptable levels the recommendations in Section 13 are to be followed. | This level of risk to life and property is ' UNACCEPTABLE' . To move the risk levels to acceptable levels the recommendations in Section 13 are to be followed. | |

Due to the depth of the excavation and its close proximity to the boundary, the portion of the excavation that runs parallel with the E neighbouring house is to be supported before any excavations commence with secant or contiguous piers or similar. Secant piers are the preferred option but, if contiguous piers are used, the gaps between the piers are to be grouted closed as the excavation is lowered, so no fill, sandy soil, or sand moves through the wall. The piers can be temporarily supported by embedment below the base of the excavation. For ease of design and construction, piers may be installed around the entire perimeter of the excavation for the proposed driveway exceeds 0.5m deep the piling will need to extend to the N end of the neighbouring garage. To drill the pier holes for the wall, a powerful excavator or small pilling rig that can excavate through medium strength rock will be required. If a machine of this type is not available, we recommend carrying out core drilling before the construction commences to confirm the strength of the rock, and to ensure the excavation equipment is capable of reaching the required depths. The retaining wall is to be tied into the concrete floor and ceiling slabs of the garage to permanently brace the retaining wall.

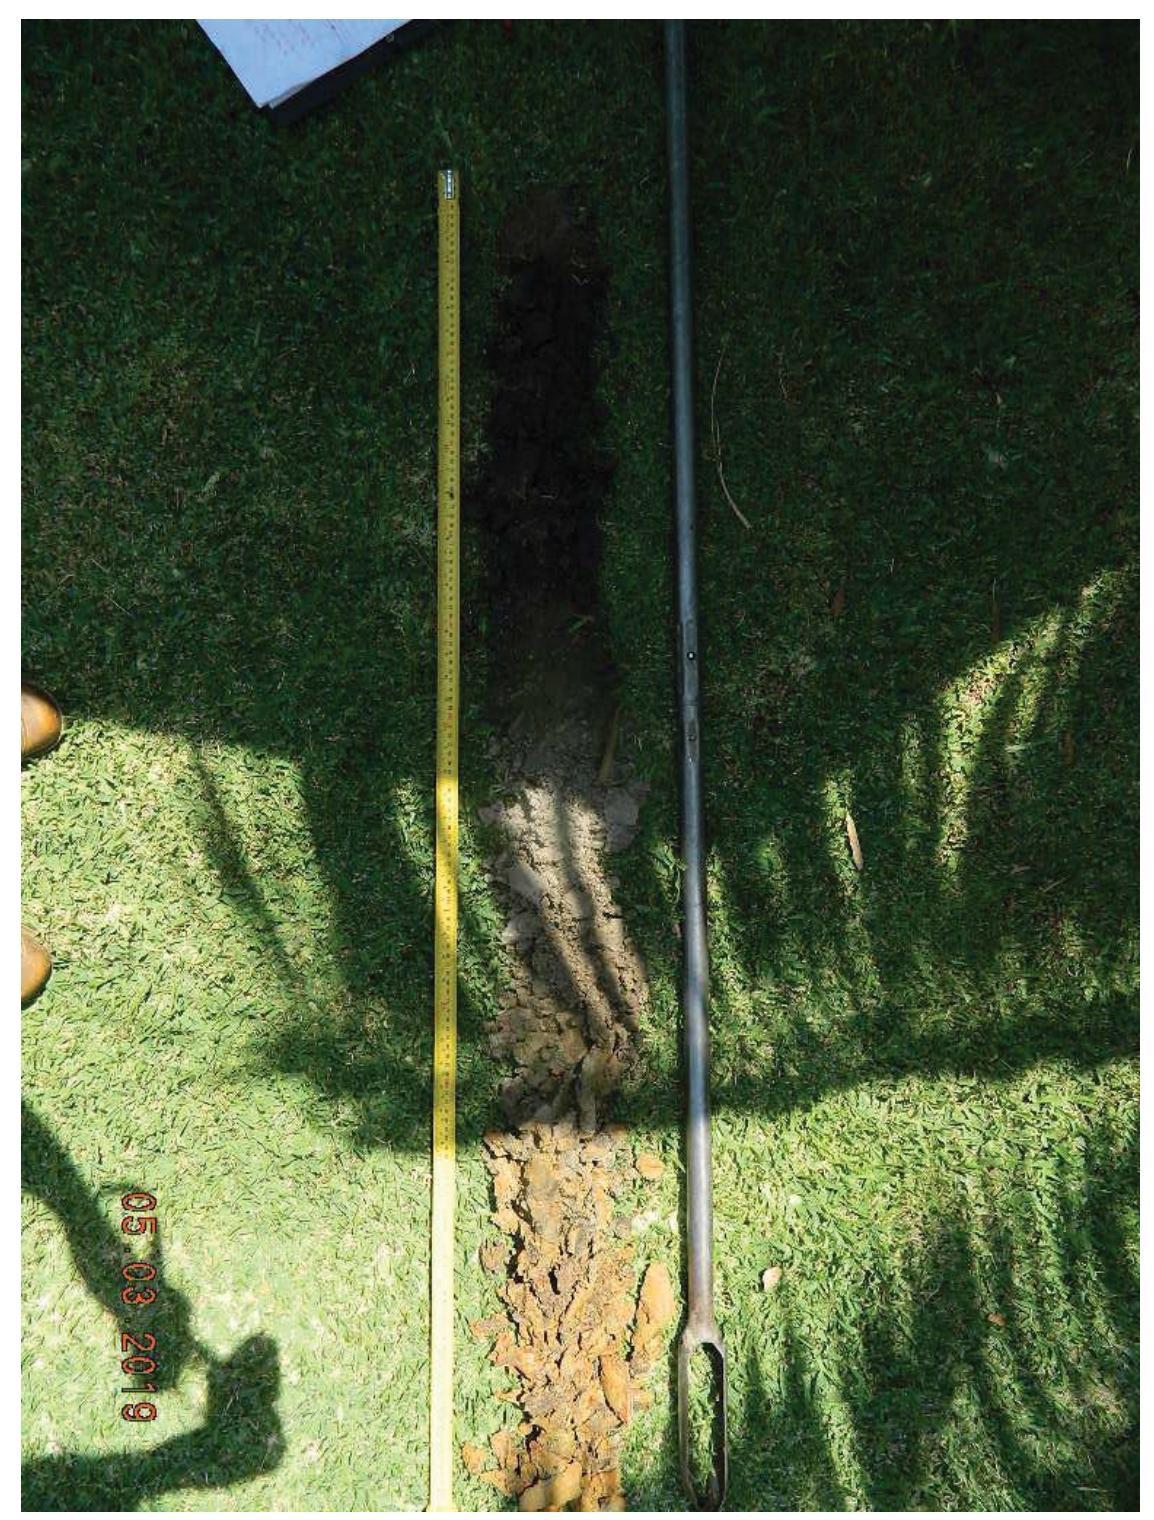
AUGER HOLE 1 (~RL12.4) – AH1 (Photo 11)

End of test @ 1.4m in sandy clay. No watertable encountered.

Photo 11: Auger Hoe 1: The base of auger hole is at the base of the image.
