arboricultural impact assessment report

AIA-01

Revision A, Issued for Authority Approval/DA 15 November, 2019

Allambie Heights Village - Project 2

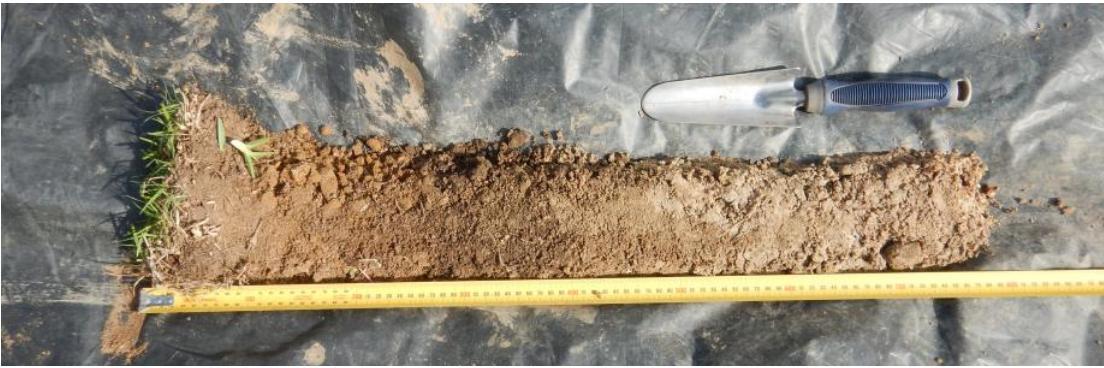
Depth – approximately 350-700mm (rock encountered below this depth) **Structure** - Weakly pedal, small to medium sized subangular blocky peds **pH** - 6.0 – moderately acidic **Texture** - Sandy loam with a high percentage of sand.

Figure 4 – Typical Soil Profile to a depth of 700mm – the auger was rejected at this depth. (Photo: Arterra)

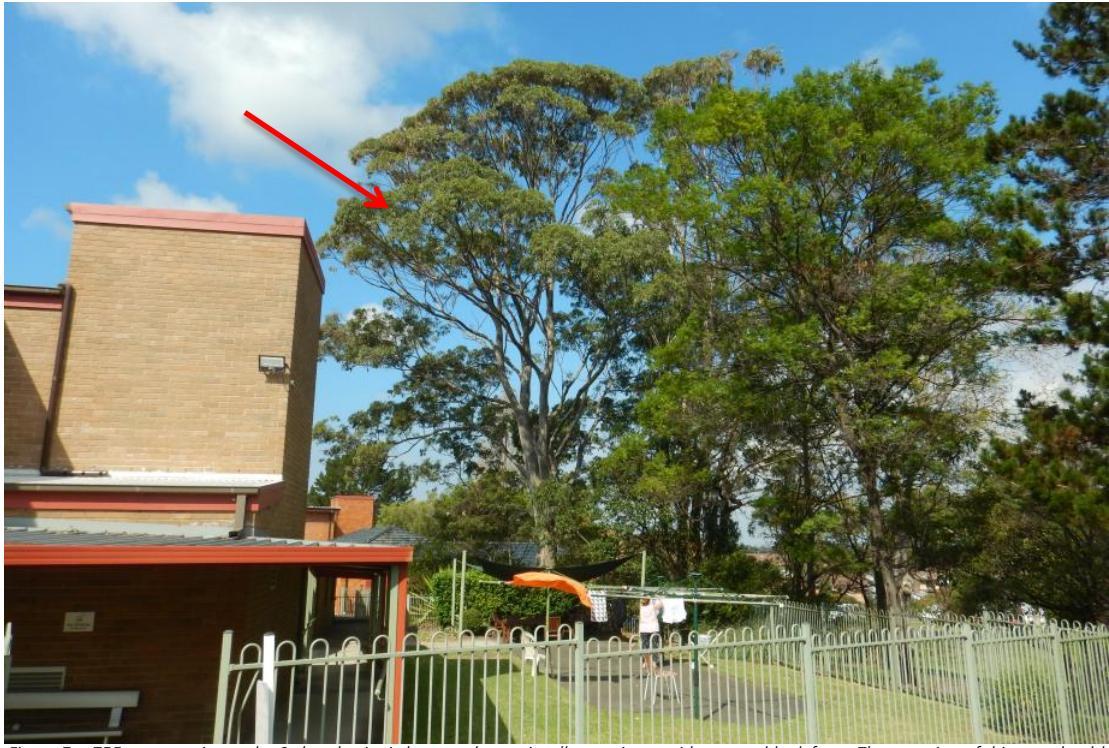
The largest and most prominent tree on the site is a large Sydney Blue Gum (*Eucalyptus saligna*) (**T55**). It is clearly visible from Allambie Road and other public areas. A similar tree to its west is in poor health and condition and should be removed. Tree **T55** should be the focus of efforts to retain. It is not 'naturally' occurring in this particular site but it will create a valuable landscape asset and will help screen and separate the new development from the existing William Charlton Village. It is visually prominent and in good health.

Figure 7 – T55 a tree native to the Sydney basin, is large and very visually prominent with no notable defects. The retention of this tree should form a priority. (Photo: Arterra 21/4/18)

This tree has a TPZ radius of 13.56m and is located in a garden bed in a steep bank between the access road and utilities area to the rear of William Charlton Village and the cleared, grassed area in the north-eastern corner of the project site. There will be what we consider a minor incursion, as defined by AS 4970, of approximately 10.6% in the south-western portion of this tree's nominal TPZ. The incursion will result from the excavations for the adjacent building's basement floor level, which will sit approximately 400 – 500mm below the current ground level. The existing ground levels and surface conditions around this tree, within the TPZ and beyond, (with the exception of the noted incursion), will be maintained at existing levels. A low retaining wall/ kerb will be constructed along the eastern side of the basement to prevent the need for any further battering. A new pedestrian pathway proposed to run through the south-eastern portion of the TPZ shall be installed as a suspended structure above the existing ground levels requiring no significant excavation, and minimising any likely root impacts in this area.

Given that the incursion occurs to a relatively small south-western portion of the TPZ and the remainder of the TPZ will experience no significant disturbance including the areas contiguous and beyond the TPZ to the north, east and south it is the author's opinion that this impact is acceptable and is likely to have little impact to the overall condition of the tree. It will be vital however to protect the remaining TPZ thoroughly, during construction. The implementation of temporary irrigation during the construction phase will be extremely beneficial and help maintain the health and vitality of the tree and is recommended.

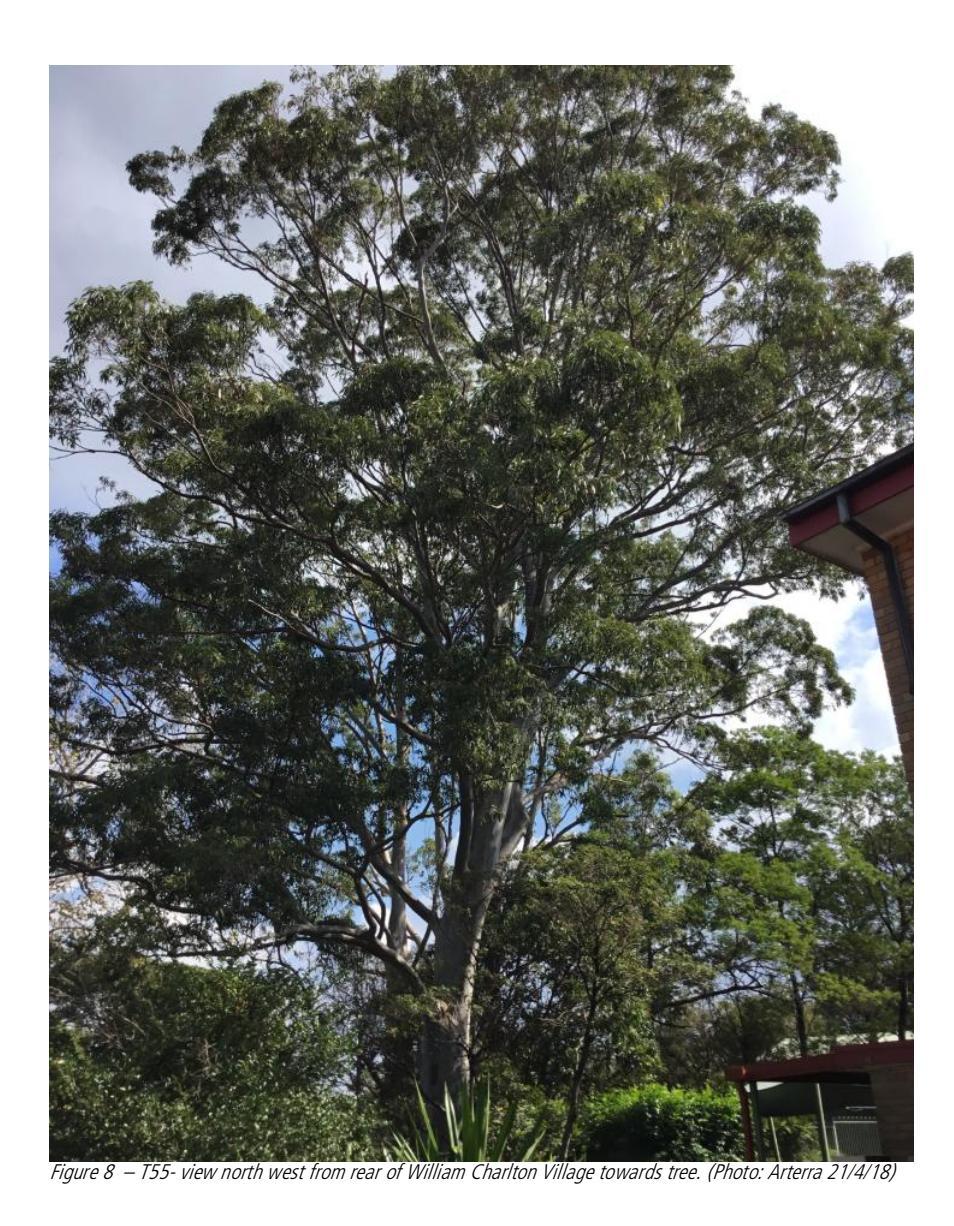
Located immediately to the west of **T55**, **is T54** which is a similar tree, however, it is in much poorer health and condition with significant borer blazes to the north and south sides of trunk. **T56-T60** are smaller trees in poor condition and weeds that are growing around the base of **T55**. It is recommended that **T54** & **T56-T60** be removed for the betterment of **T55**.

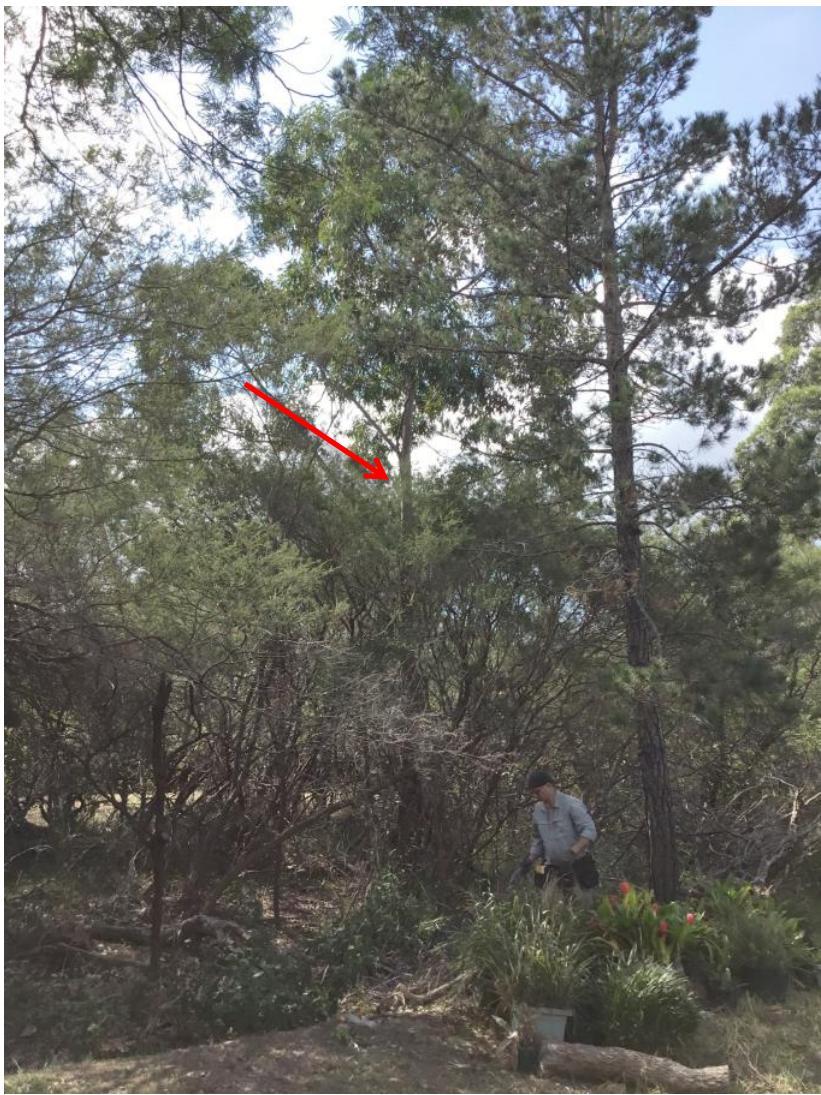
T76 is a young and healthy tree located adjacent to the northern site boundary just north of the proposed extent of works. The existing carpark is to be extended north and a garbage bin storage area is proposed adjacent to this tree. The carpark has been designed around the tree to minimise construction impacts to the tree and allow its retention. The potential disturbance caused by the construction of the bin storage facility results in a minor incursion to the southern portion of the TPZ of 10%. Any other root impacts are expected to be minimal and it is the author's opinion that this incursion is acceptable and likely to have little impact to the condition of this young tree.

Figure 09 – T76 view to the north from the northern edge of the existing carpark (Photo: Arterra 21/4/18)

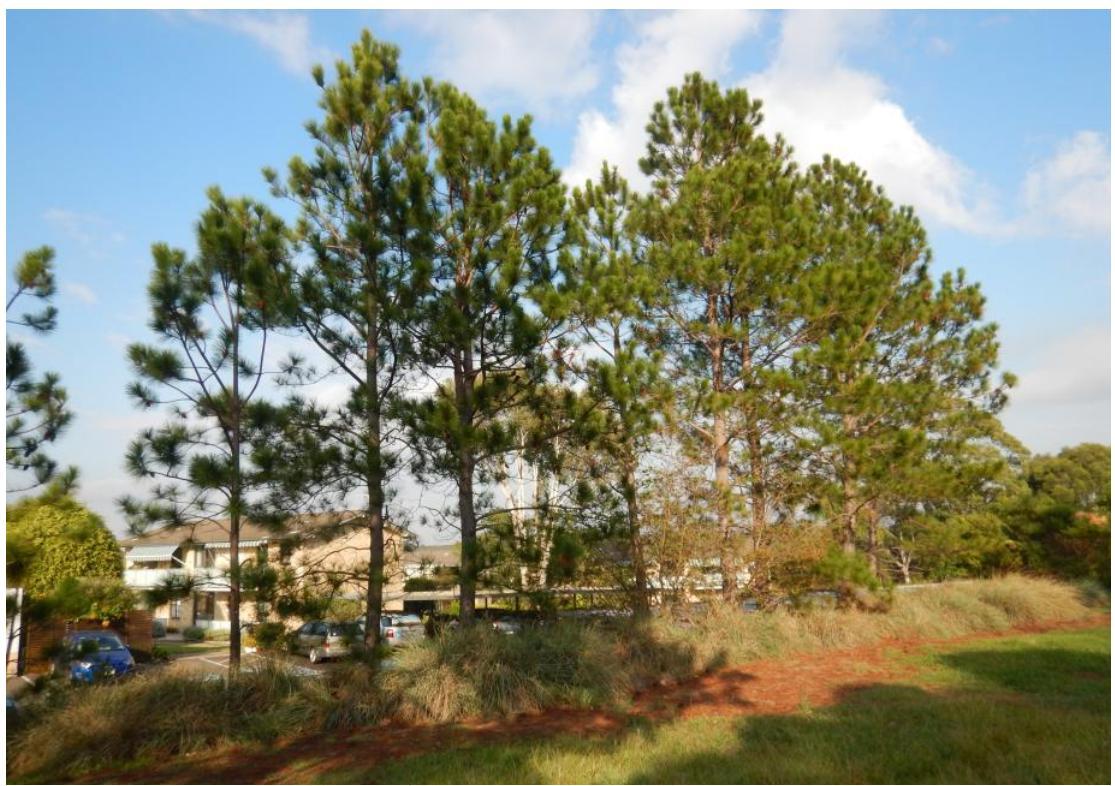
There are several Pine trees (believed to be *Pinus canariensis*) located on the boundary embankment along the southern edge of the development site. Pinus are an exempt species and may be removed without approval. These are a potentially invasive species and are growing on the edge of a steep drop-off. Given the above exemption and the likely shallow soils and limited root development to the southern side of these trees we believe it is prudent to remove them. Suitable replacement planting is proposed within the new landscaping of the site, which will to continue to provide suitable low level screening between the new development and Allambie Heights Village to the south.

Figure 10 – T03-T12- view south-west from rear of William Charlton Village. (Photo: Arterra 21/4/18)
