1110 BARRENJOEY ROAD – PALM BEACH, NSW
ARBORICULTURAL ADDENDUM REPORT
Ref No: 10721

This addendum report has been requested by Jorge Hrdina Architects. The purpose of this report is to address design modifications adjacent neighbouring trees 21 & 22, with this report confirming review of latest design plans as referenced below.

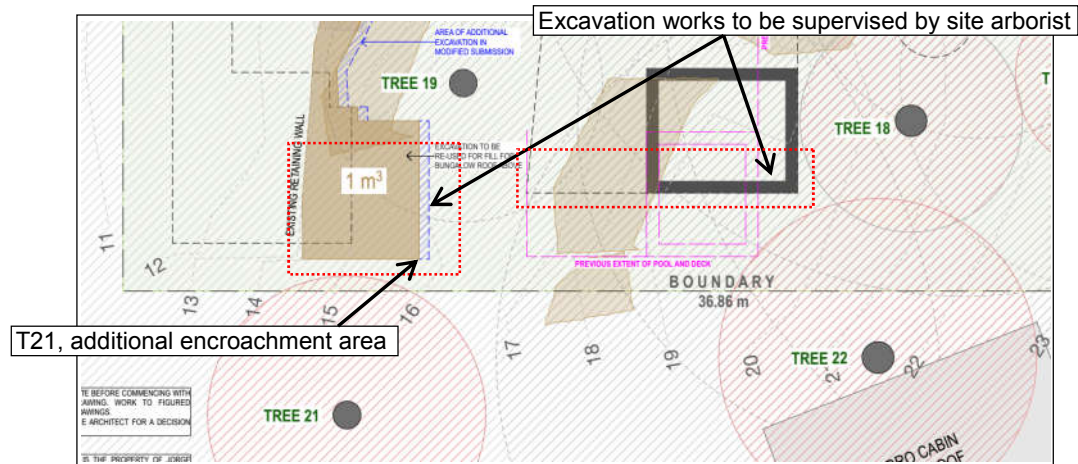
Figure 1, T21 & 22 management areas

Tree 21: As shown within Figure 1 the additional minor encroachment at or near 245mm from the existing footprint will unlikely affect the vitality of the tree.

Tree 22: The location of the amended swimming pool footprint has Minor (<10%) at or near 7.5% Tree Protection Zone (TPZ) occupancy, of low level impact and encroachment within TPZ.

Tree management: The management of the trees during works is to consist of all recommendation provided within Raintree Consulting's Arboricultural Impact Assessment (AIA) report specific to:

- 1) The extent of existing retaining wall demolition, new all construction and any over excavation required to accommodate the design proposal shall be clearly marked within construction drawings prior to obtaining a Construction Certificate (CC).
- 2) An appointed project arborist shall be engaged to supervise excavation within tree protection zone setbacks with all encountered tree roots protected in accordance with AS4970 – 2009 Section 4.5.4 *Root protection during works within the TPZ*, such that tree roots are not damaged or ripped beyond the point of excavation by site machinery. Root pruning should also be conducted in accordance with Section 9 of Australian Standards AS 4373 Pruning of Amenity Trees 2007 specific to: all cuts shall be clean cuts made with sharp tools such as secateurs, pruners, handsaws, chainsaws or specialized root pruning equipment.

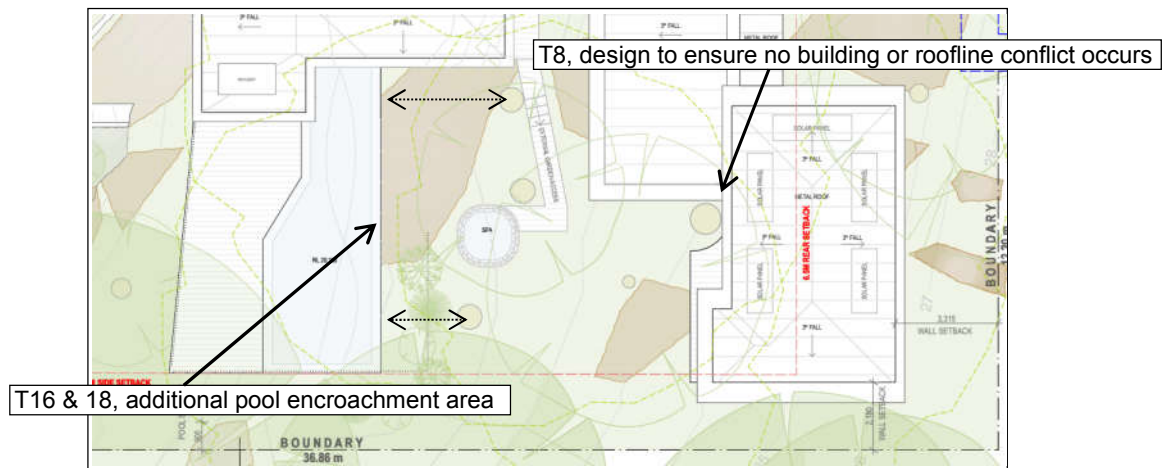
Figure 2, showing amended pool location & roofline adjacent T8

Amended pool location, trees 16 & 18 [Plan DA2002].

The amended pool location slightly increases TPZ occupancy and potential impact. Further information is required based on pool construction methodology with design plans showing how the pool will be constructed to mitigate impacts within tree protection zones. Prior to obtaining a Construction Certificate (CC) final pool construction drawings are to be reviewed and endorsed by an appointed project arborist.

Tree 8, Roof Plan [DA2005]

Design is to ensure no building or roofline conflict occurs where suitable space is to provided that allows for ongoing natural tree growth.
