Tree Consultants

ARBORICULTURE IMPACT ASSESSMENT *re Development Application (DA2018/0569) Submission* **JUNE 2018**

Site: Lot 20 in DP 22275
60 Binburra Avenue
AVALON BEACH, NSW 2107

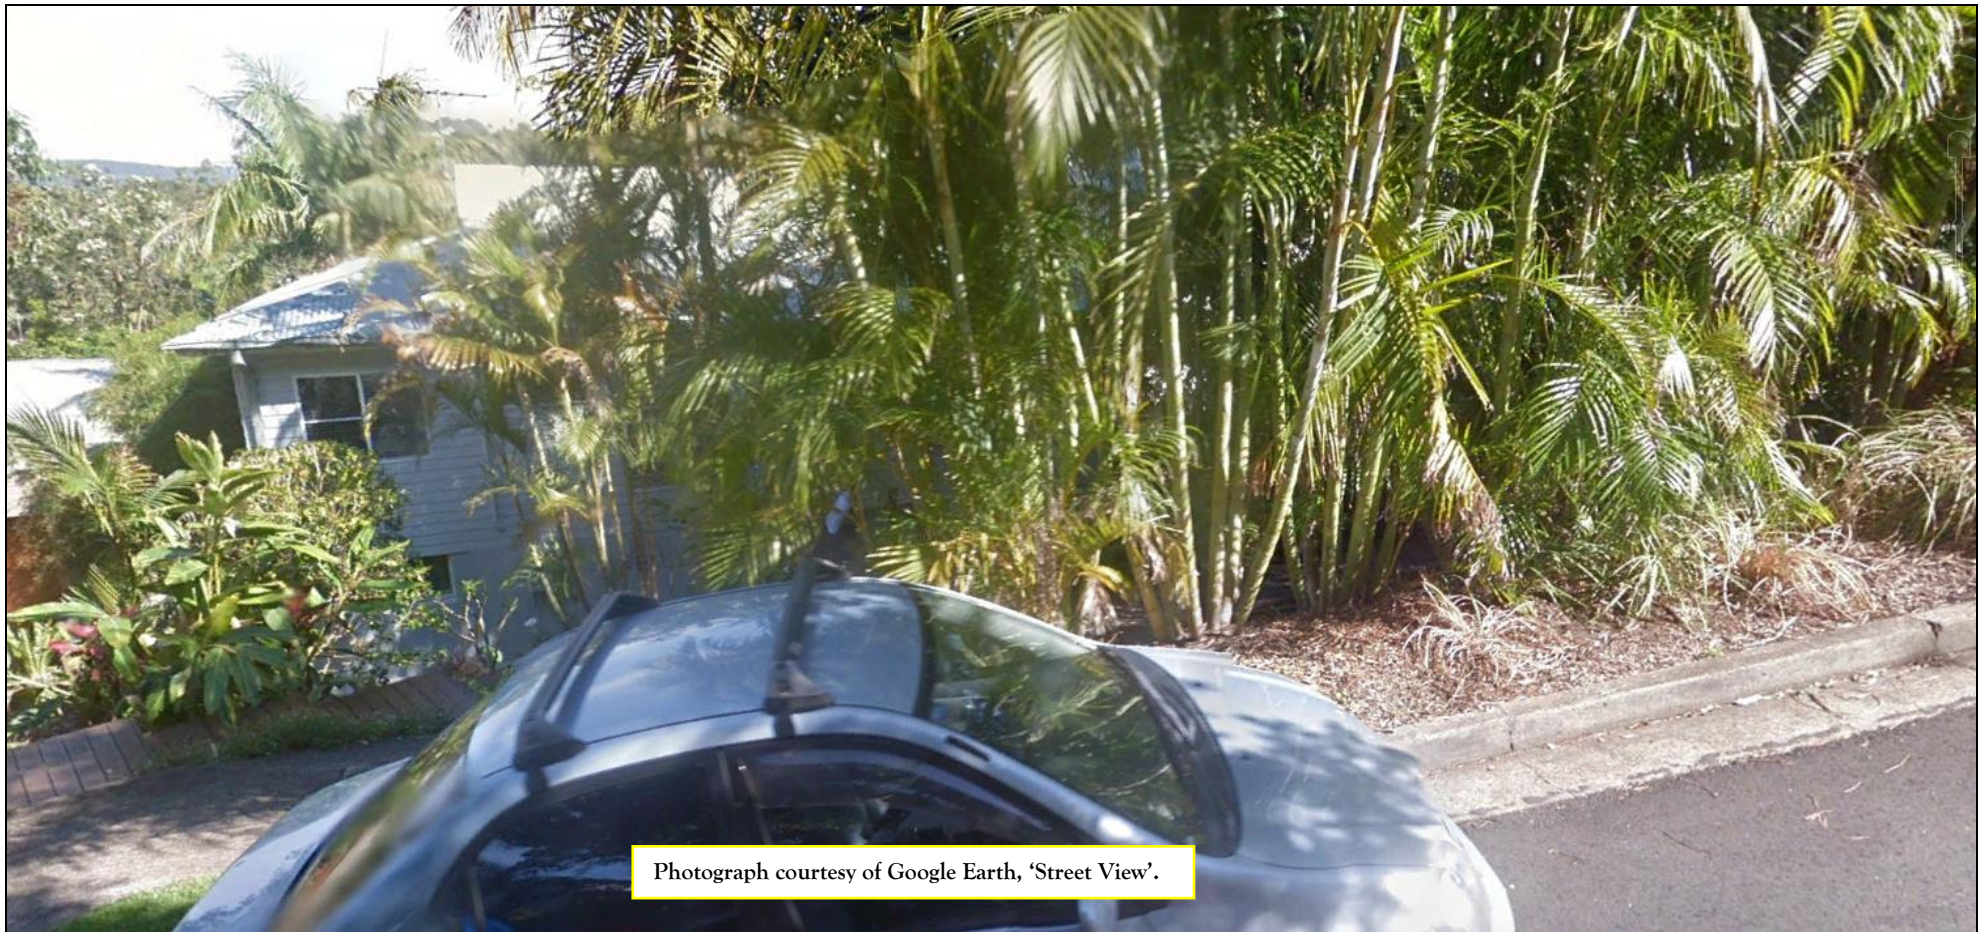
Figure 5: Left side of driveway vegetation to be removed/replaced for proposed garage. Centre-right vegetation whilst not protected will be retained at the front of the subject site.

Trees #3 are located within the front yard of the subject site. They are assessed/confirmed as required to be removed by virtue of the location of the proposed new garage & secondary dwelling.

Trees #3: Remove & Replace

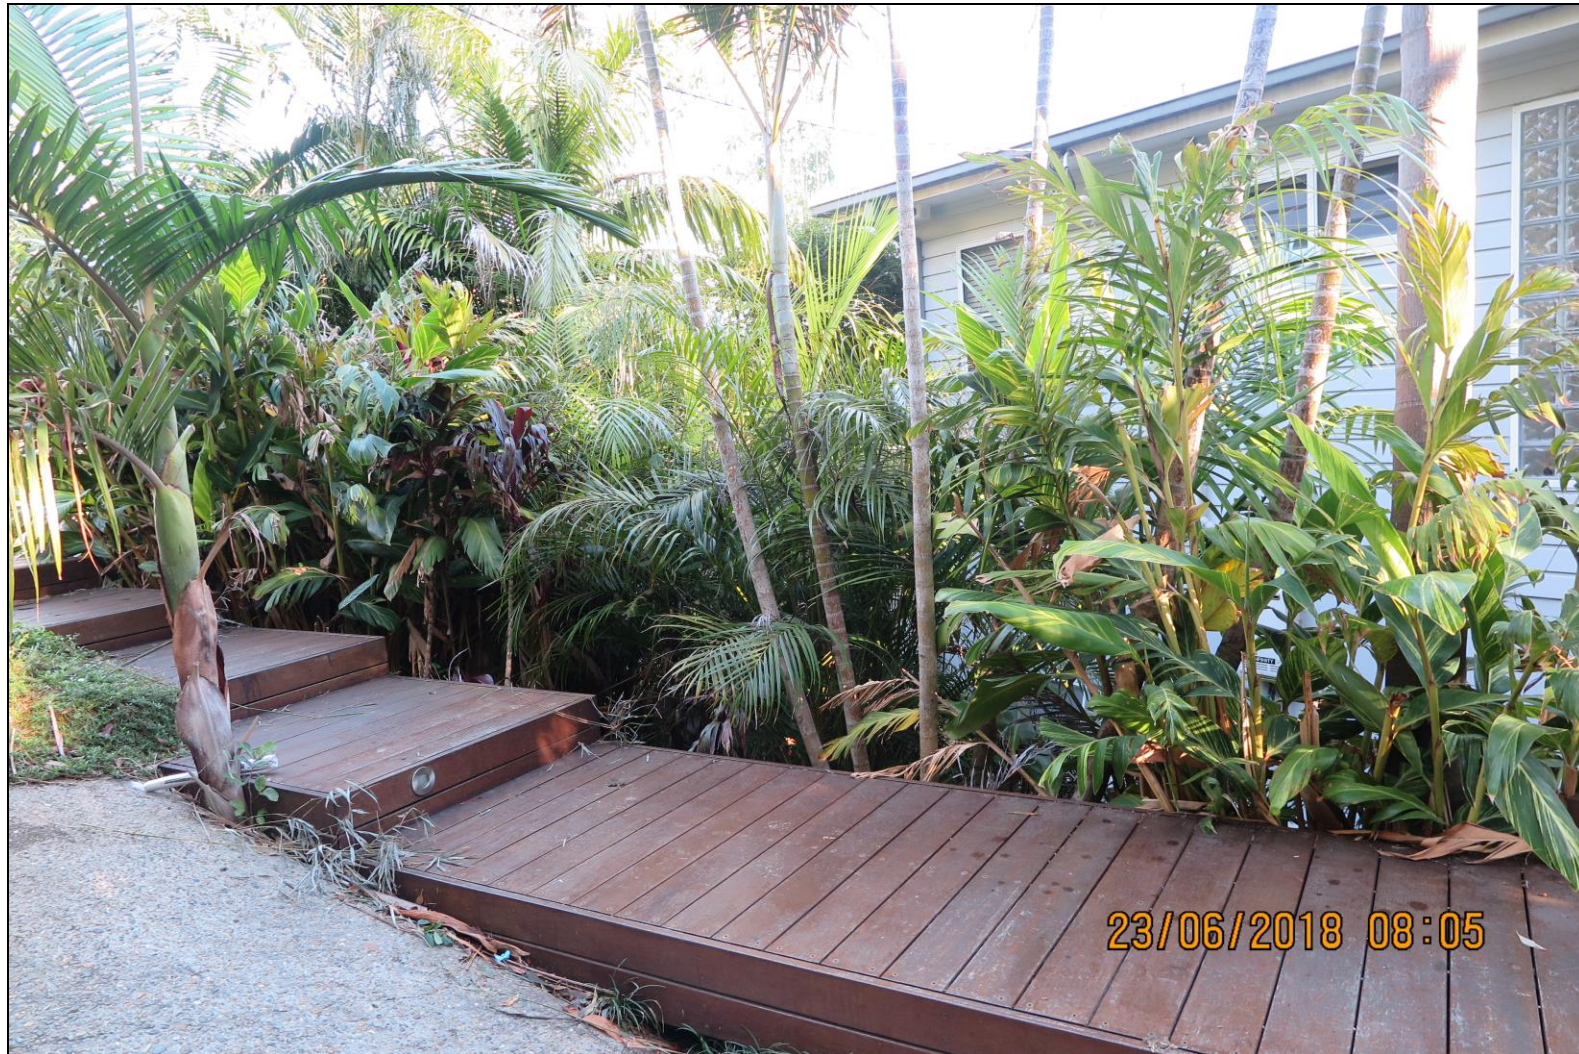
Figure 6: Illustrates east/south area of subject site front proposed to be retained vegetation, (confirmed to not be protected).

Trees #2 are not proposed to be subjected to any ground level disturbance. On the basis they are within the front of the subject site (east side) & well away from any proposed disturbance it is not considered necessary to isolate these trees by the installation of any temporary 'physical barrier'.

- *Retain & Manage*
- *Retain & Manage by implementation of best practice ‘cultural practices’.*

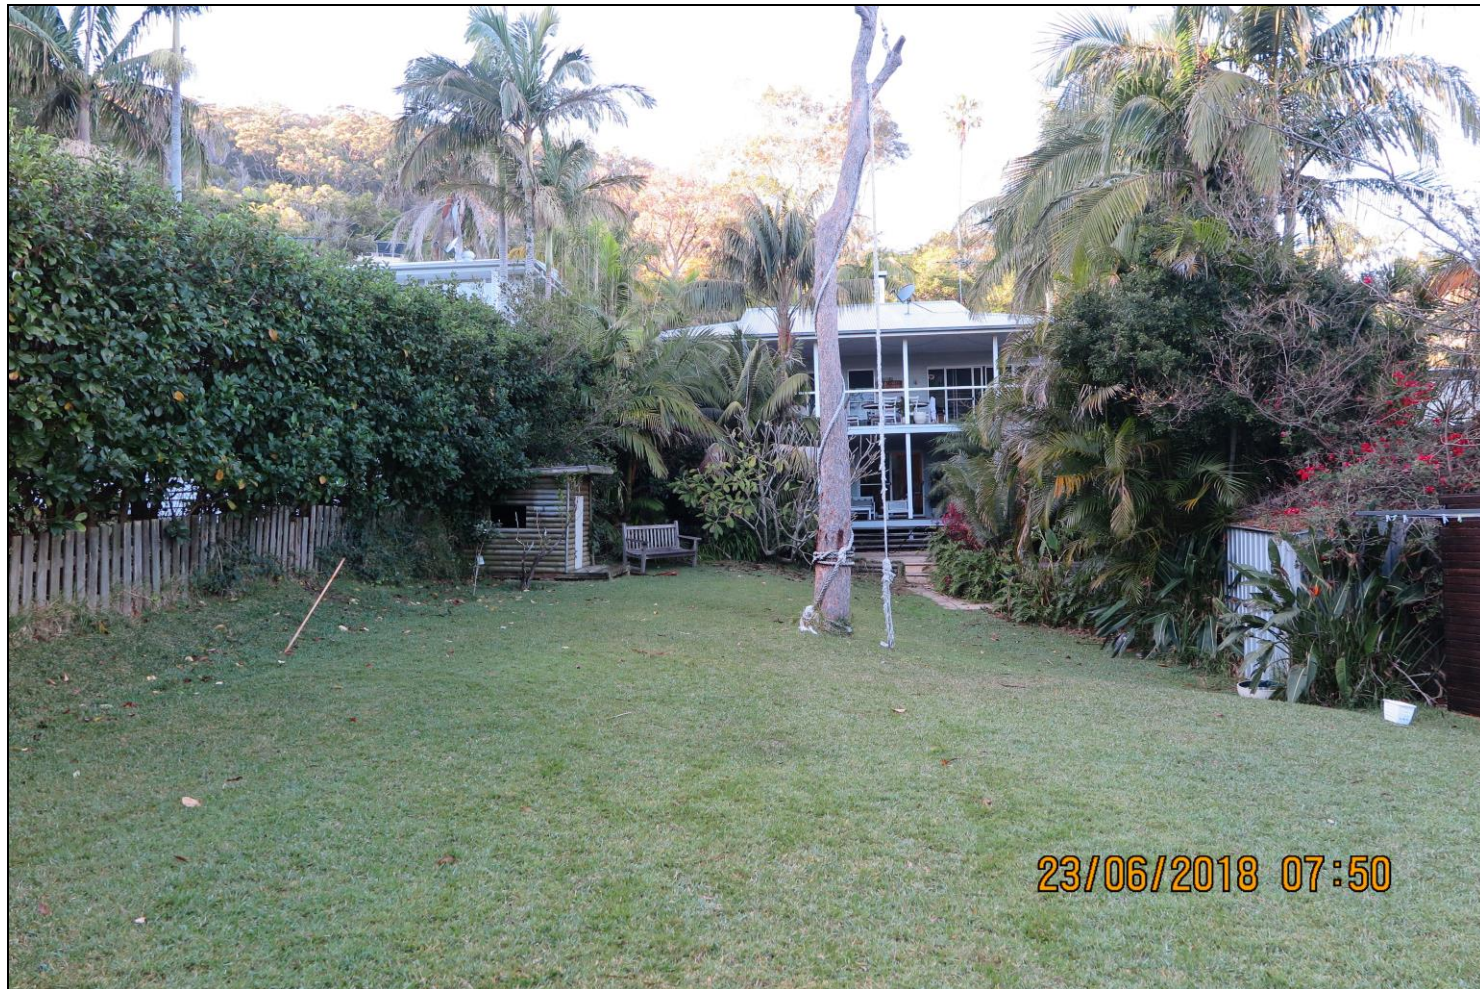
Figure 7: Illustrates east & west sides of rear yard trees mostly proposed to be removed/replaced. Centre of photograph illustrates location of the only identified as protected tree species discussed.

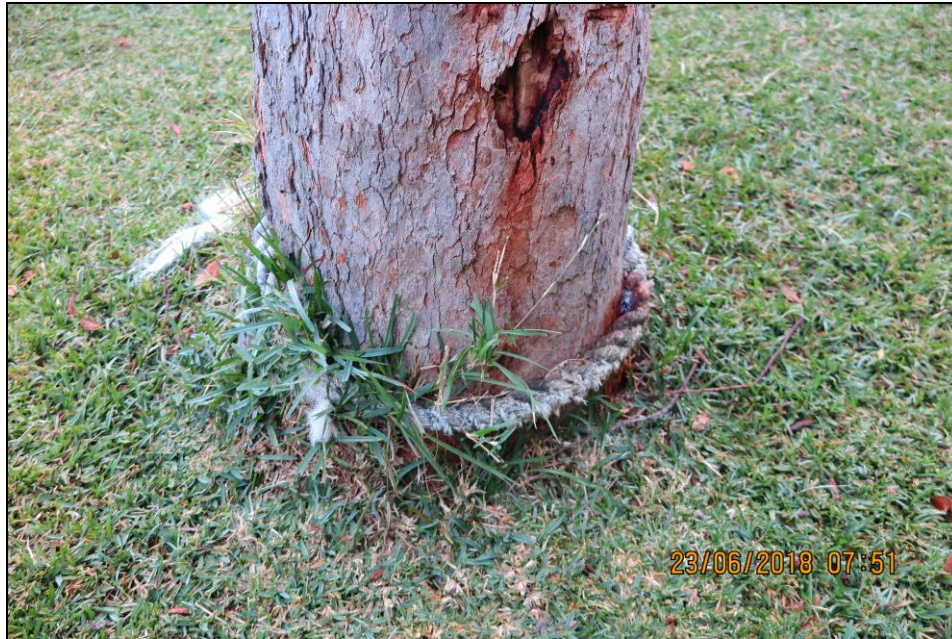
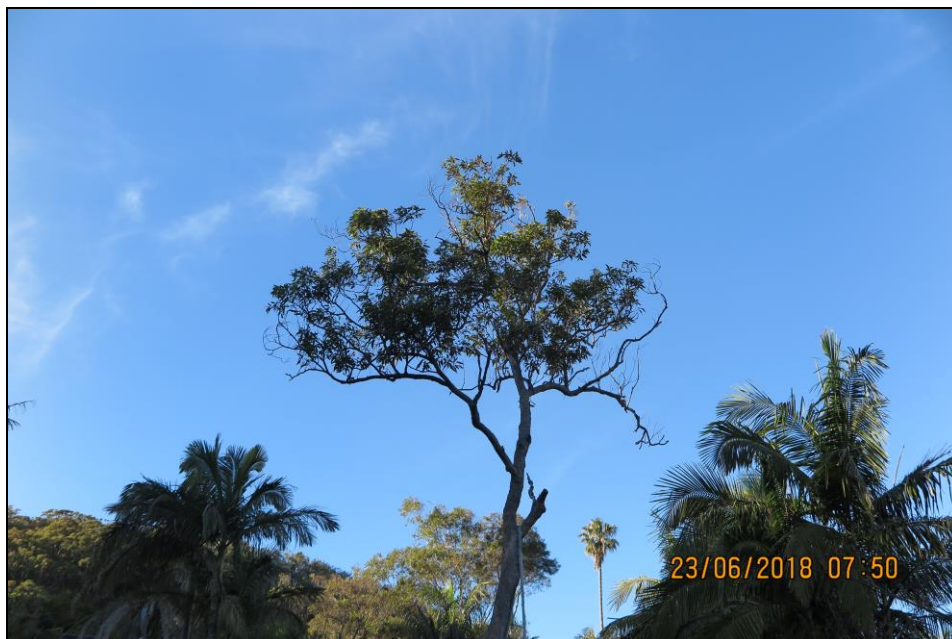
One (1) tree, (Tree #6) noted in as lodged documentation to be a dead tree is actually not dead but in a 'state of advanced decline'. It is confirmed to be a locally indigenous tree species. Its 'state of advanced decline' of advanced decline is easily explained. Previous subject site owners (not the as proposed DA DA benefactors) in an effort to create a near level outdoor (grassed) playing area have changed natural soil levels. Simply, natural soil levels have been raised. The evidence being side of rearyard battered/grassed edges parallel to adjoining long common boundary properties & 'NO EXPOSED Tree #6 base of tree trunk flare, (a classic give-away).

As a direct consequence of the 'change of natural environment' soil levels Tree #6 displays classic indicators of 'tree root dysfunction'. They include 'branch tip dieback' as well as the death of larger diameter dead branches that the property owner confirmed to have been recently pruned on the 'grounds of safety'.

No one can accurately estimate how long the it will take for Tree #6 to actually die. However, it will never recover to be a healthy example of its species.

Figure 8: Above photograph confirms 'total absence of tree trunk base flare'. Below illustrates 'dead/dying branch & branch tips' as described in text.

Tree #6 by location is technically able to be retained but by virtue of its 'advanced state of decline' it is supported to be removed & replaced.

Tree #6: Remove & Replace
