Report on Geotechnical Investigation

Proposed Additions and Alterations 35 Kanimbla Crescent, Bilgola Plateau

> Project 99804.00 August 2021

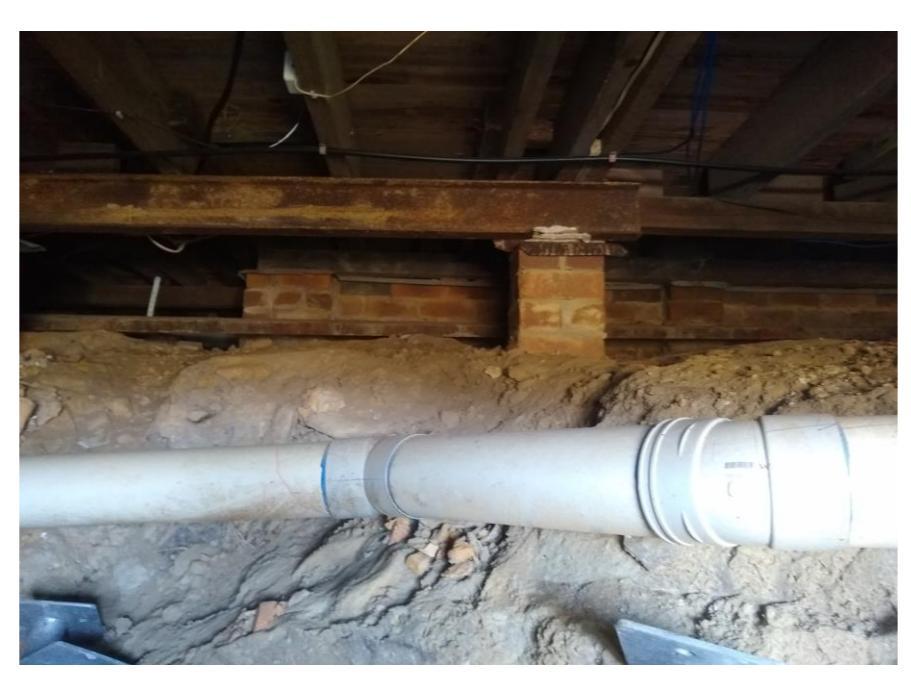
- From what could be seen beneath the house it appears that the small brick footings are founded on bed rock. The footings appear to be in good condition (refer to Photo 1 & 2);

Photo 2: View underneath house, footings on rock

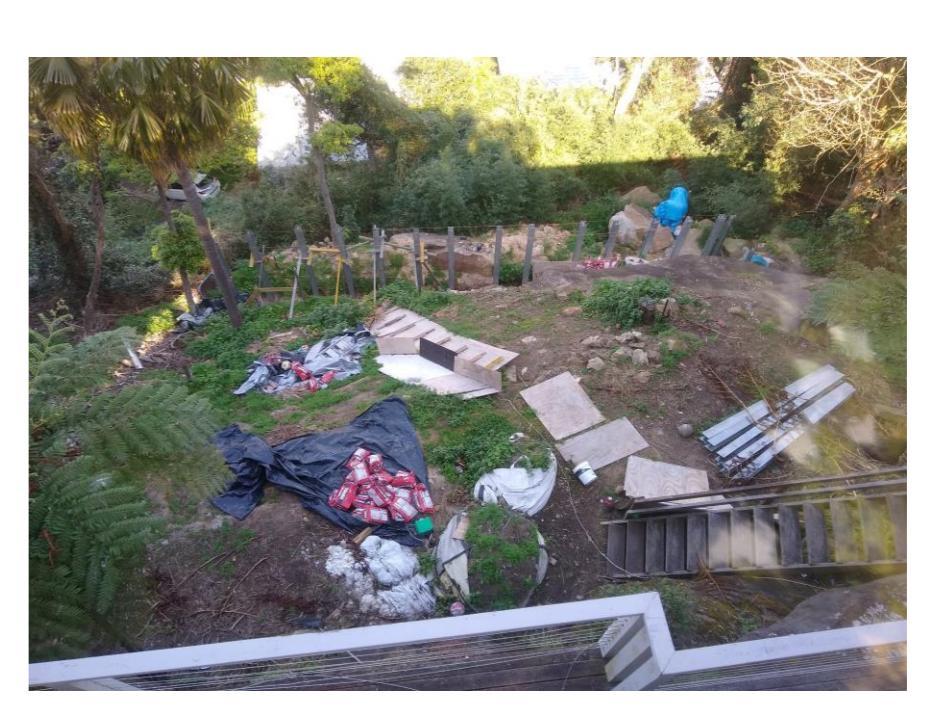
- An unfinished steel post retaining wall is located at the base of the slope (refer to Photo 3);
- The decking structure appears to be supported by steel posts founded on bedrock (Refer to Photo 4);

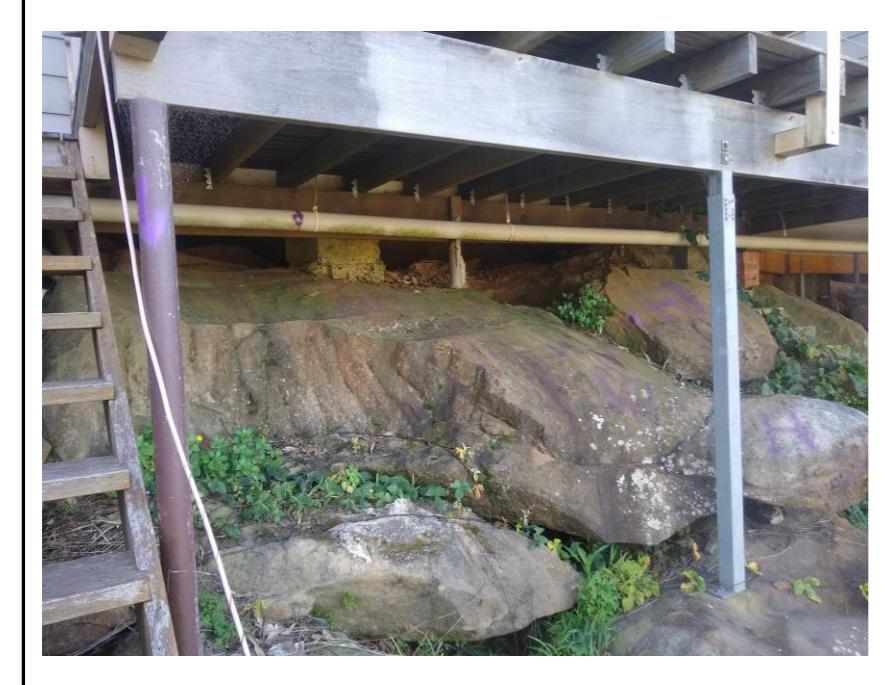
Photo 4: Underside of residence, western end (view north)

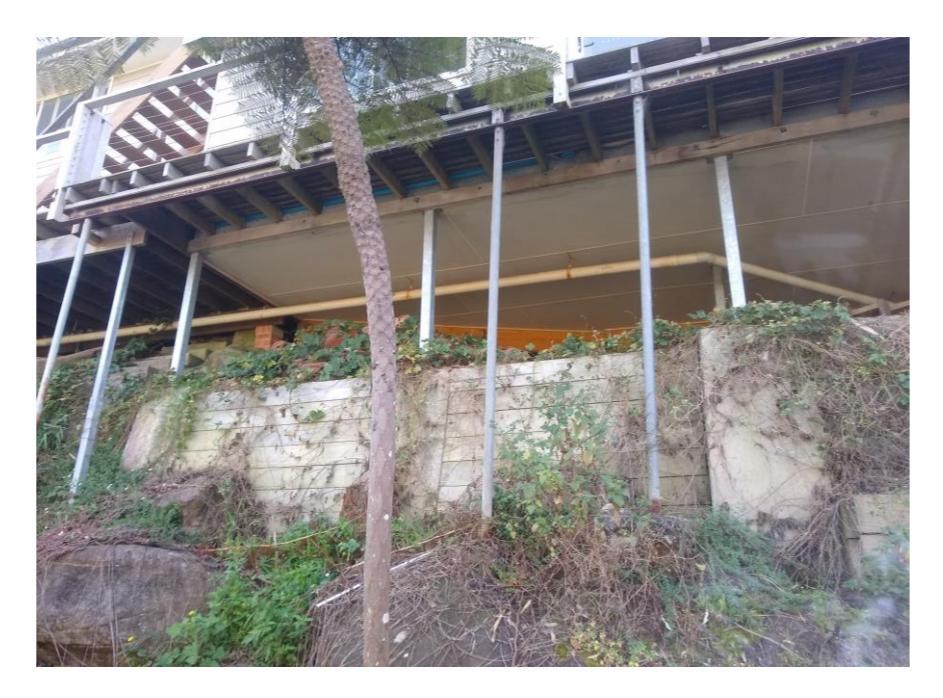
- A concrete post and wood retaining wall founded on bedrock beneath the house appears to be in good condition (refer to photo 5). This retaining wall appears to have been constructed to allow a bench to be formed beneath the house;

Photo 5: Underside of residence, eastern end (view north)

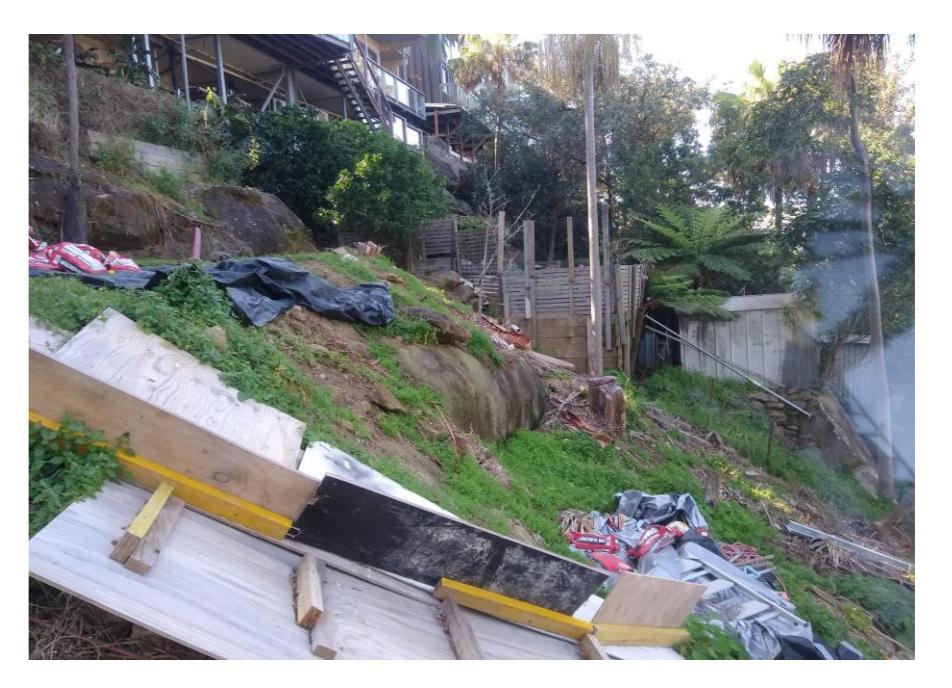
- Sandstone outcrops and boulders are located down slope of the house (refer to Photo 6). A large boulder that is 5 m by 4 m wide is located along the northern boundary, directly above the unfinished retaining wall;

Photo 6: View of slope below residence (view east)
