ARBORICULTURAL IMPACT ASSESSMENT

RELATING TO THE PROPOSED INCLINATOR AT

11 PORTIONS LOVETT BAY NSW 2105

Prepared for Phillip Pryke 31 March 2021

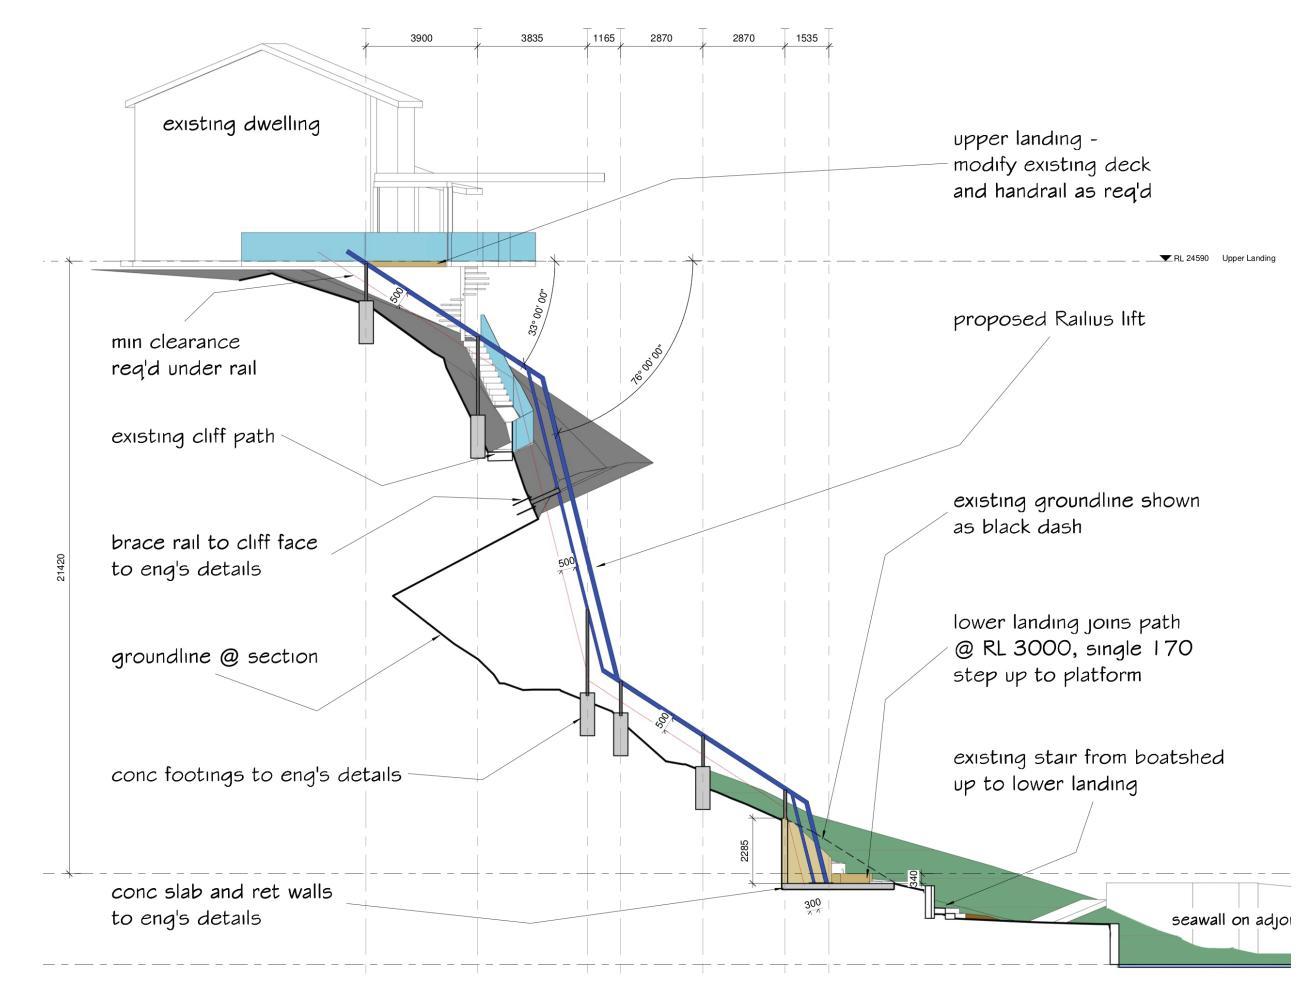
Figure 5: Section architectural drawing prepared by Peter Downes Designs illustrating position of inclinator rail and pier locations. Note, drawings are not to scale.

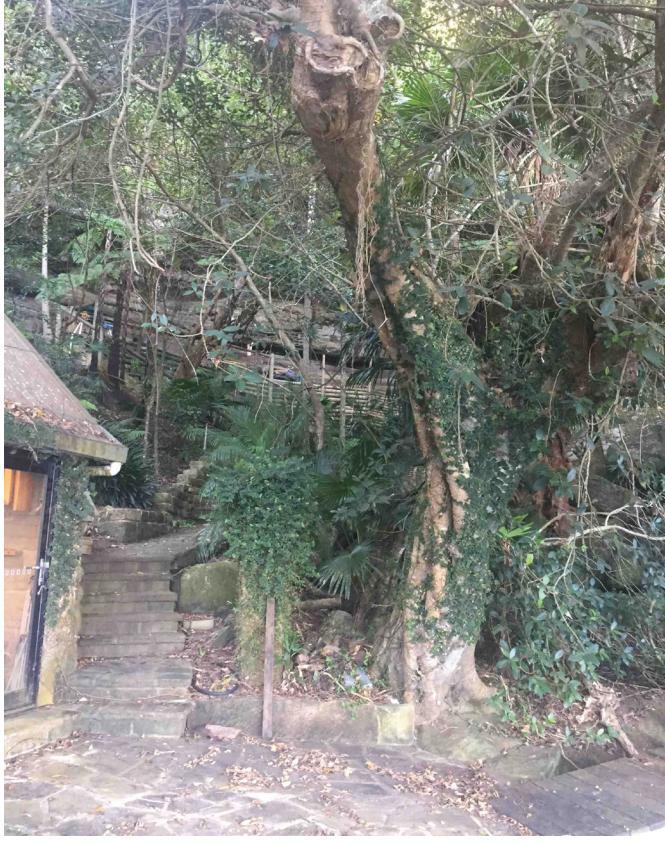
Figure 7: Photograph viewing north from the boat shed level. The trunk of Tree No. 5 (Port Jackson Fig) is visible to the right hand side (Photo: J Willis)

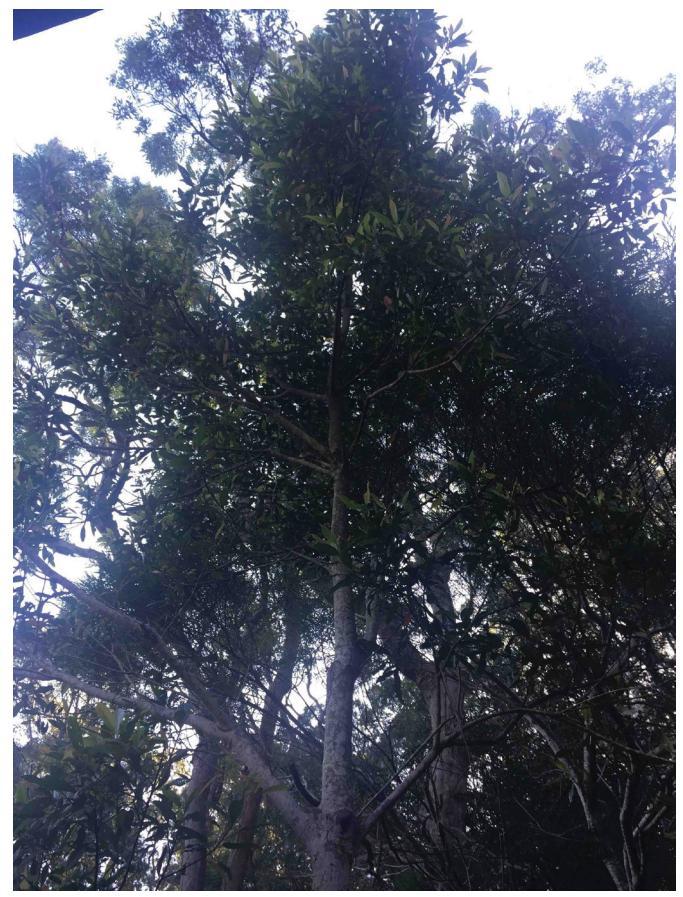
Figure 8: Photograph viewing the upper canopy of Tree No. 1 (Blueberry Ash) which is positioned adjacent to the upper landing (Photo: J Willis)

- 4.5 The inclinator rail, upper landing and pier is located in or close to the TPZ of Tree No. 1 (Blueberry Ash). The encroachment is considered acceptable providing the pier (and any additional post footings) are excavated by hand and the cutting of any large structural woody roots greater than 30mm diameter is avoided. Very minor canopy pruning may be required. The extent is estimated to be less than 10% and should not result in any adverse impact upon the tree.

- 5.4 The positioning of the upper pier to support the inclinator rail is located in the TPZ of Tree No.1 (Blueberry Ash). All excavation for piers must be by hand (ie. non-mechanical methods). Final positioning of piers must ensure there is no cutting of any structural woody roots greater than 30mm diameter. Where woody roots greater than 30mm diameter are encountered and the pier cannot be relocated, further advice must be sought from a qualified Arborist prior to root severance. Any roots less than 30mm in diameter shall be cut cleanly with a sharp pruning implement.

- 5.5 It is recommended trunk protection is installed around Tree No. 1 (Blueberry Ash) prior to commencement of works. As a minimum, the trunk protection shall consist of 1.8 metre lengths of pine board timbers (90 x 45mm) spaced at 100-150mm centres secured together with perforated metal straps. These shall be strapped around the trunk (not fixed in any way) to avoid mechanical injury or damage. Trunk protection should be installed prior to any site works and maintained in good condition for the duration of the construction period. Trunk protection will help to protect the tree from any inadvertent damage that may result from construction activities during the course of the inclinator works.

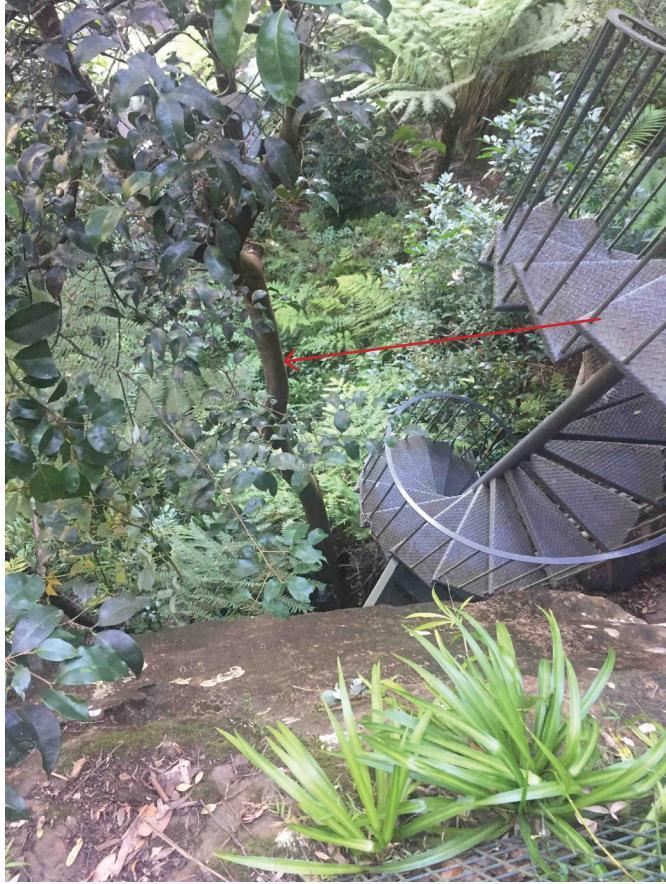
Figure 10: Photograph viewing the the trunk of Tree No. 2 (Tucker Bush) located adjacent to the spiral staircase - see red arrow (Photo: J Willis)

- 4.4 It is estimated a significant amount of canopy pruning will be required to Tree No. 2 (Tucker Bush) to provide adequate clearance for the inclinator rail and cart as it extends up past the sandstone overhang. Due to the steep topography of the site and obstruction of views, it is was difficult for the author to provide an accurate estimation of the canopy loss due to future pruning works while on site. However it is estimated at least 40% of the tree's canopy would be removed which would likely render the tree unviable. The tree is a locally occurring species and therefore holds high ecological significance. However the tree does exhibit major decay on the lower trunk where a co-dominant limb has previously failed. Overall, with consideration to the existing population of the species on the site and its propensity to self-seed, if excessive canopy pruning is required its removal would be considered acceptable.

- 5.2 The proposed works will likely result in significant canopy pruning to Tree No. 2 (Tucker Bush) which is positioned adjacent to the spiral staircase. The extent of canopy pruning is estimated to be greater than 40% of the tree's live crown. If this estimation is correct, and the excessive canopy

pruning renders the tree unviable it is recommended the tree is removed and replacement planting is undertaken on the site with the same species.

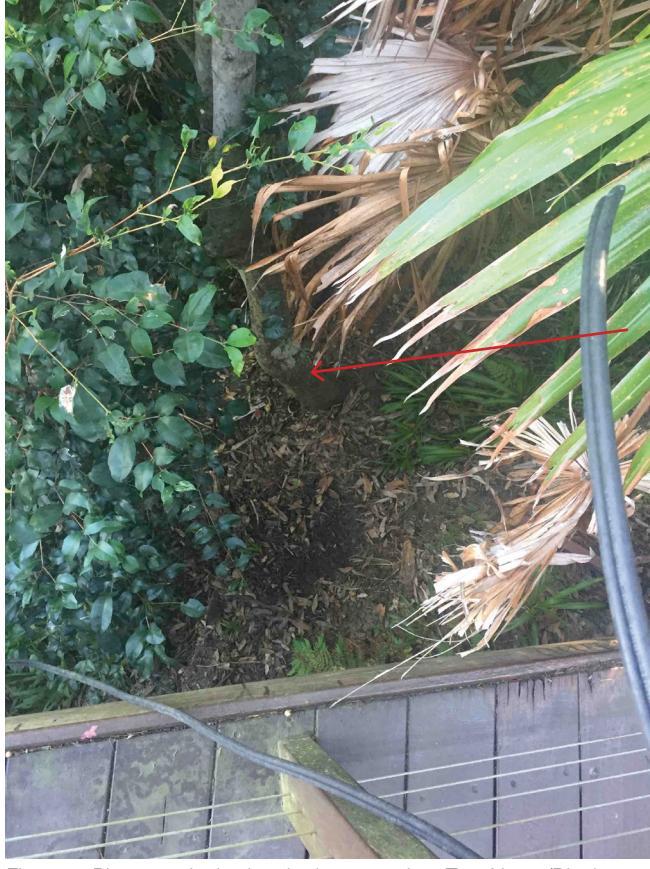
Figure 9: Photograph viewing the lower trunk of Tree No. 1 (Blueberry Ash) - see red arrow. (Photo: J Willis)

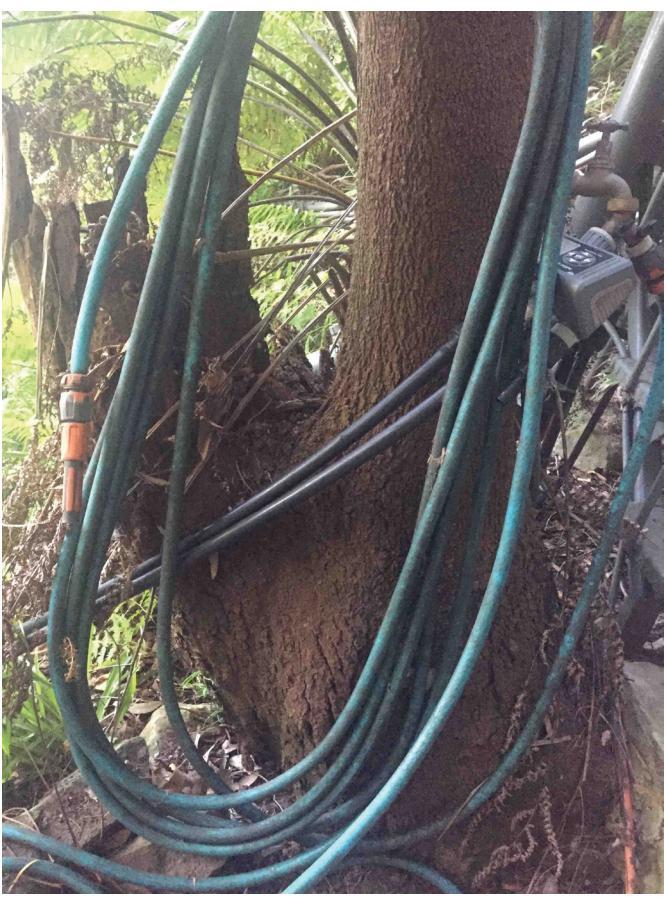
Figure 11: Photograph viewing the base of Tree No. 2 (Tucker Bush). (Photo: J Willis)

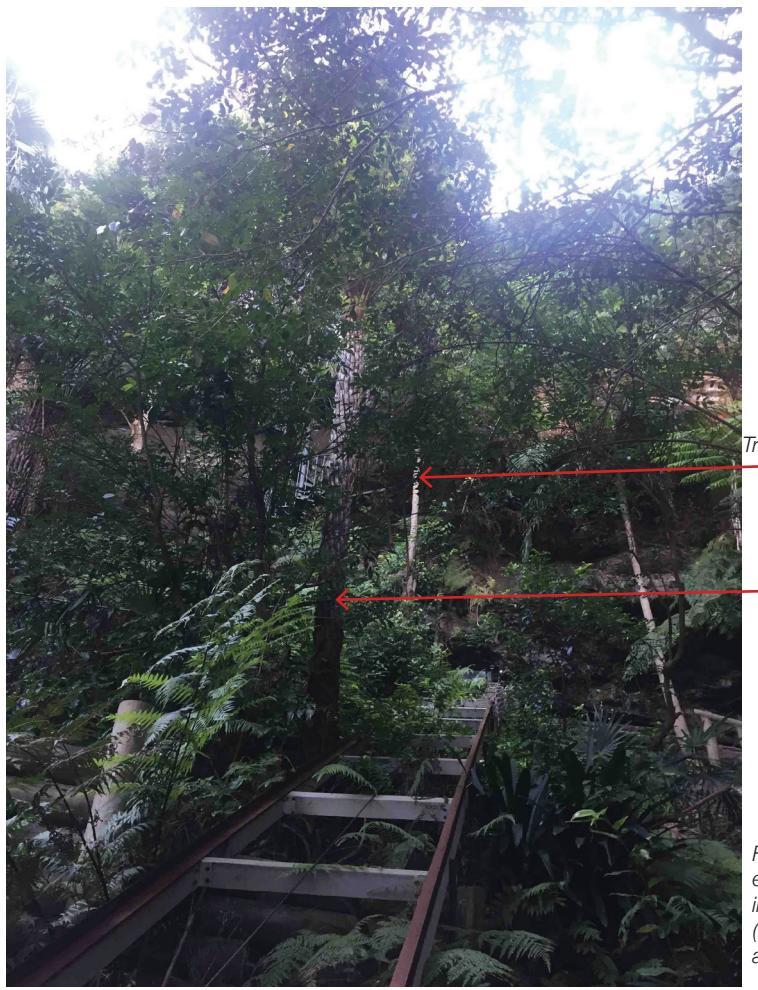
Figure 12: Photograph viewing north at the existing rail with Tree No. 4 (Tree Fern) visible in the foreground and the trunk of No. 3 (Bolwarra) visible in the background - see red arrows. (Photo: J Willis)

- 4.3 The inclinator rail and clearance for the cart will necessitate the removal of Tree No. 3 (Bolwarra) and No. 4 (Australian Tree Fern). Whilst both tree and fern are locally indigenous species and therefore hold a high ecological significance, they represent a small portion of the canopy cover and biodiversity to the site. Overall, Tree No. 3 and 4 are not considered worthy of posing a constraint to the proposed inclinator.

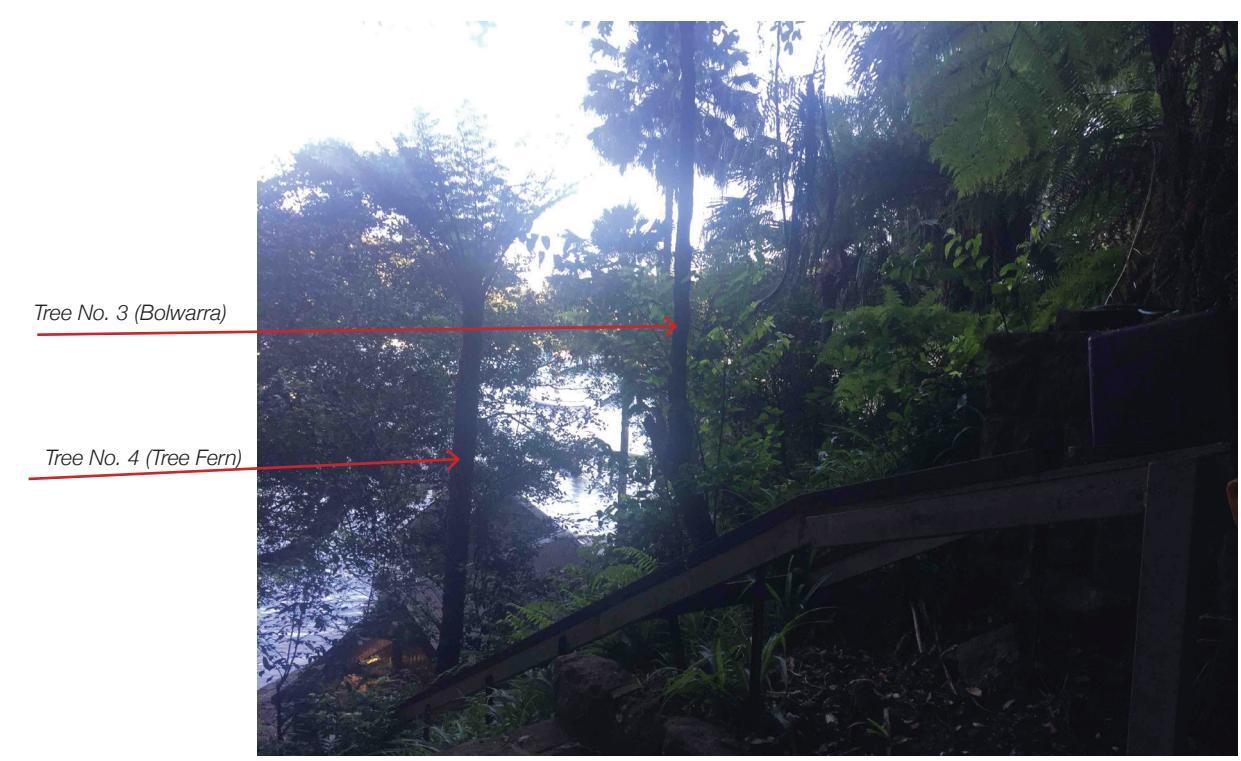
Figure 13: Photograph viewing west at the existing rail with Tree No. 4 (Tree Fern) visible to the left hand side and the trunk of No. 3 (Bolwarra) visible to the right hand side - see red arrows. (Photo: J Willis)
