## **77A Myola Road, Newport**

### Geotechnical Comments for Section 4.55

## **GEOTECHNICAL INVESTIGATION:**

### **Alterations & Additions at 77A Myola Road, Newport**

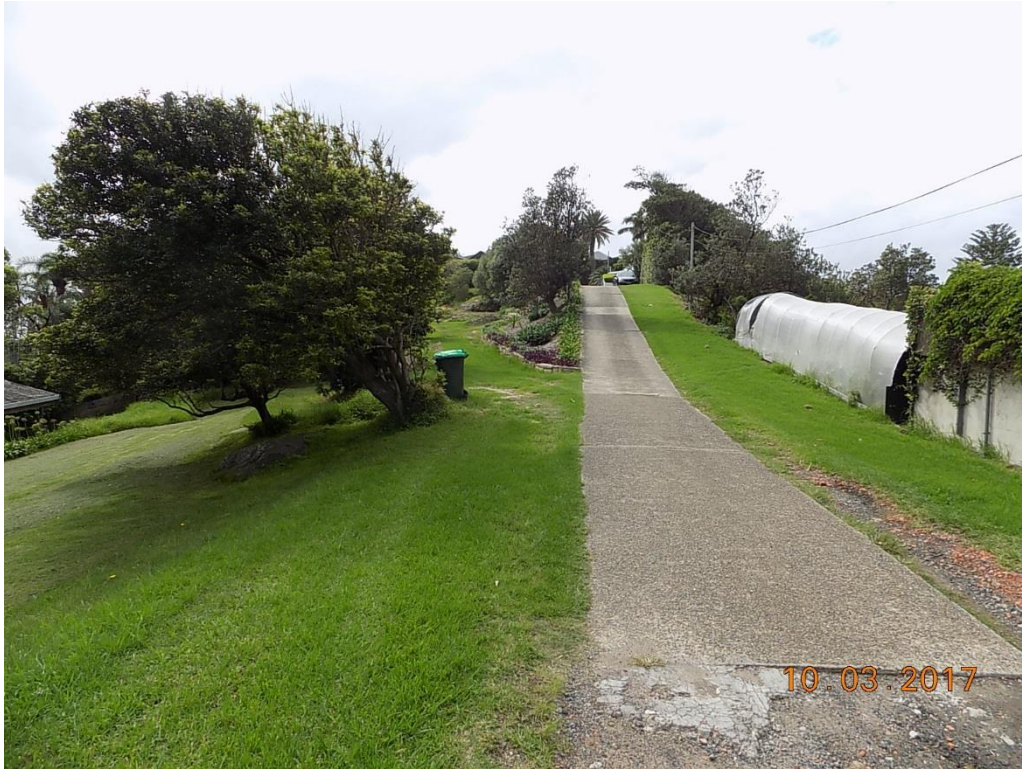
Photo 1

- 2.3 At the road frontage, a concrete Right of Carriageway (ROW) runs up the slope along the ridgeline to a concrete parking area on the W side of the property (Photos 1 & 2). Between the parking area and the house is a near-level lawn covered fill. The fill for this lawn and for the parking area is supported by an old timber crib retaining wall reaching ~1.3m high (Photo 3). The timber has moved slightly in places as is typical for these types of walls. The wall can be seen to be backfilled with cobble sized sandstone and is well-drained. The wall is currently considered stable but to be prudent we recommend it be monitored by the owners on an annual basis and a photographic record of these inspections kept. Should further movement be observed a geotechnical consultant is to be engaged to re-assess the wall. Below the wall, competent medium strength sandstone outcrops and steps down on the neighbouring property (Photo 4). The top of

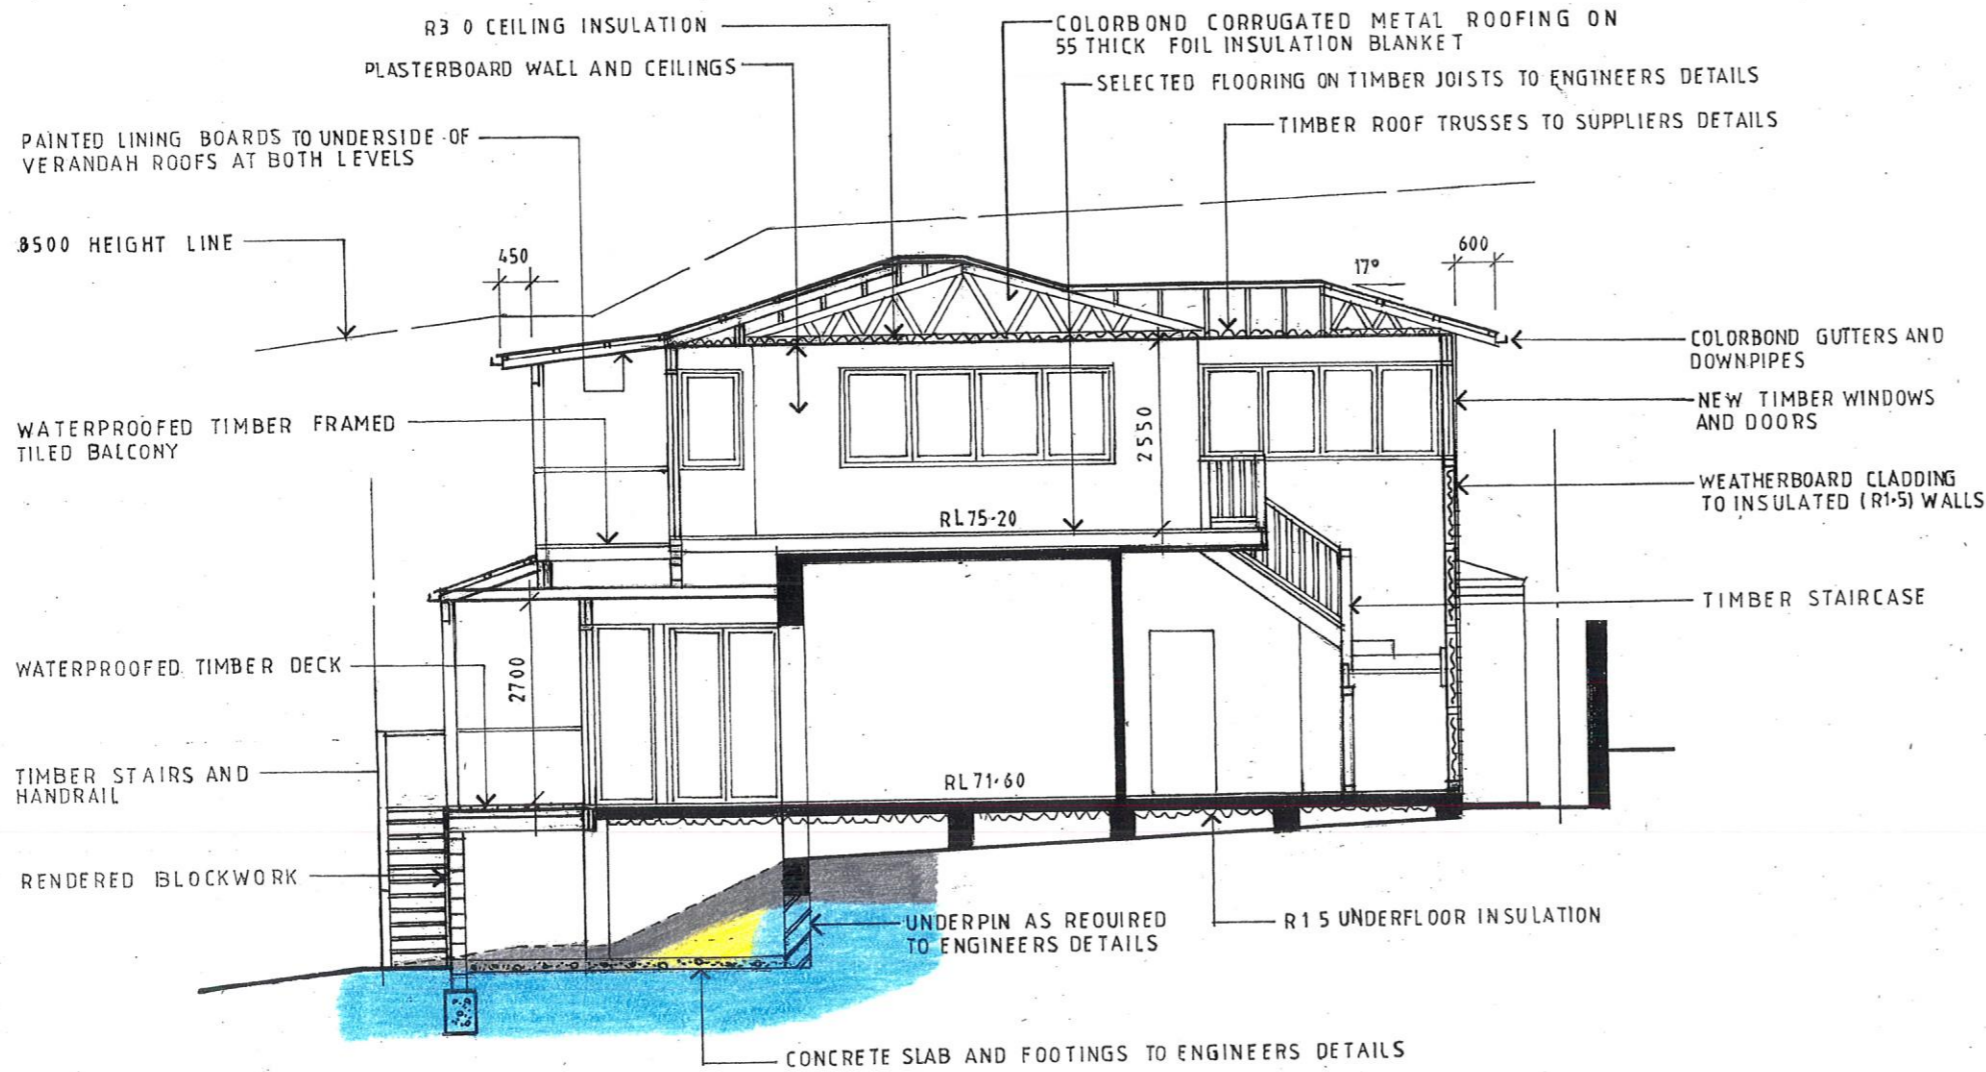
TYPE SECTION – Diagrammatical Interpretation of expected Ground Materials

Sandstone bedrock was observed to be outcropping across and below the site. This is an unusually thick sandstone bed within the Narrabeen Group of rocks. The surface features of the block are controlled by the outcropping and underlying sandstone bedrock that steps up the property forming sub-horizontal benches between the steps. Where the grade is steeper the steps are larger and the benches narrower. Where the slope eases the opposite is true. Where the rock is not exposed it is overlain by filling, sandy soils, and firm to stiff sandy clays that fill the bench step formation. In the test locations, the depth to rock ranged between 0.1 to 2.6m below the current surface, being deeper where filling has been placed for the house and due to the stepped nature of the rock. It is possible DCP 4 was over a joint (crack) in the rock as sandstone was observed to be outcropping on both sides of the test. It is interpreted from ground tests and observations of the retaining wall that DCP 5 passes through ~1.2m of fill before encountering a more typical shale profile. The outcropping sandstone on the property and immediately below is estimated to be medium strength sandstone or better and similar strength rock is expected to underlie most of the site. See Type Section attached for a diagrammatical representation of the expected ground materials.
