# Construction Impact & Management Statement

### March 2021

Site:	Lot 104 in DP 752046						
	39 Attunga Road						
	NEWPORT, NSW						
Client:	Lance Horton						
	c/ MHDP						
	Level 2, 271 Alfred Street						
X	NORTH SYDNEY, NSW 2060						
Author:	Kyle A Hill						
The State of the S	Registered (Arb Aus #1884) Practising & Consulting Arborist						
	Post Graduate Certificate in Arboriculture, Uni of Melb						
	Diploma of Horticulture-Arboriculture TAFE, Grow SA						
	Certificate of Horticulture, TAFE						
	Certificate Advanced Tree Care TAFE						
	Founder -Growing My Way Tree Services (1977)						
	Member of International Society of Arboriculture						
	Member of Arboriculture Australia

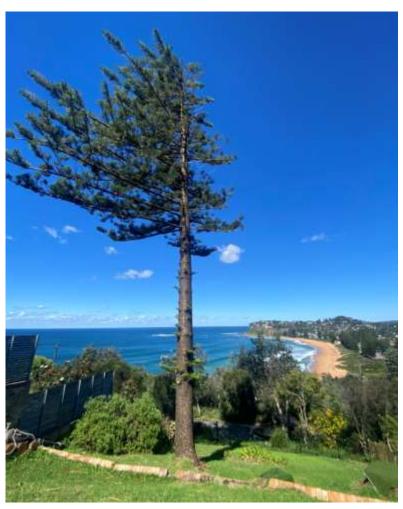
Figure 6: Photographs confirm the location & habit of the one (1) discussed tree. Note: Asymmetrical canopy profile.

Identification	Height (m)	Crown (m)	DBH (m)	TPZ (m)	SRZ (m)	Age	Health/ Vigour	Structure	Significance/ Retention Values	Comments
1	<b>Araucaria</b> <b>heterophylla</b> Norfolk Island Pine	<25.00	<11.50	0.67	8.04	2.90	Mature	Fair & Fair	Atypical, tree has asymmetrical canopy as a consequence of competition for solar access with recently removed (2x) same species trees.	Low/ Low	Remove, Protect & Manage: Tree looks silly by virtue of its poor appearance at a landscape amenity level.  Tree will never be typical of its species  Tree is assessed as easily managed (below ground level) by implementation of the 'Site Specific Plan of management' within this document.

<u>Tree #1</u> is acknowledged as being of Low Significance & Low Retention value with respect to its present landscape amenity value, (deemed to be very low).

- tree trunk protection,
- below ground 'live root management' that minimises any Tree Protection Zone (from herein TPZ) total surface area (203.08m²) intrusion relative to existing soil level
- the installation of a composted mulch maintained from prior to commencement until completion of the project at a minimum thickness of 75mm
- a Tree Trunk Guard is specified to be installed from ground level to 3.50m high so as to protect the tree trunk from works to form/build the swimming pool structure.

Any required footing located within its TPZ radial distance (8.04m) must be designed to have the capacity to be flexibly located should any significant diameter 'live root' be exposed. Simply, any 'live root' exposed greater than fifty millimetres (50mm) in diameter is defined as being of a significant diameter & as such every effort for viable preservation must be undertaken. (The reason: to not further compromise its already compromised ULE.)
