Geotechnical Assessment

Project: Inclined Lift
12 Sunrise Road, Palm Beach NSW

REF: AG 20277
5 November 2020

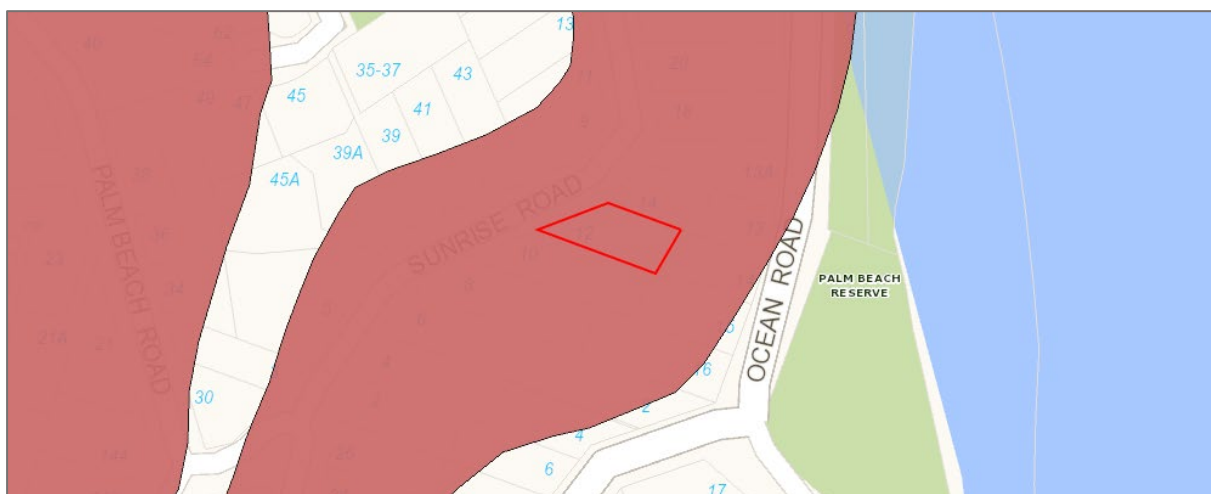
Image 2. PLEP Geotechnical Hazard Map
– 12 Sunrise Road, Palm Beach NSW

- No evidence of significant soil creep, tension cracks or large-scale landslip instability were identified across the site or on adjacent properties, as viewed from the subject site, at the time of our inspection.
- A significantly undercut sandstone outcrop is situated immediately upslope of the house. A large slab has delaminated from the roof of the cantilever arm and is resting in a stable position. (Note that the condition of this detached slab is unchanged since the authors last site visit in 2014.) While the large cantilever arm is considered stable in current condition, it should be noted that it is impossible to accurately predict the potential failure of the sandstone outcrops of this type.
- The property is classified as **Geotechnical Hazard H1** with reference to Northern Beaches Council PLEP Landslip Risk Map Sheet (PLEP Geotechnical Hazard Map **Image 2** below).

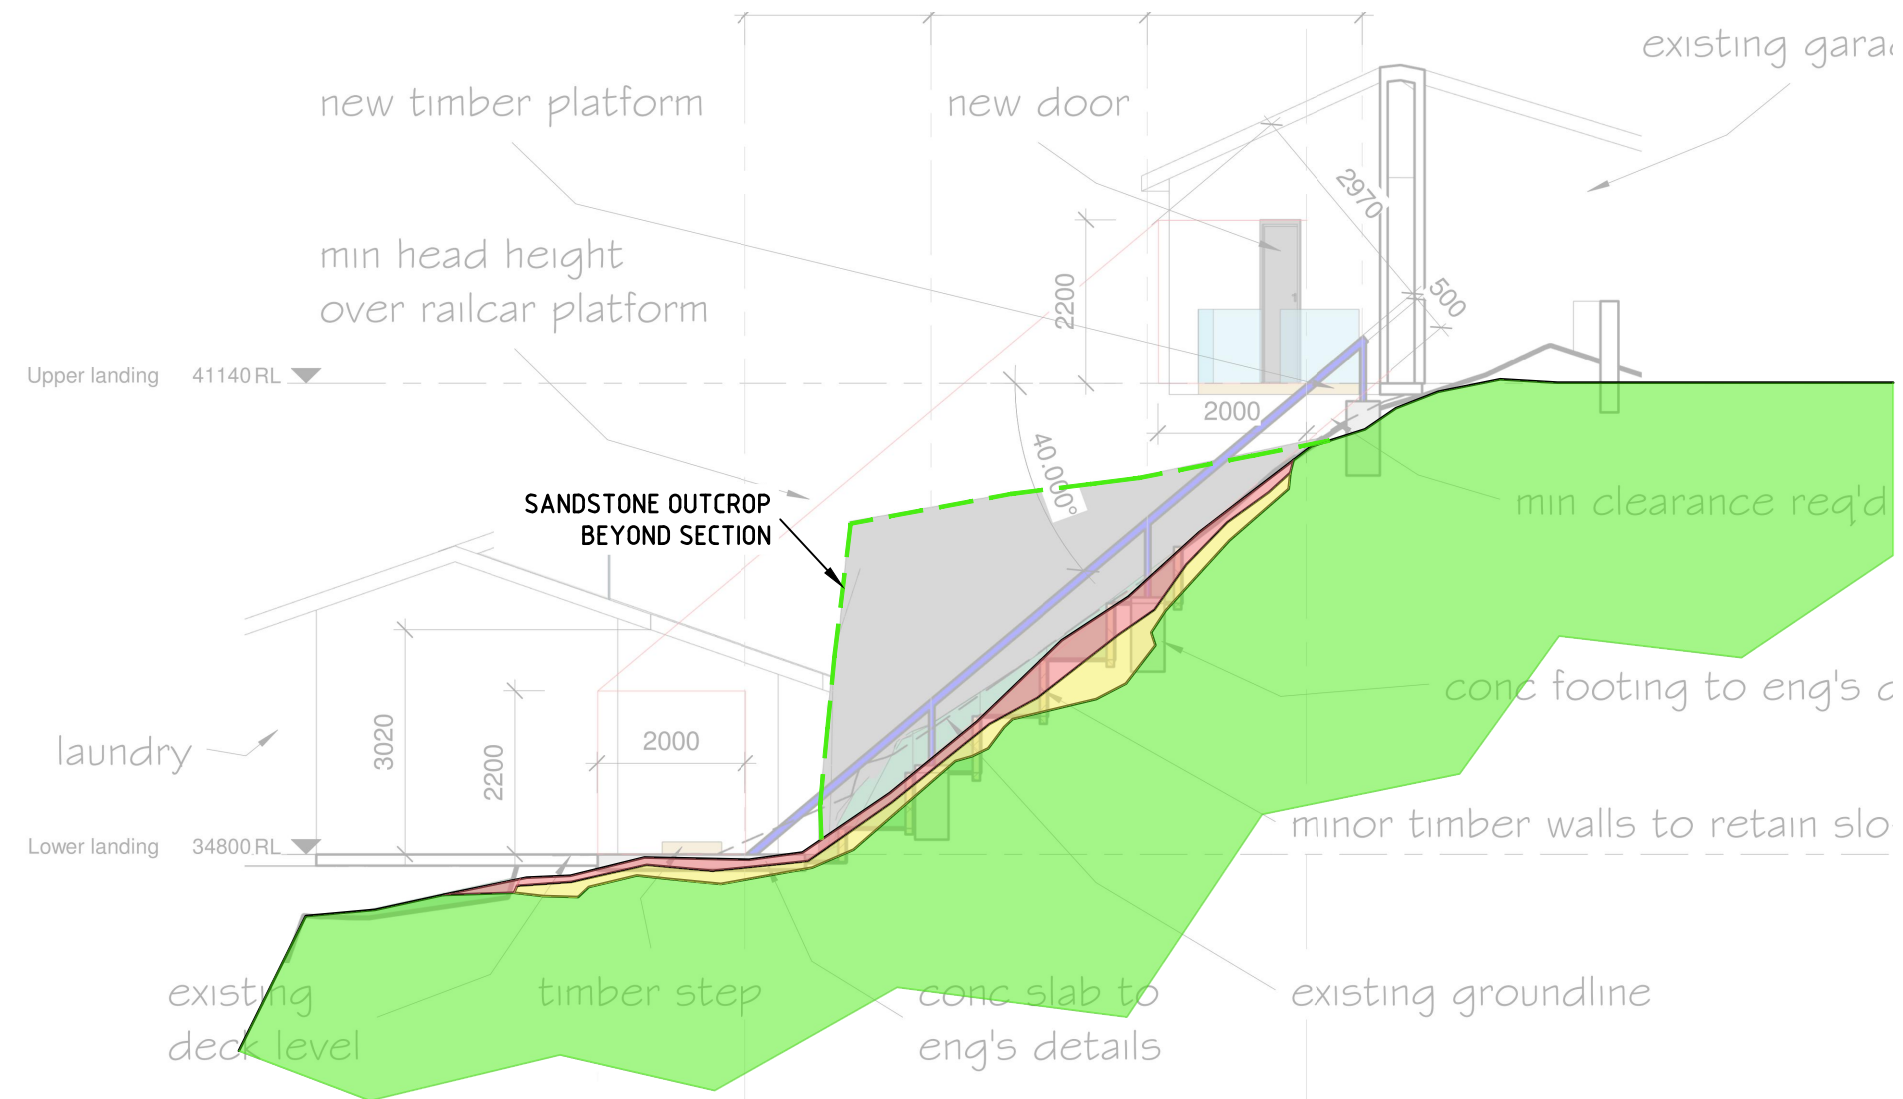
INFERRED GEOLOGICAL SECTION
SCALE NTS

INTERPRETED SUBSURFACE SECTION ONLY.
ACTUAL GROUND CONDITIONS MAY VARY.
