**RE: Mod2023/0554 - 316 Hudson Parade CLAREVILLE NSW 2107**

**In relation to the Modification of Development Consent DA2020/1762, granted for demolition works and construction of boatshed, ramp, slipway, jetty and steps (application number Mod2023/0554).**

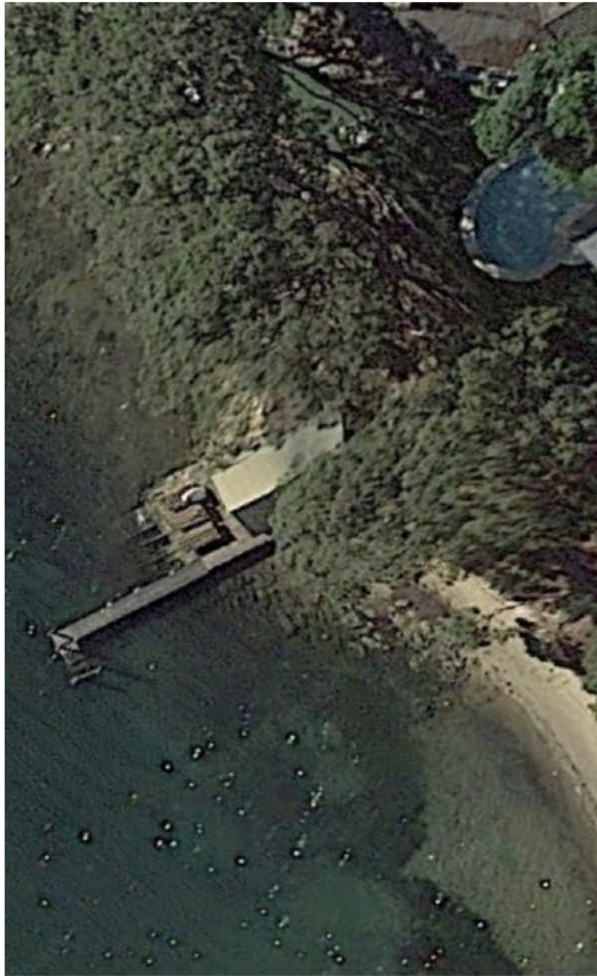
**Image A: Google Earth screen shot approx. 2016**

Image A shows the original boat house with jetty and jetty pylons.

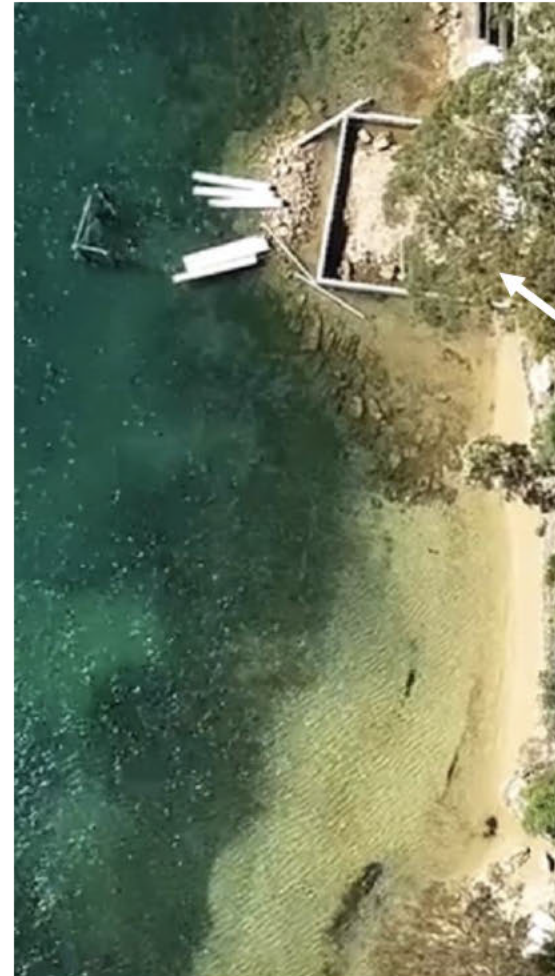
**Image B: Aerial photo 2<sup>nd</sup> November 2018**

The more recent Image B shows the footprint of the new boat house.

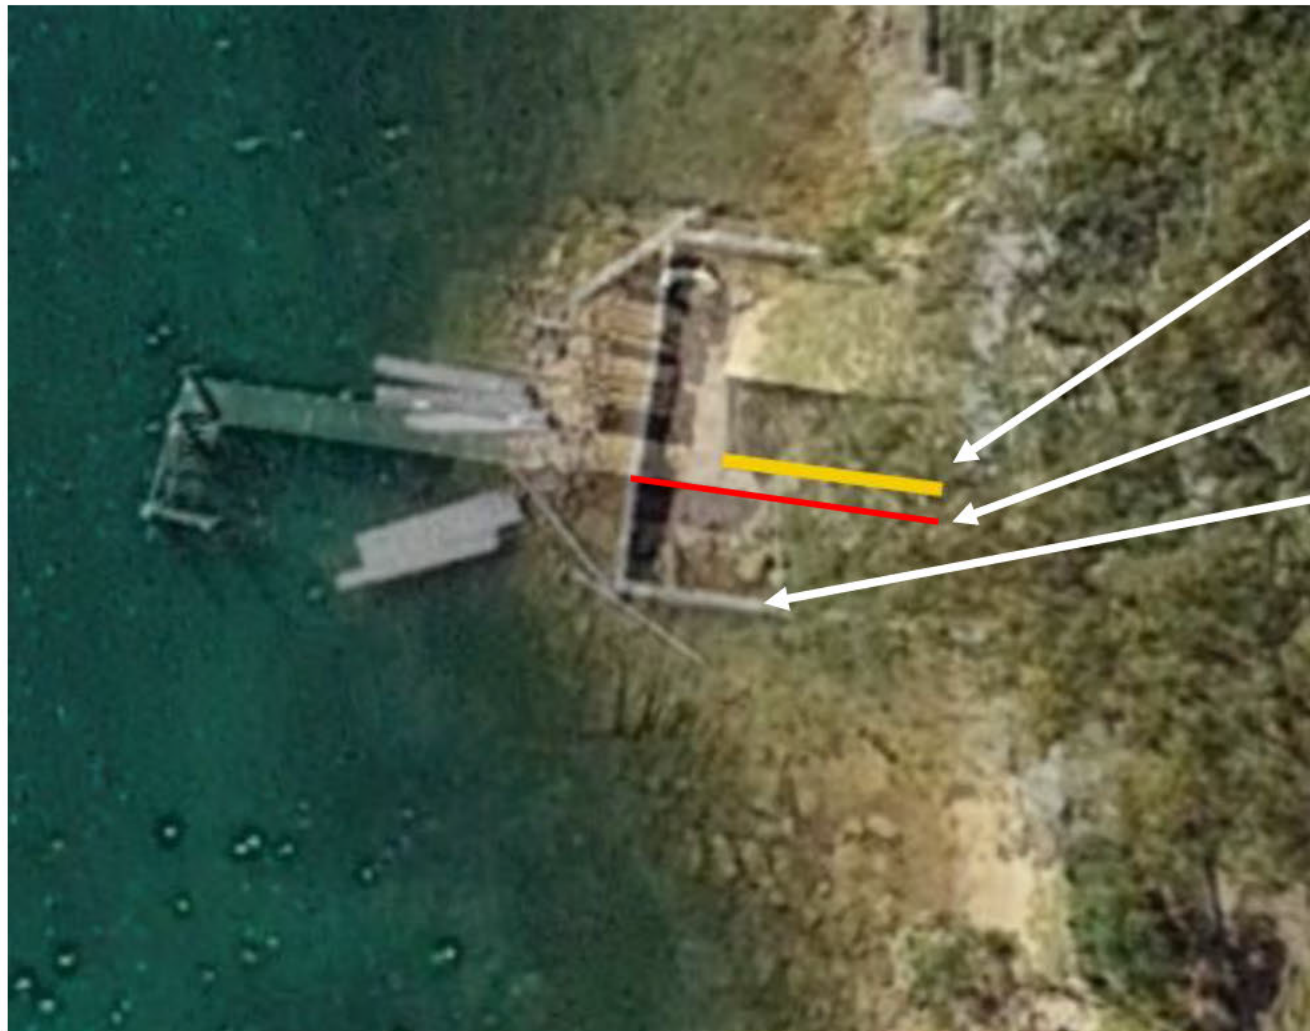
Image C: Overlay of Image A and Image

Approx. location of original sandstone wall of previous boat house.

Approx. Location of the original sandstone wall

Location of new southern Dintel wall, considerably further south than the original sandstone wall footprint

These images show the southern Dintel wall of the new boat house is significantly further south than the sandstone wall of the original boat house.

Image C is an overlay of Image A & B, in which you can see the new southern Dintel wall is now in line with the southern two jetty pylons, whereas the southern wall of the previous structure was set back and to the north from these pylons

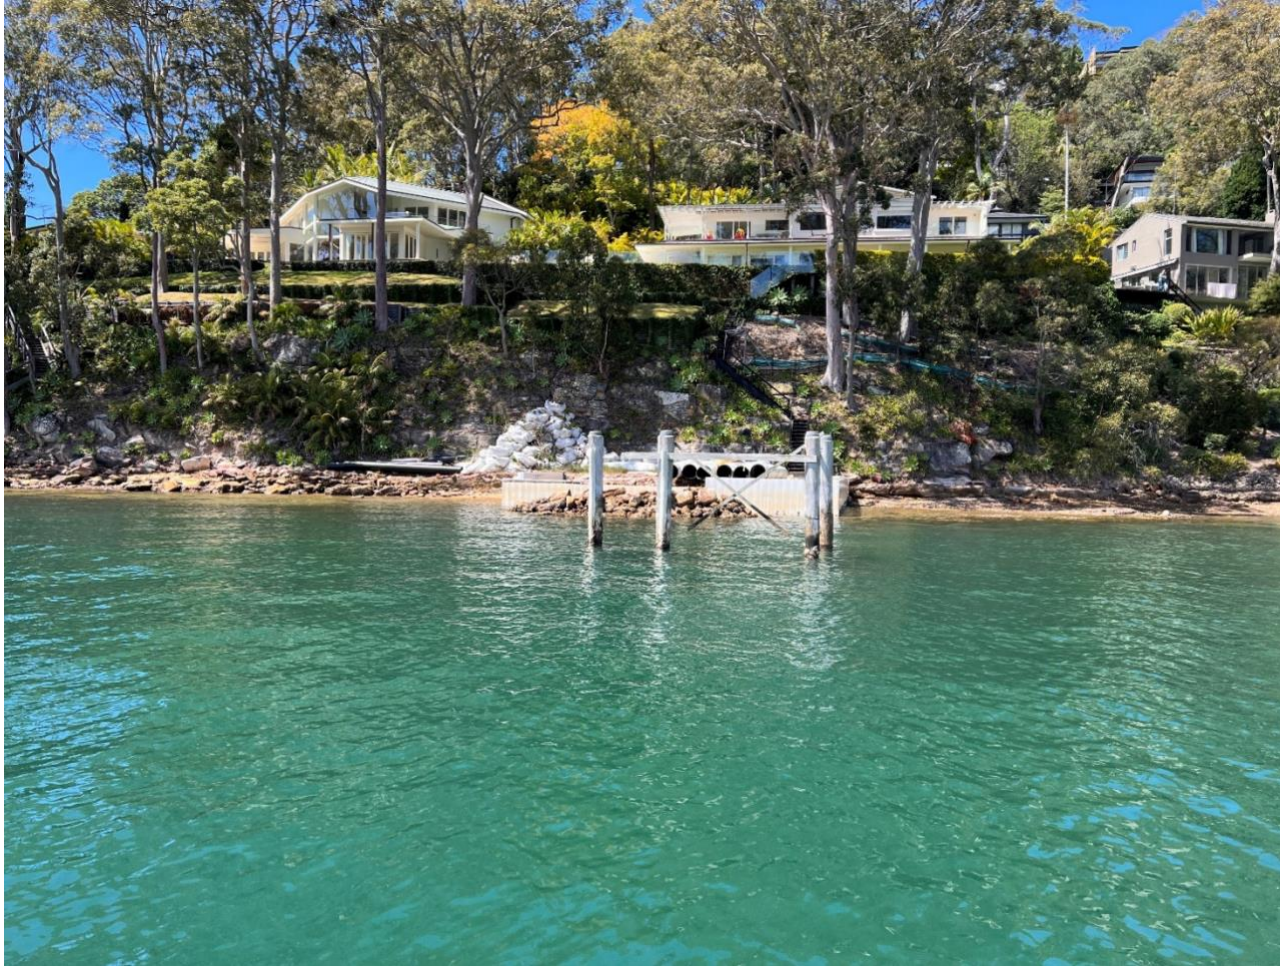
**Image D: Photo taken 8<sup>th</sup> October 2023.**

This photo shows the existing jetty pylons and the new boat house southern wall in line with them

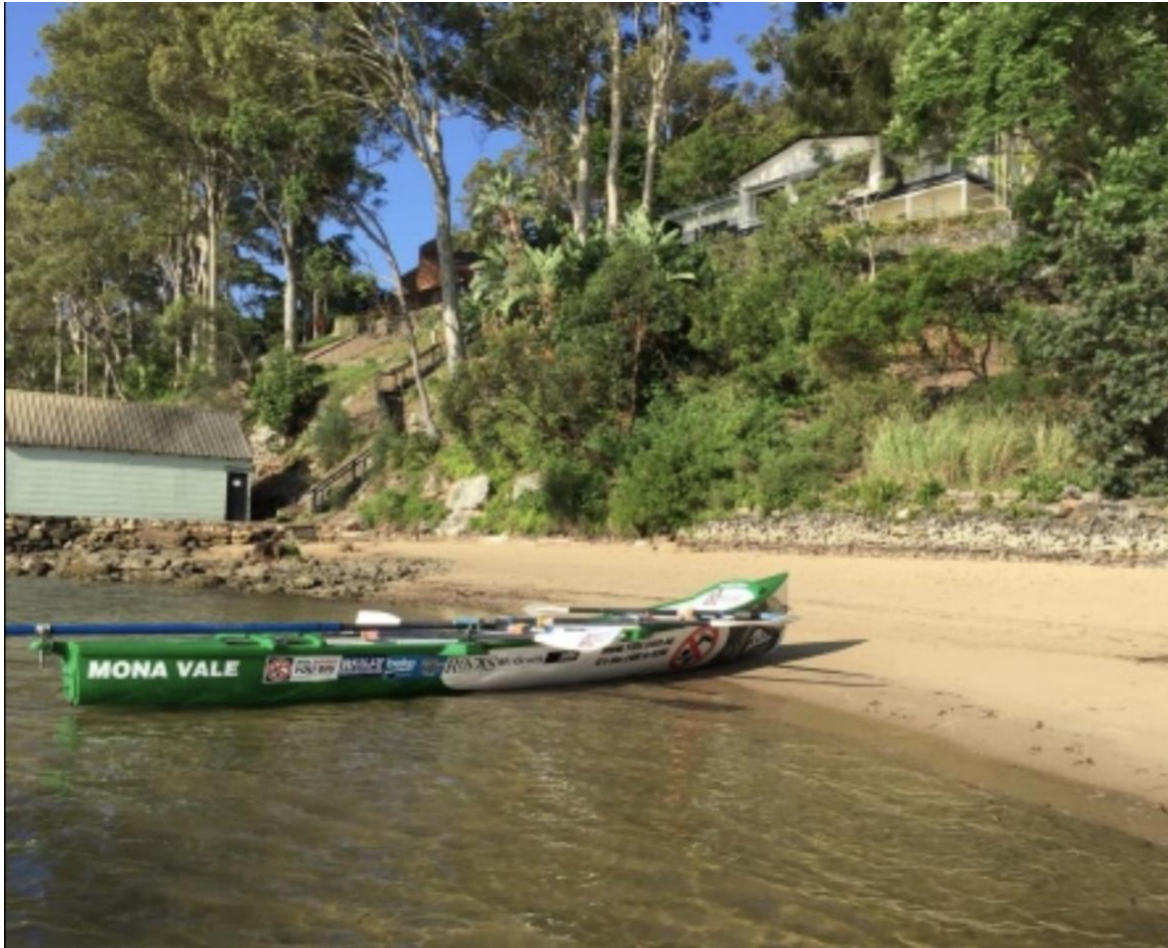
**Beach Image 1: Photo taken 9<sup>th</sup> February 2016**

Shows the original boat shed & beach with plenty of sand. Note the sand running high up the highwater mark and into the rocks. Great condition.

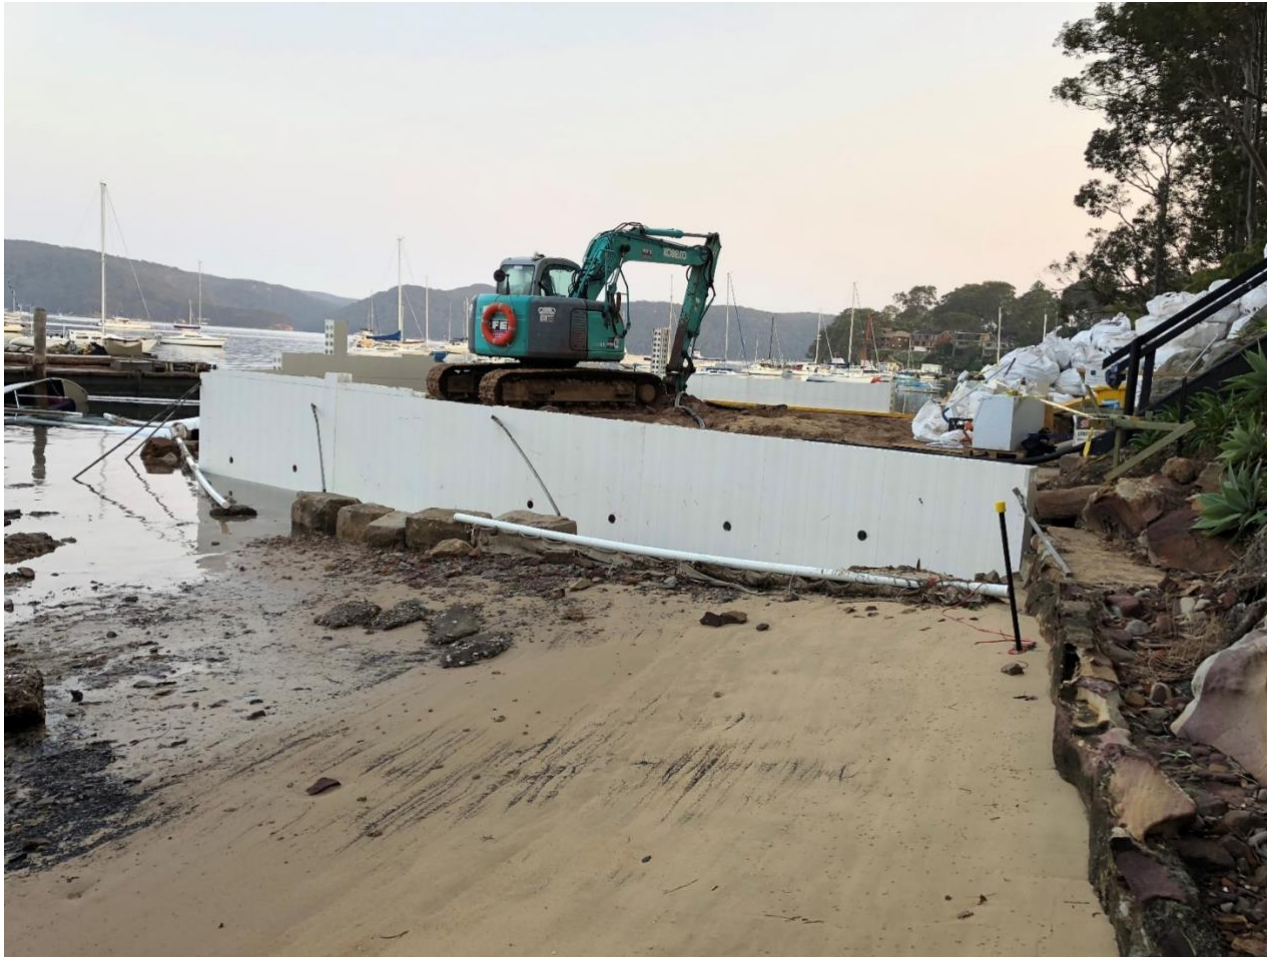
**Beach Image 2: Photo taken 11<sup>th</sup> September 2018**

Shows the new dintel walls being erected. Note the sand running high up the highwater mark and into the rocks. There are very little rocks showing and the beach is in excellent condition.

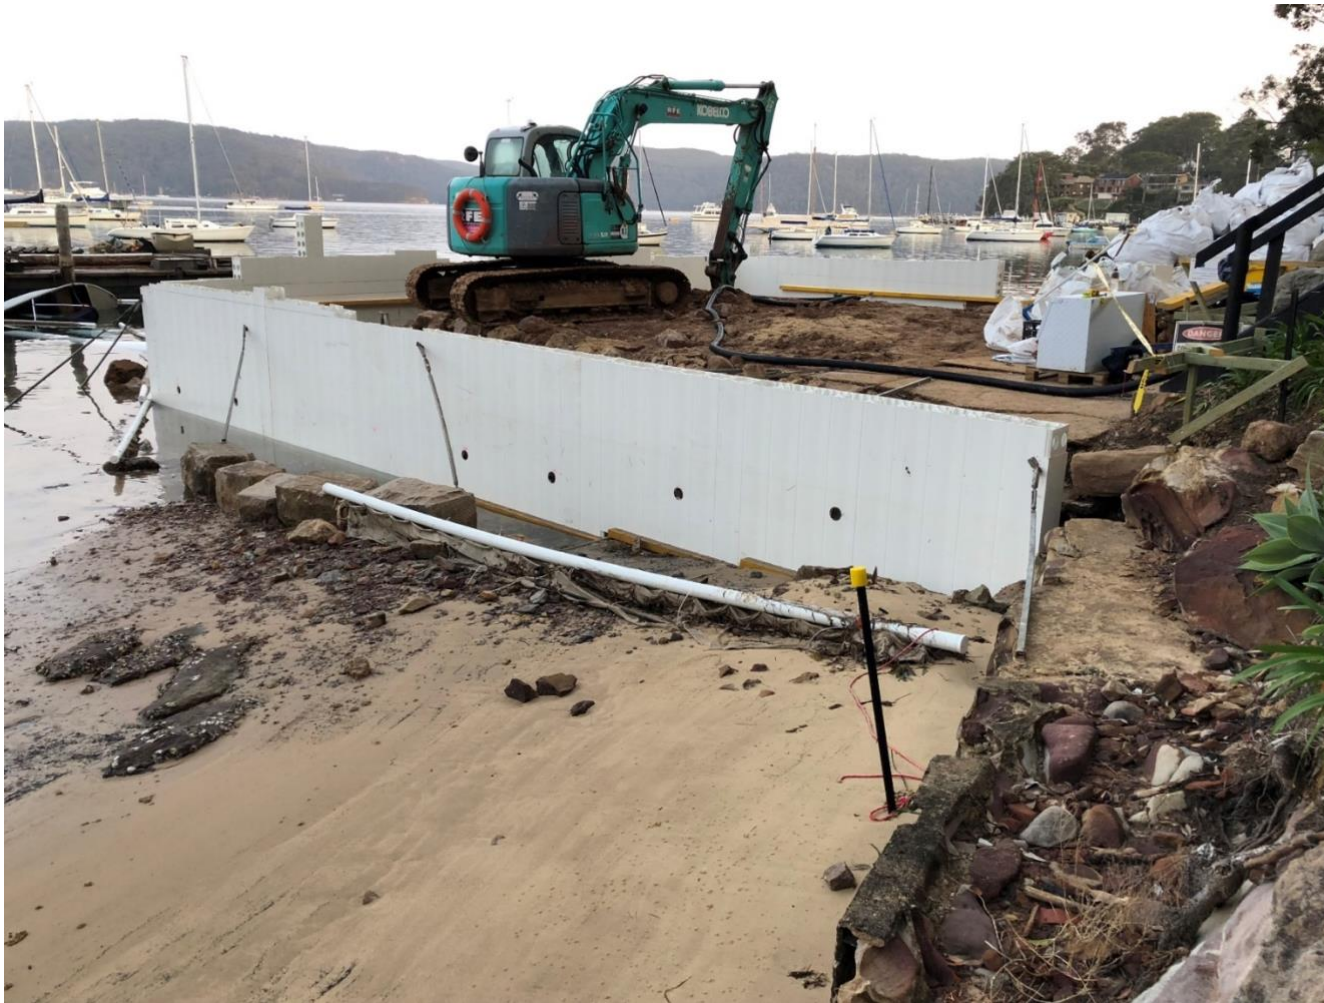
**Erosion of beach Image 3: Photo taken 11<sup>th</sup> September 2018**

Again showing plenty of sand and very few rocks to be seen.

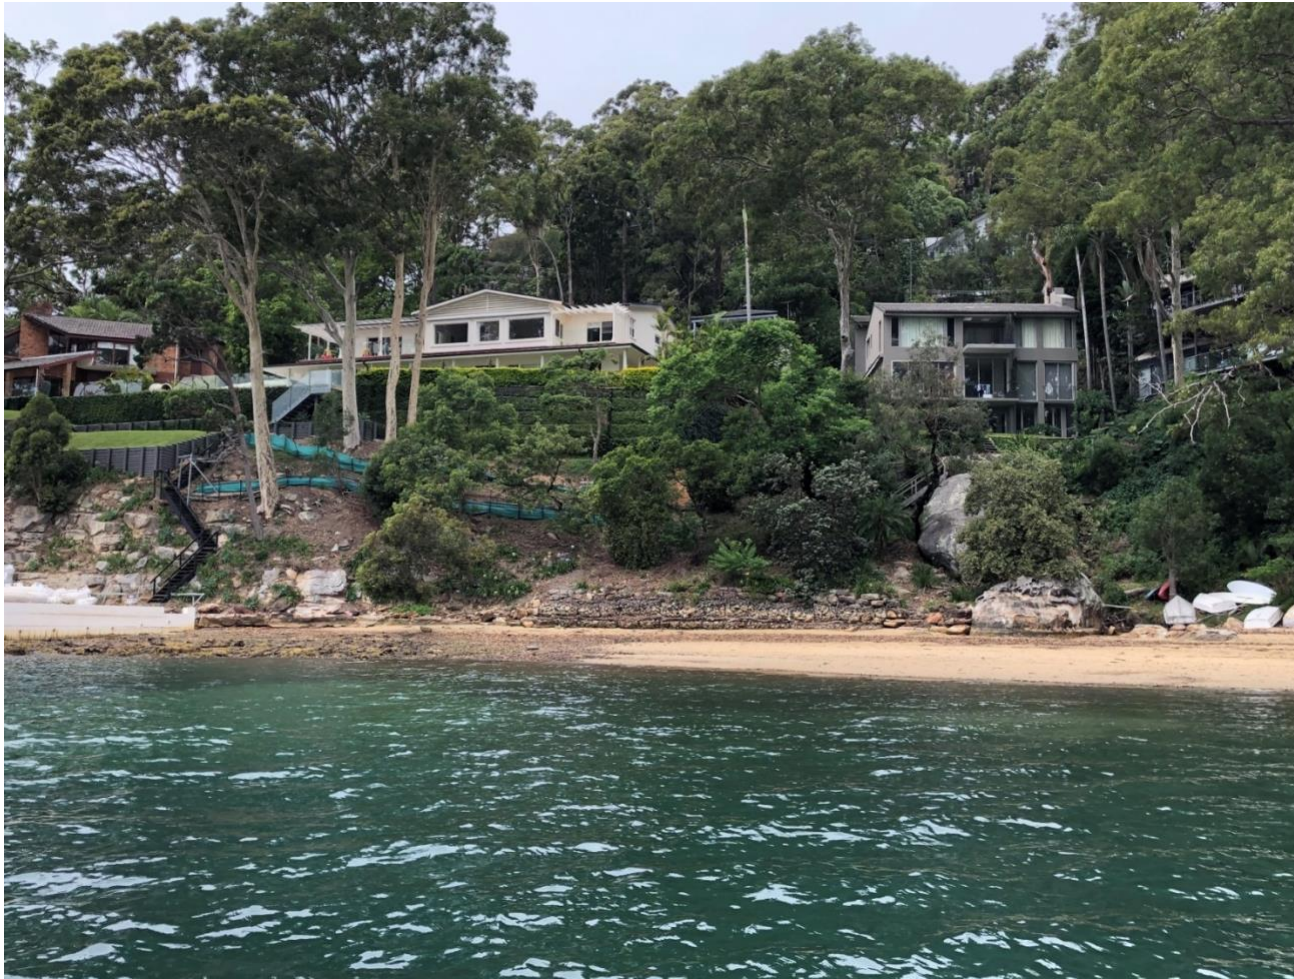
**Erosion of beach Image 4: Photo taken 19<sup>th</sup> January 2019**

Already by January 2019 you can see rapid deterioration of the beach due to the new dintel walls. The sand is being washed away and rocks are being uncovered on the beach. The new dintel walls are have a significant detrimental effect on the beach.

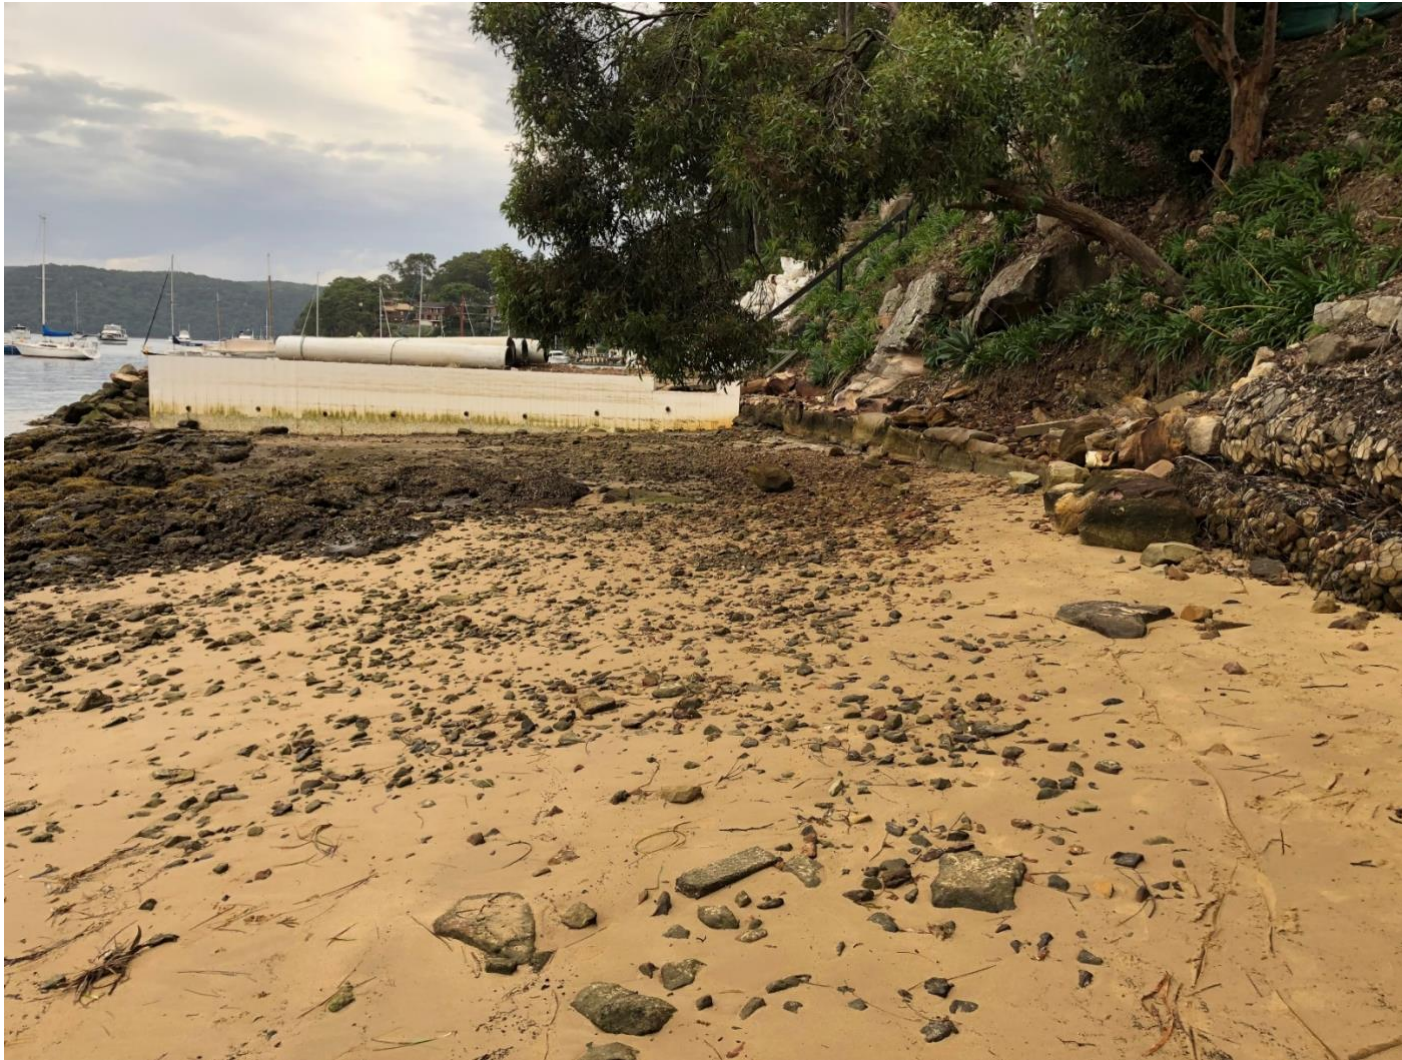
**Erosion of beach Image 5: Photo taken 24<sup>th</sup> March 2019**

By March 2019 the beach erosion is clearly evident, the rocks are further and further uncovered as the sand is washed away due to the new dincel walls.

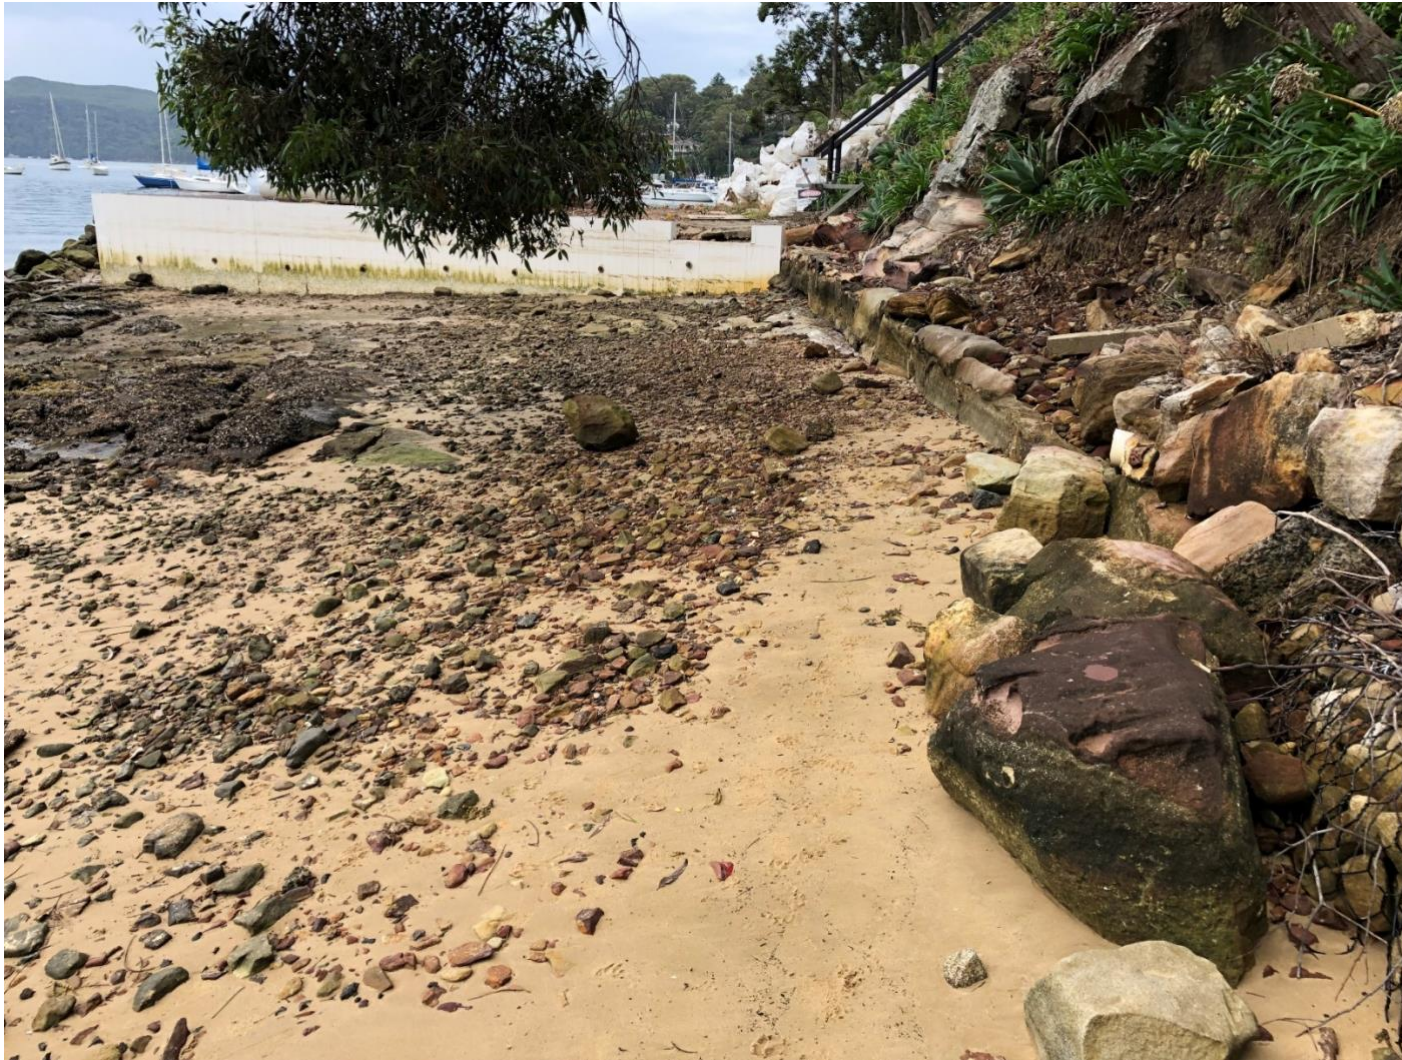
**Erosion of beach image 6: Photo taken 24<sup>th</sup> March 2019**

By March 2019 the erosion of the beach clearly evident with the rocks creeping further and further south. There are no signs of the beach improving.

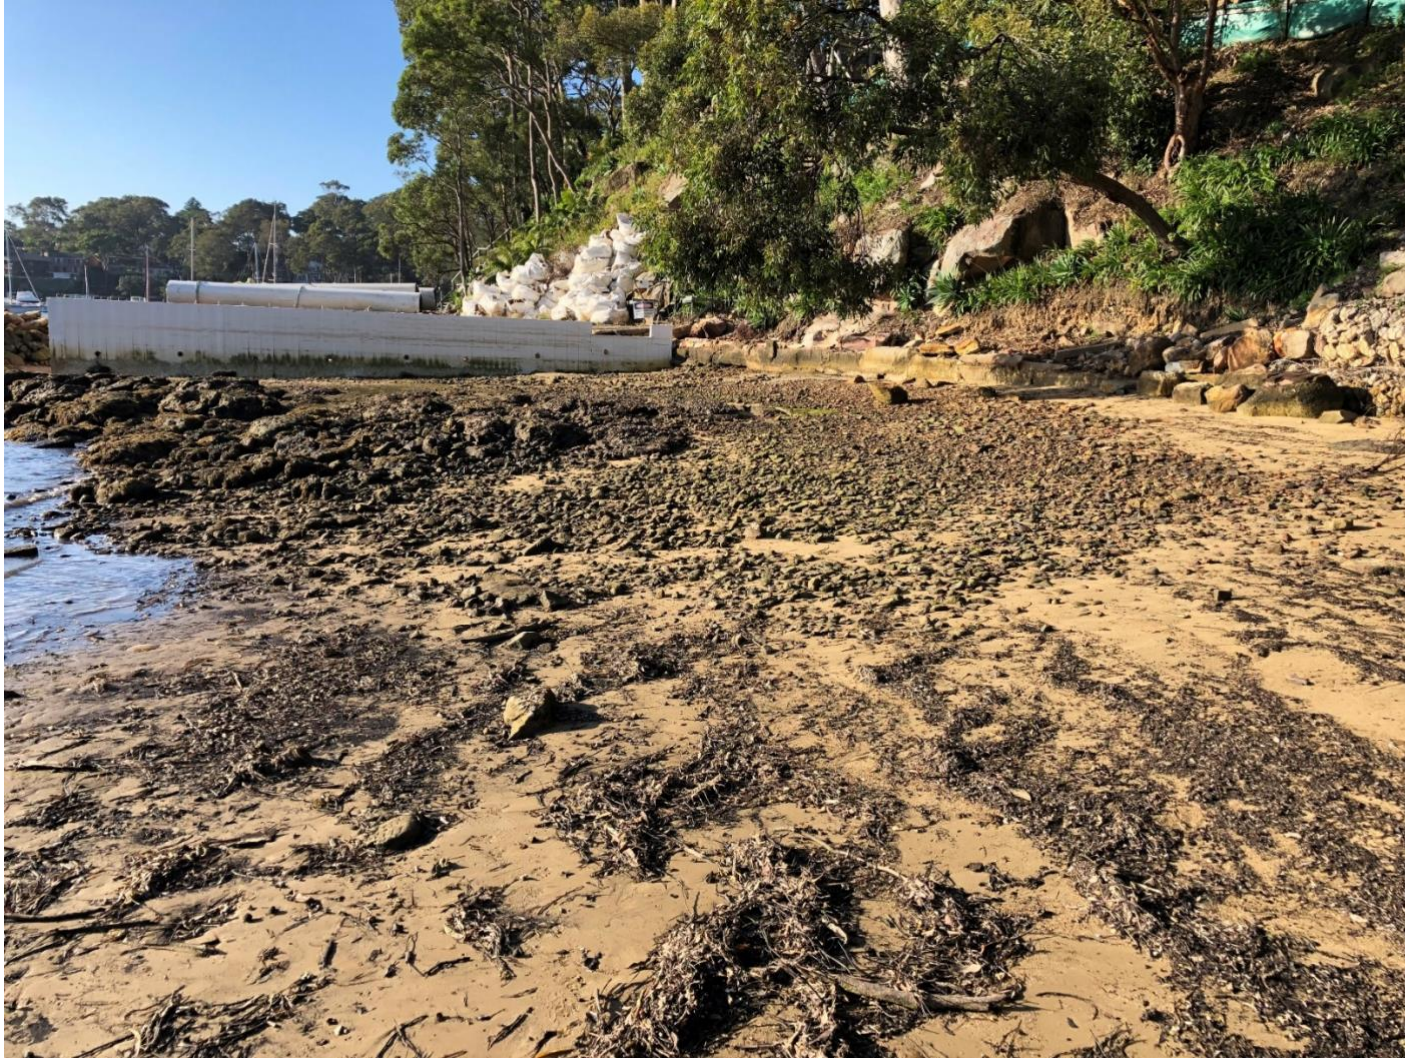
**Erosion of beach image 7: Photo taken 19<sup>th</sup> April 2019**

By April 2019 you can see that there is now more rocks than sand.

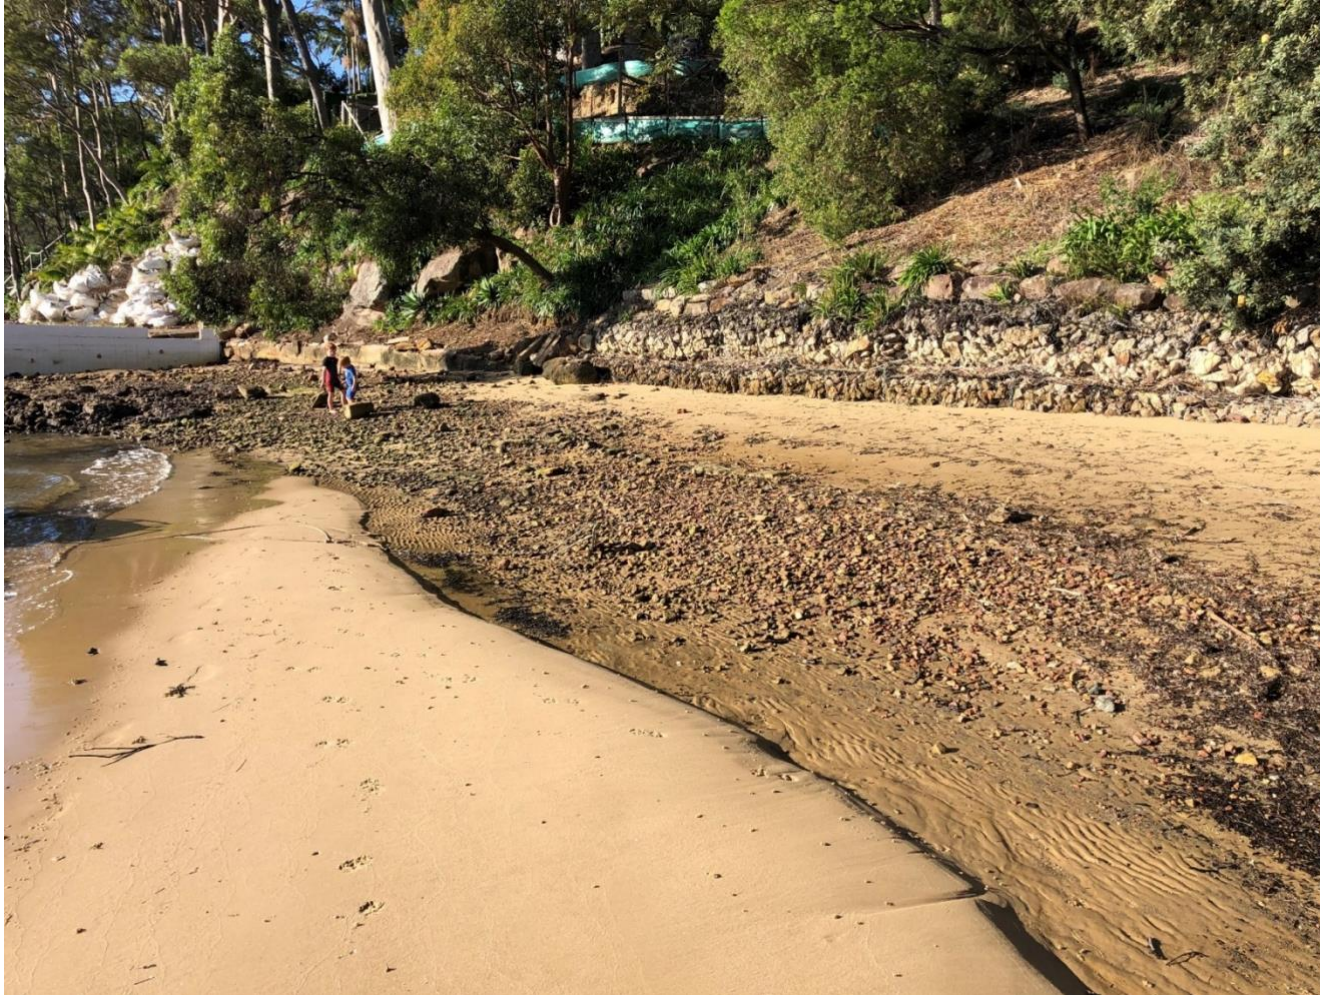
**Erosion of beach Image 8: Photo taken 24<sup>th</sup> April 2020**

By April 2020 the beach had not recovered. Sand has continued to be washed away and replaced with uncovered rocks.

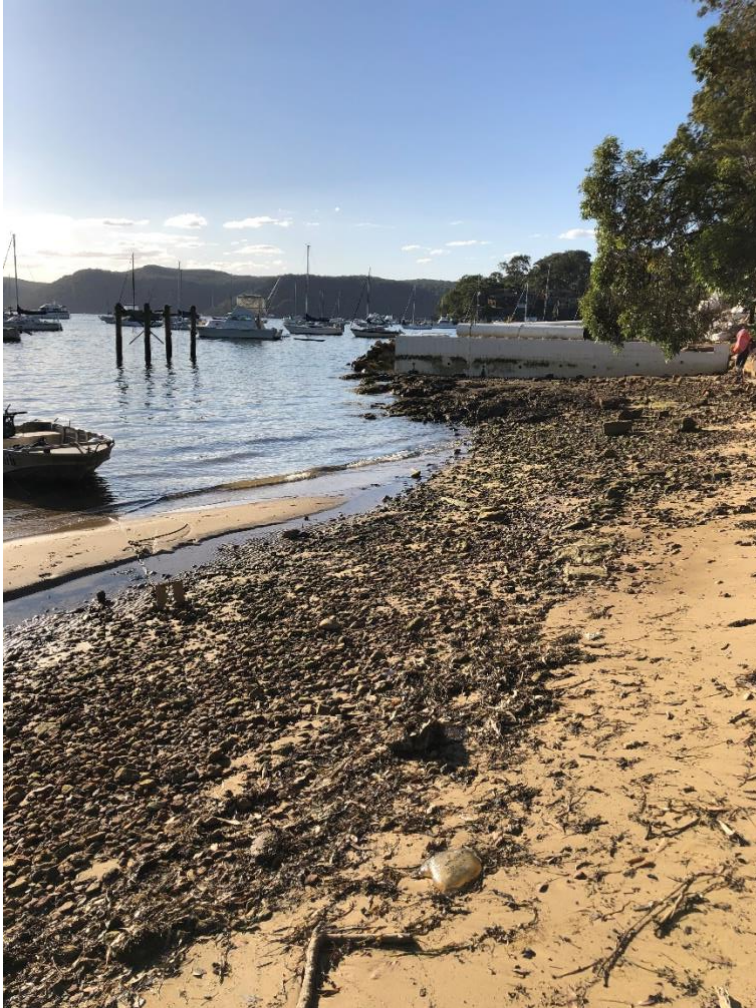
**Erosion of beach Image 9: Photo taken 24<sup>th</sup> April 2020**

By April 2020 the beach had not recovered. Sand has continued to be washed away and more rocks uncovered.

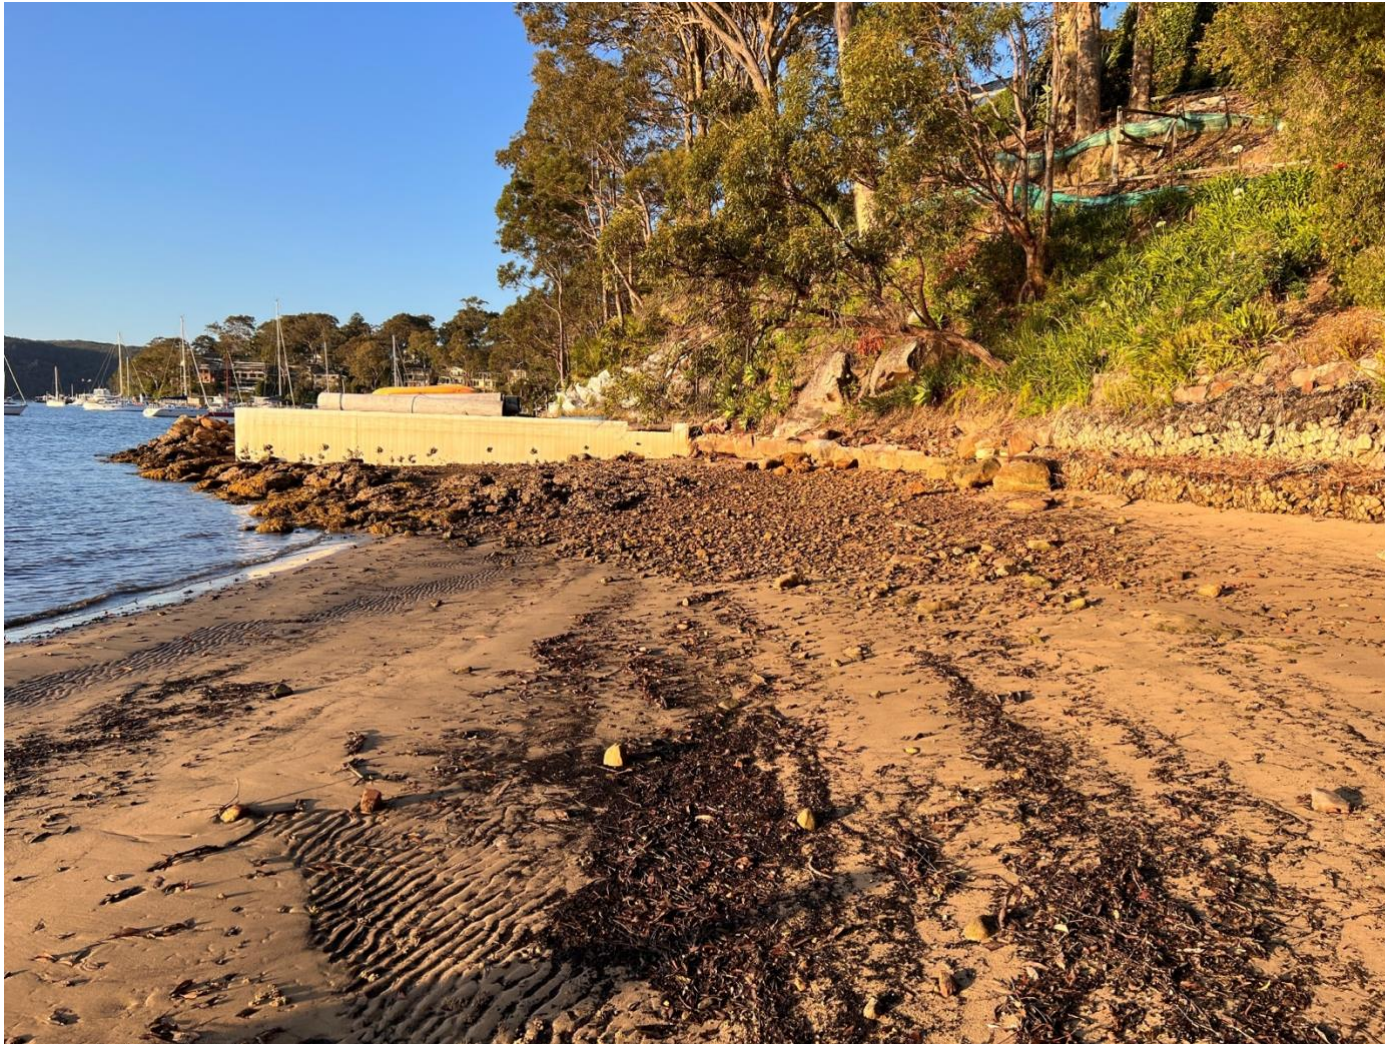
**Erosion of beach Image 12: Photo taken 18<sup>h</sup> November 2023**

Now in November 2023 the sand continues to be washed away. What was once a beautiful sandy foreshore is increasingly becoming a rocky foreshore. Dangerous to the kids that play on the beach. This gem of a beach in Pittwater is fast being lost and becoming an eyesore just like the new dintel walls.
