GEOTECHNICAL RISK MANAGEMENT POLICY FOR PITTWATER FORM NO. 1 – To be submitted with Development Application

GEOTECHNICAL RISK MANAGEMENT POLICY FOR PITTWATER FORM NO. 1(a) - Checklist of Requirements For Geotechnical Risk Management Report for Development Application

REPORT

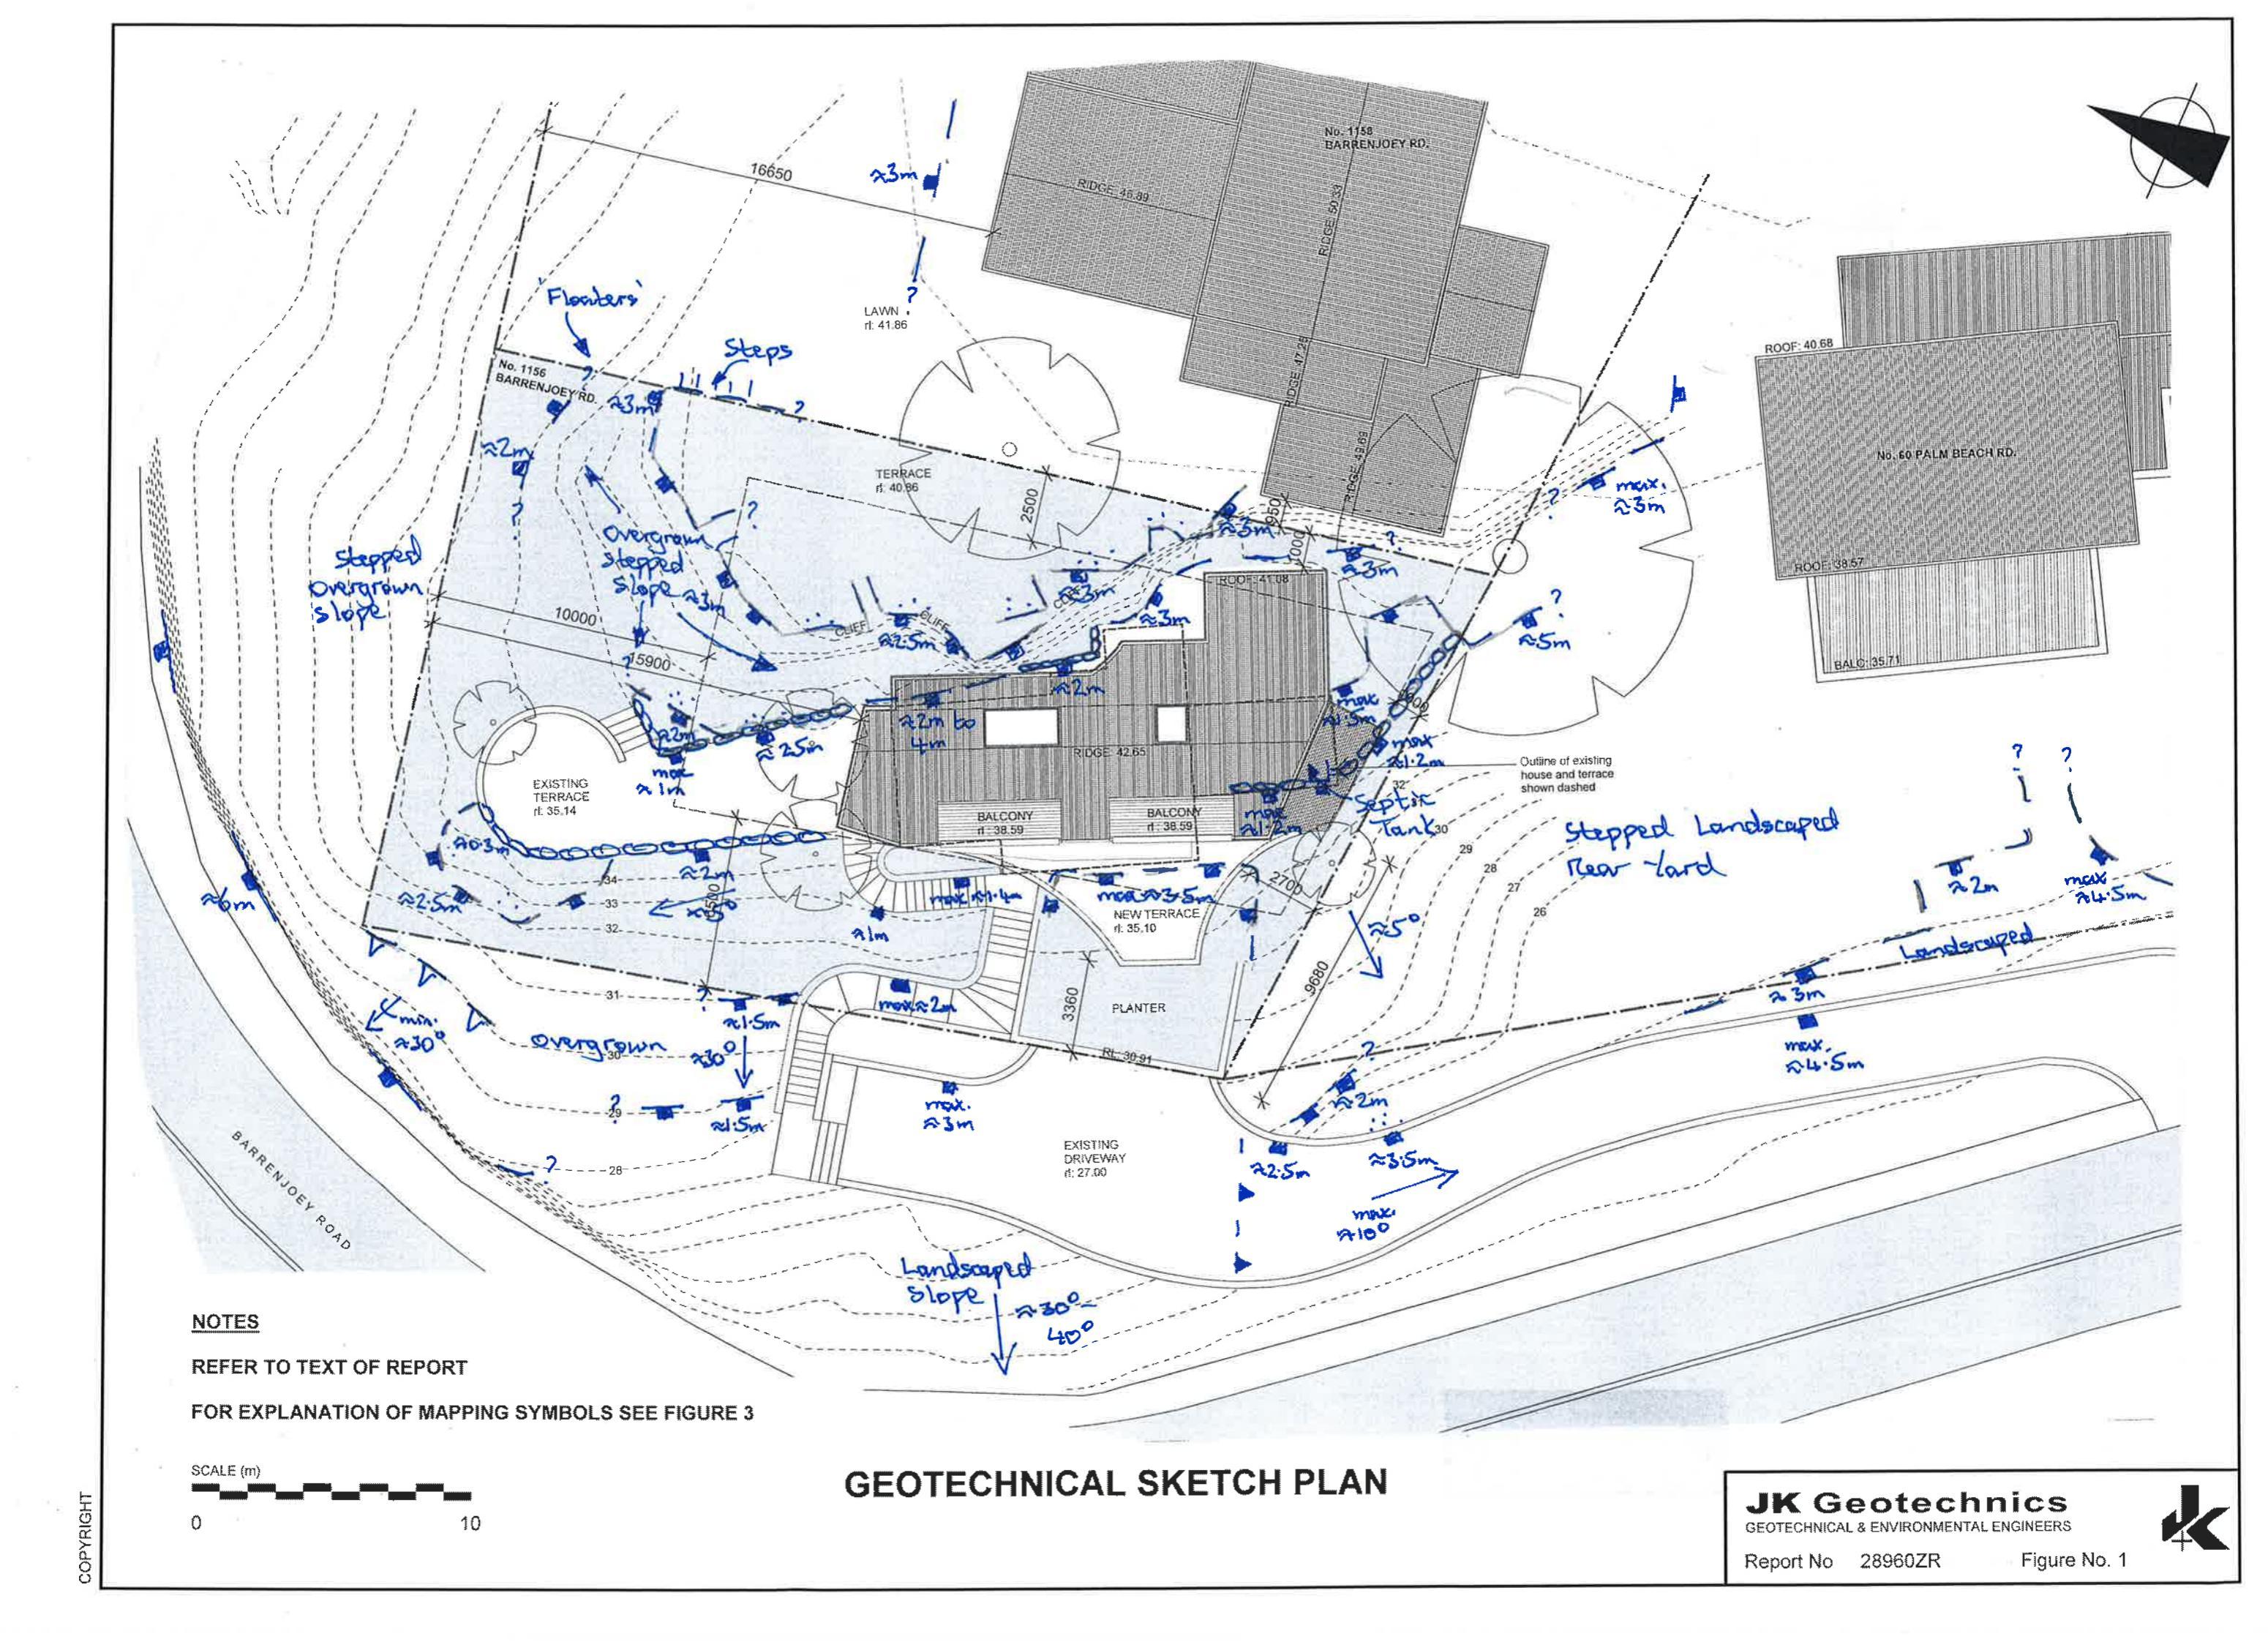
We recommend that the summary of observations which follows be read in conjunction with the attached Figure 1. We have also included relevant information from our involvement in the design and construction of recently completed driveway access and garage outlined in Section 1, above.

- The site is located on a hillside that slopes and steps down to the north and west.
- The site is battle axe shaped in plan and has northern and western frontages onto Barrenjoey Road, which curves around the base of the slopes within the site. The northern portion of the street frontage was lined by a sub-vertical rock cut face which was a maximum of about 6m height. Barrenjoey Road sloped down to the south at a maximum of about 8° and was paved with asphaltic concrete (AC); the AC surface was generally in reasonable condition.

- The north-western portion of the paved area terrace was founded on a sandstone bedrock outcrop (maximum height about 2.5m). The eastern side of the terrace area was lined by a

dilapidated stacked sandstone wall (maximum height about 1m). Above the retaining wall the cliff face was characterised by open sub-vertical joints orientated approximately 020° and 110°. The joints were open a maximum of about 0.3m with soil infill and some loose blocks (maximum 0.5m dimension) were also noted. The western side of the terrace area was supported by a sandstone masonry wall (maximum height about 1.2m) which was founded on the bedrock outcrop. Below the northern and western sides of this upper paved area the natural thickly vegetated convex hillside sloped down to the north and west typically at about 30° to 35° to the crest area of the rock cut face which lined the street frontage below.

7.1.1 The existing dilapidated stacked sandstone wall lining the eastern side of the terrace area requires strengthening or replacing. Retaining wall design parameters are provided in Section 7.1.7, below. The removal of the short section of dilapidated sandstone masonry wall located behind the house will need to be carefully completed during demolition. Geotechnical inspection of the exposed rock face behind the wall will be required to assess the need and extent of stabilisation measures such as rock bolts, reinforced shotcrete, underpins etc.

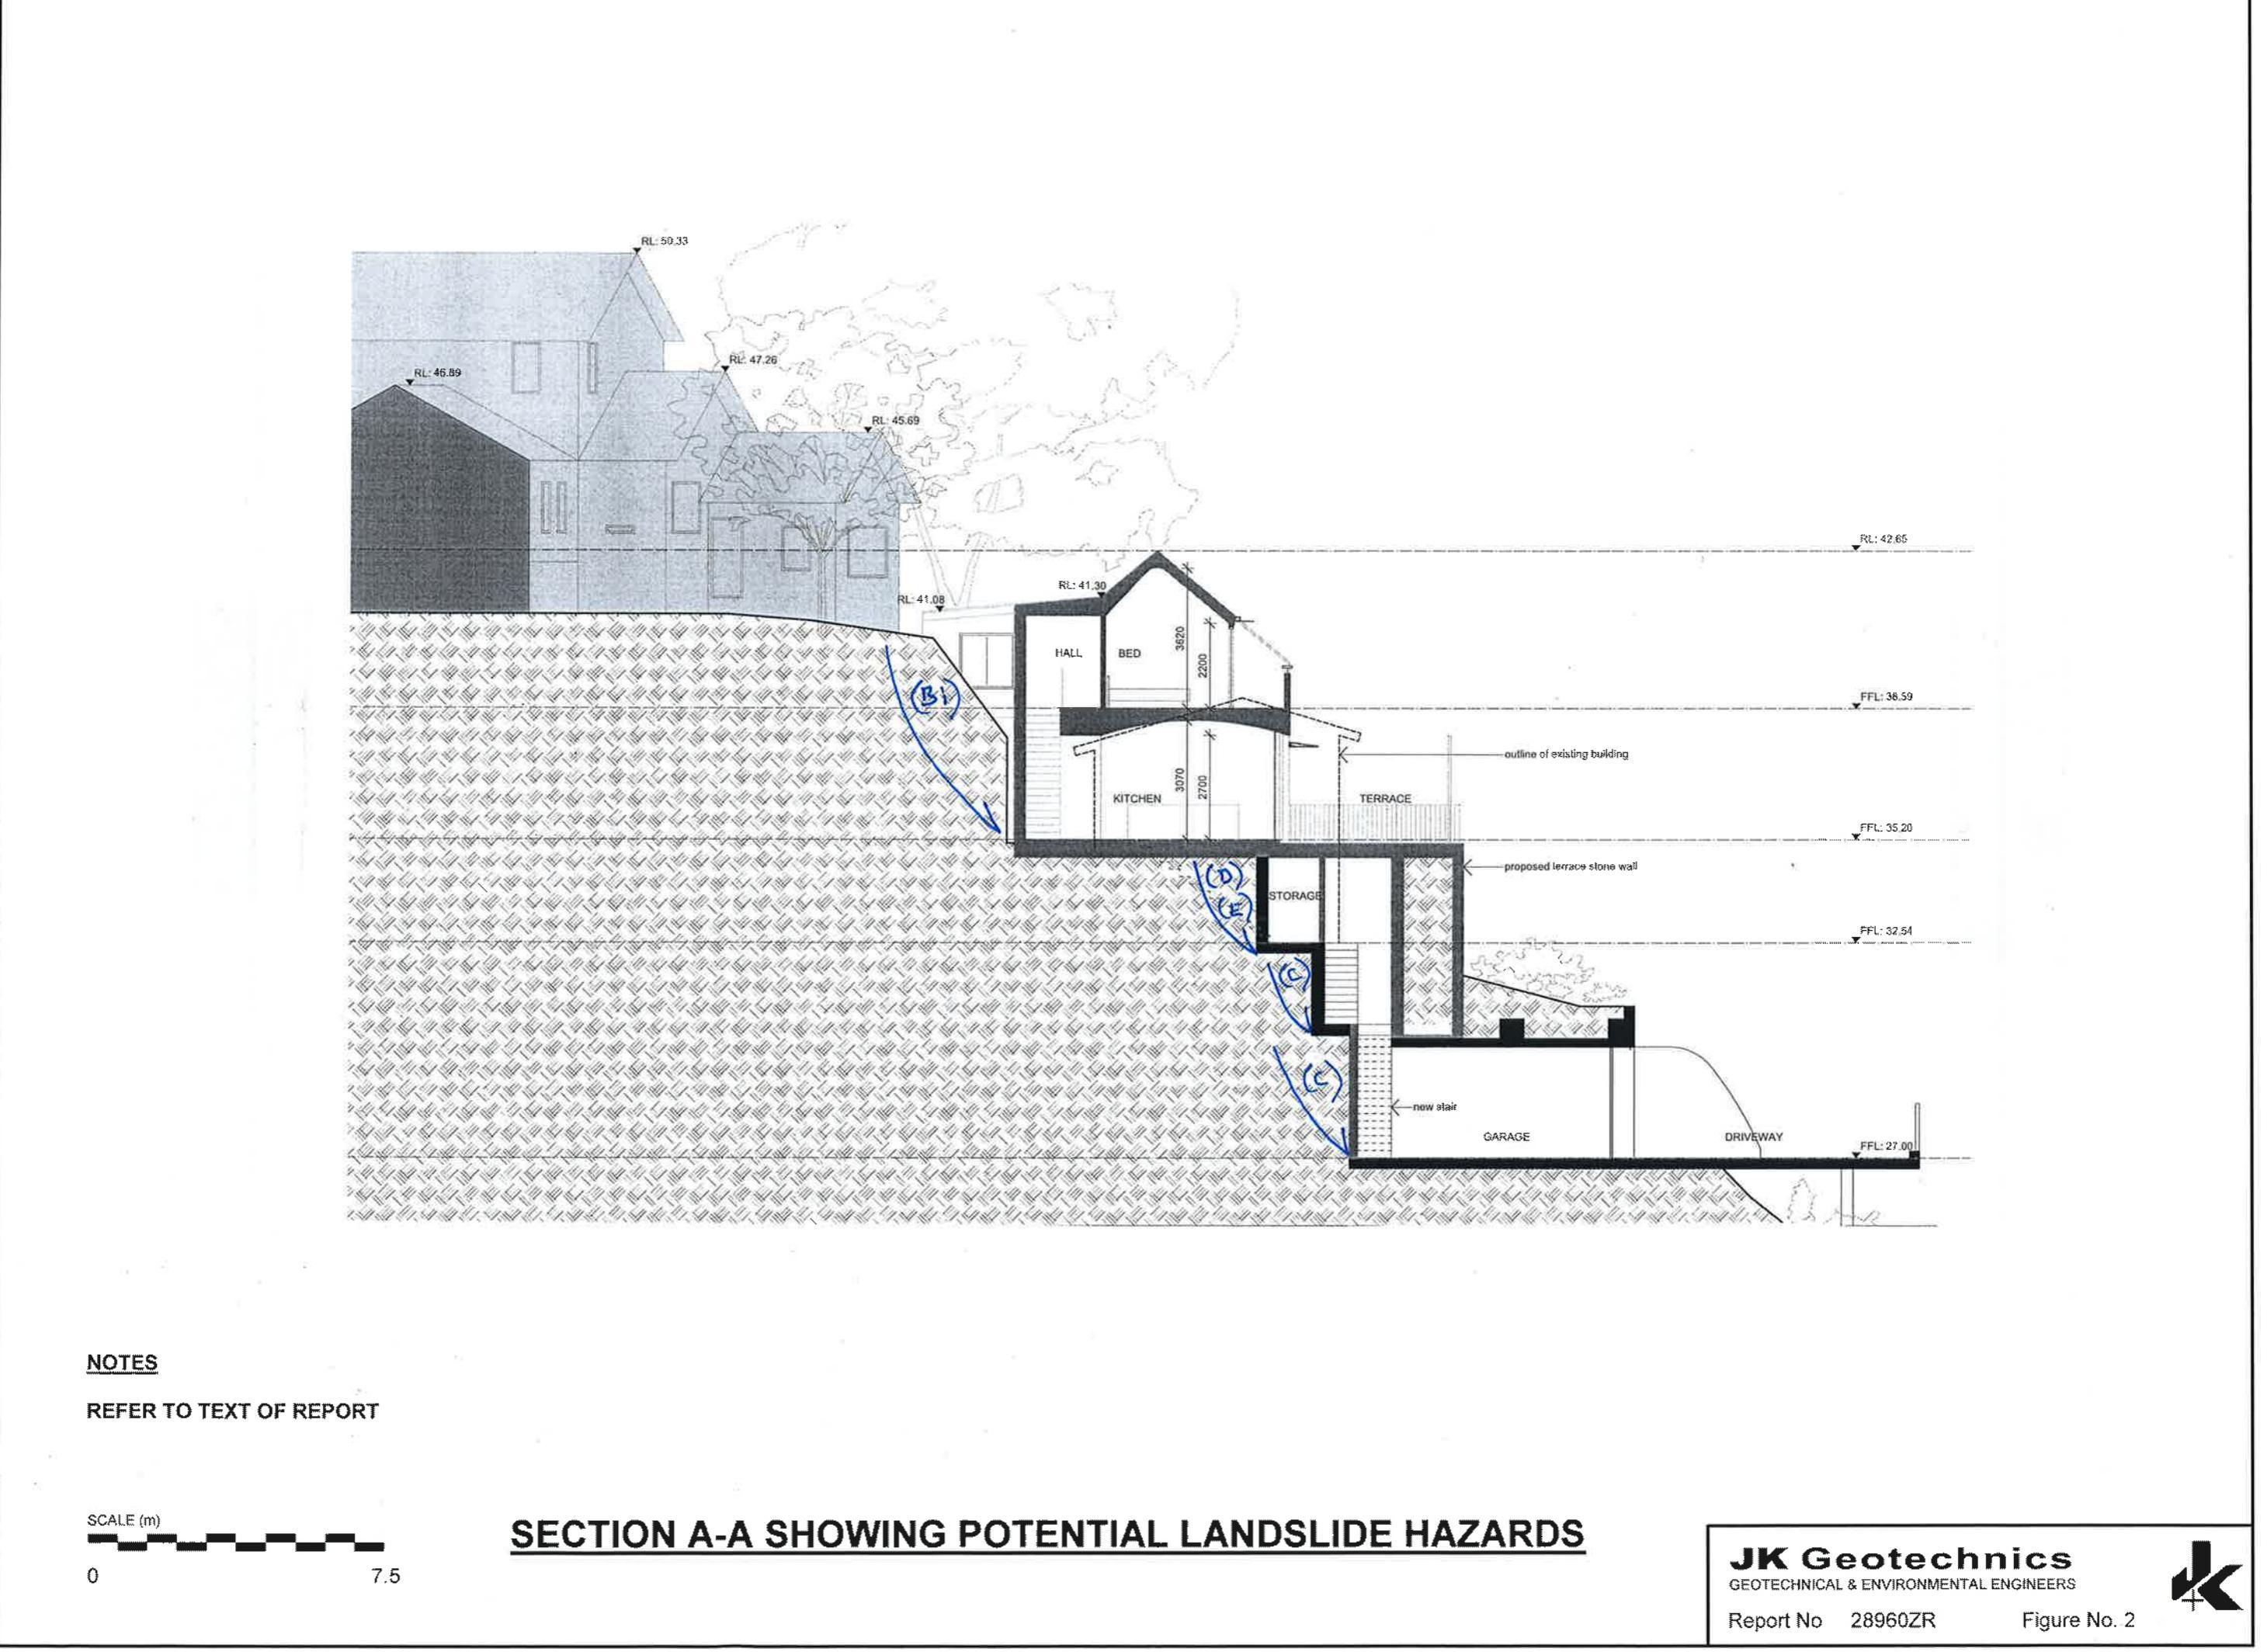
We consider that the potential landslide hazards associated with the site to be the following:

- A Instability of existing stacked sandstone retaining walls:
 - (i) Poor condition retaining walls.
 - (ii) Sandstone masonry walls.
 - (iii) New concrete walls supporting the stepped access.
- B Instability of the hillside slopes:

These potential hazards are indicated in schematic form on the attached Figure 2.
