7 Cooleena Road, Elanora Heights

GEOTECHNICAL INVESTIGATION:

Subdivision and Driveway at **7 Cooleena Road, Elanora Heights**

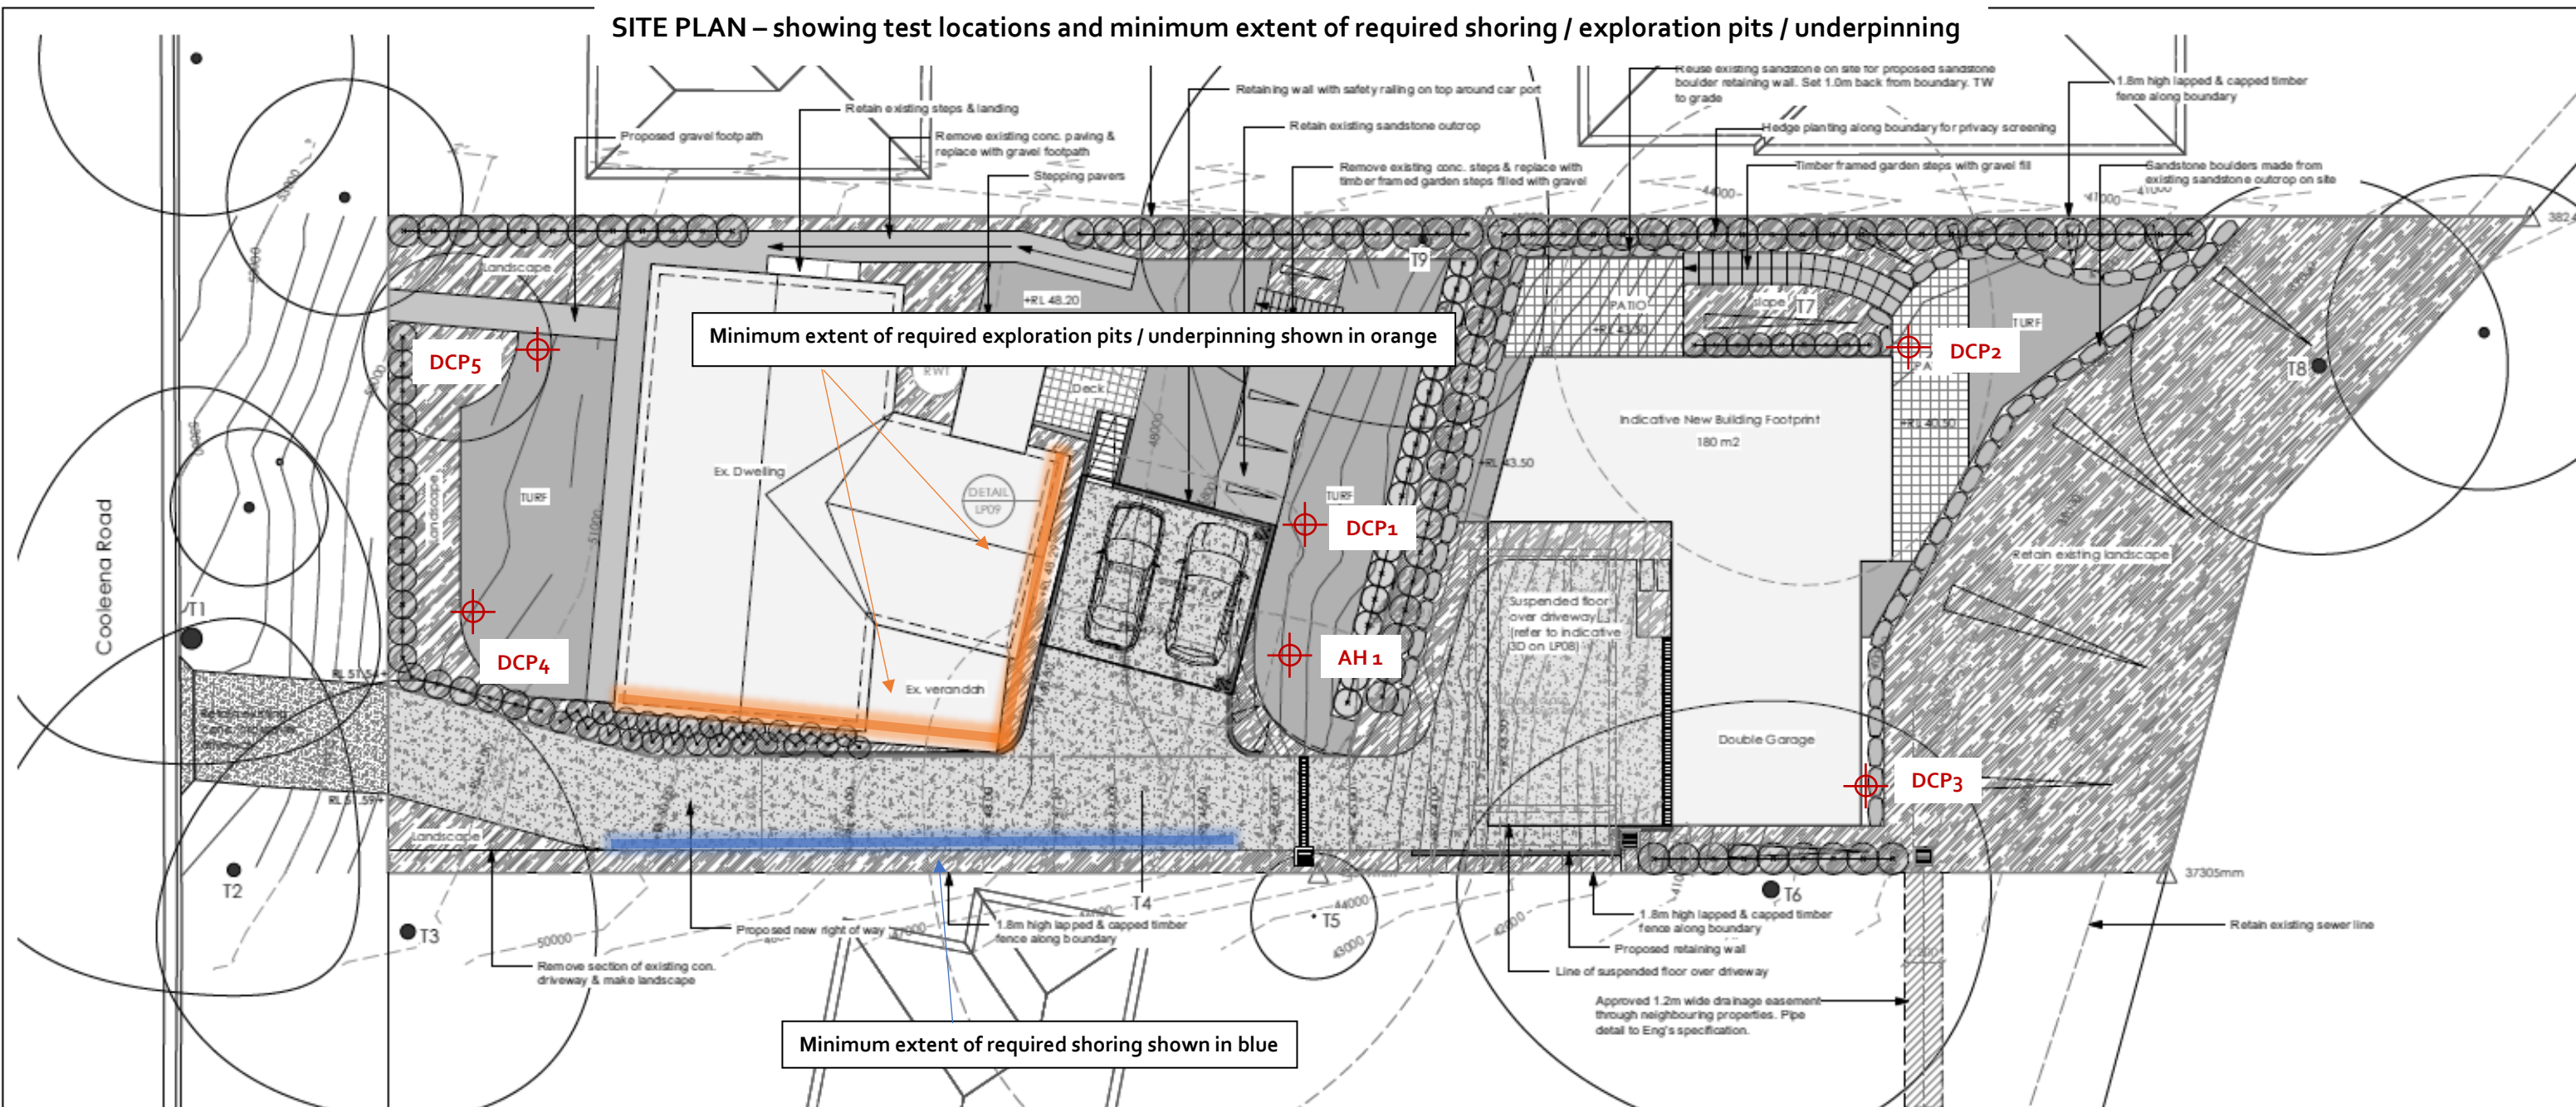
SITE PLAN – showing test locations and minimum extent of required shoring / exploration pits / underpinning

One hand Auger Hole (AH) was put down to identify the soil materials. Four Dynamic Cone Penetrometer (DCP) tests were put down to determine the relative density of the overlying soil and the depth to bedrock. The locations of the tests are shown on the site plan attached. It should be noted that a level of caution should be applied when interpreting DCP test results. The test will not pass through hard buried objects so in some instances it can be difficult to determine whether refusal has occurred on an obstruction in the profile or on the natural rock surface. This is not expected to be an issue for the testing on this site. However, excavation and foundation budgets should always allow for the possibility that the interpreted ground conditions in this report vary from those encountered during excavations. See the appended "Important information about your report" for a more comprehensive explanation. The results are as follows:

If the foundations are confirmed to be supported on rock or extend below the zone of influence of the proposed excavation, the excavation may commence. If they are not, the walls will need to be underpinned to rock or to below the zone of influence of the cut prior to the excavation commencing. See the site plan attached for the minimum extent of the required exploration pits/underpinning.
