ARBORICULTURAL IMPACT ASSESSMENT REPORT

14 – 22 Wentworth Street & 19 – 21 South Steyne Manly

Royal Far West

10th June 2022 Revision 01. AB-RPT - 0001

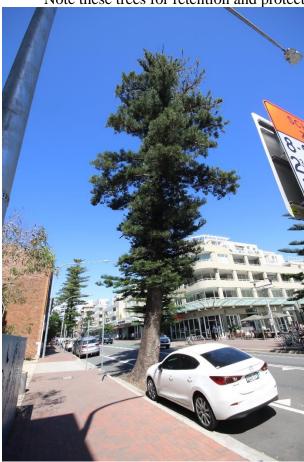
- 3.2 We have examined the trees on site and can suggest the following considerations for the development works:
- 1. Trees 1, 2 & 3 *Araucaria heterophylla* are all showing good condition with Tree 2 showing minor die-back in its apical point and Tree 3 has an old basal injury (stable) refer plates 1, 2 & 3.

Before any construction works commence on Site, trunk protection and temporary fencing shall be installed – refer Annexure D.

Note these trees for retention and protection in the Tree Management Plan (TMP).

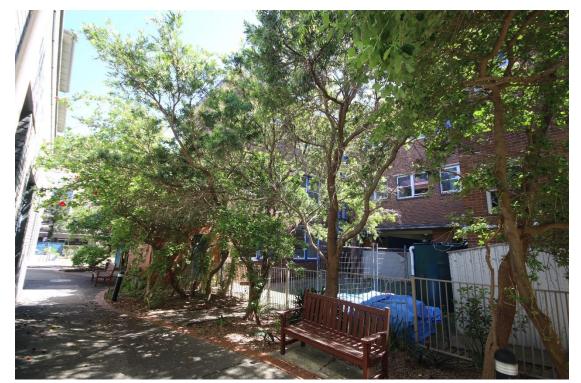
Plate 4: Trees 4 - 10.

2. The following trees are located within the proposed building footprint: Tree 4, 5, 6 & 7 *Callistemon viminalis* (fair vitality, fair vitality, good vitality & fair vitality), tree 8 *Callistemon viminalis* (Exempt tree <5m), tree 9 *Hibiscus rosa-sinensis* (Exempt tree <5m), tree 10 *Murraya paniculata* (Exempt tree <5m), tree 11 *Hibiscus rosa-sinensis* (fair – good vitality), tree 12 & 13 *Coprosma repens* (Exempt tree <5m) – refer plates 4, 5, 6.

These trees are a mixture of protected trees (4, 5, 6, 7, 11) and Exempt species (8, 9, 10, 12 & 13) with an assessed low retention value (can be easily replaced in the landscape works).

Removal of these trees is supported with the replanting of replacement trees on site.

Note these trees for removal in the TMP.

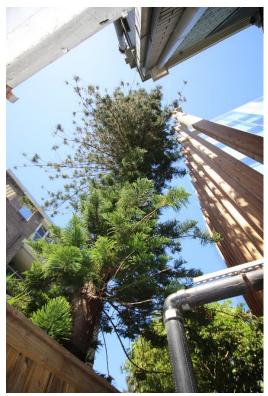
Plate 7: Tree 14.

3. Tree 14 *Araucaria columnaris* is showing good vitality and has been pruned away from the existing buildings on site – refer plate 7.

This tree is located in the adjoining site to the east of the site and has a high retention value.

The development works near this tree are over the existing building footprint which will not result in any root disturbance. Plus, no canopy pruning is required.

The scaffolding can be installed with any small branches can be tied back or carefully push away.

During the construction works the appointed project arborist shall be present to monitor if any roots from this tree have grown beyond the existing building and its foundations when undertaking localised excavations.

If required a root mapping investigation shall detail the size, location and depth of any roots from this tree to determine the potential impact on its stability, viability and longevity. This report will form the basis of actions to retain Tree 14.

Note this neighbour's tree for retention in the TMP.

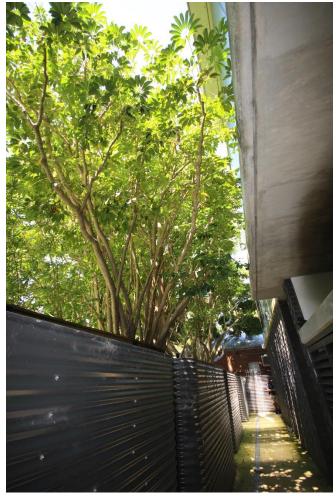
Plate 8: Tree 15.

4. Tree 15 *Schefflera actinophylla* is showing good vitality and has been pruned away from the existing buildings on site – refer plate 8.

This tree is located in the adjoining site to the east of the site.

The development works near this tree are over the existing building footprint which will not result in any root disturbance. Plus, no canopy pruning is required.

The scaffolding can be installed and any small branches should tied back or carefully push away.

The same monitoring of this tree shall be undertaken during localised excavations by the appointed project arborist with AQF Level 5.

Note this neighbour's tree for retention in the TMP.

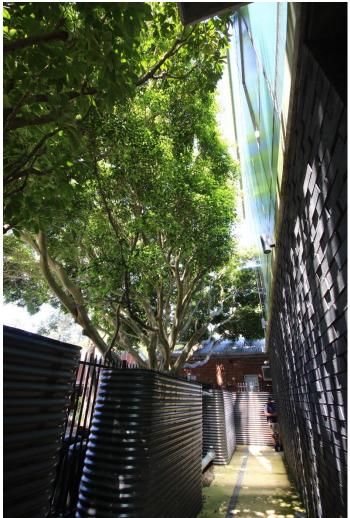
Plate 9: Tree 16.

5. Tree 16 *Ficus benjamina* is showing good vitality and has been pruned away from the existing buildings on site – refer plate 9.

This tree is located in the adjoining site to the east of the site.

The development works near this tree are over the existing building footprint which will not result in any root disturbance. Plus, no canopy pruning is required.

The scaffolding can be installed with any small branches can be tied back or carefully push away.

The same monitoring of this tree shall be undertaken during localised excavations by the appointed project arborist with AQF Level 5.

Note this neighbour's tree for retention in the TMP.
