ARBORICULTURE IMPACT ASSESSMENT for Soon to Be lodged Development Application Submission

March 2020

Site: Lot 20 in DP 22275
60 Binburra Avenue
AVALON BEACH, NSW 2107

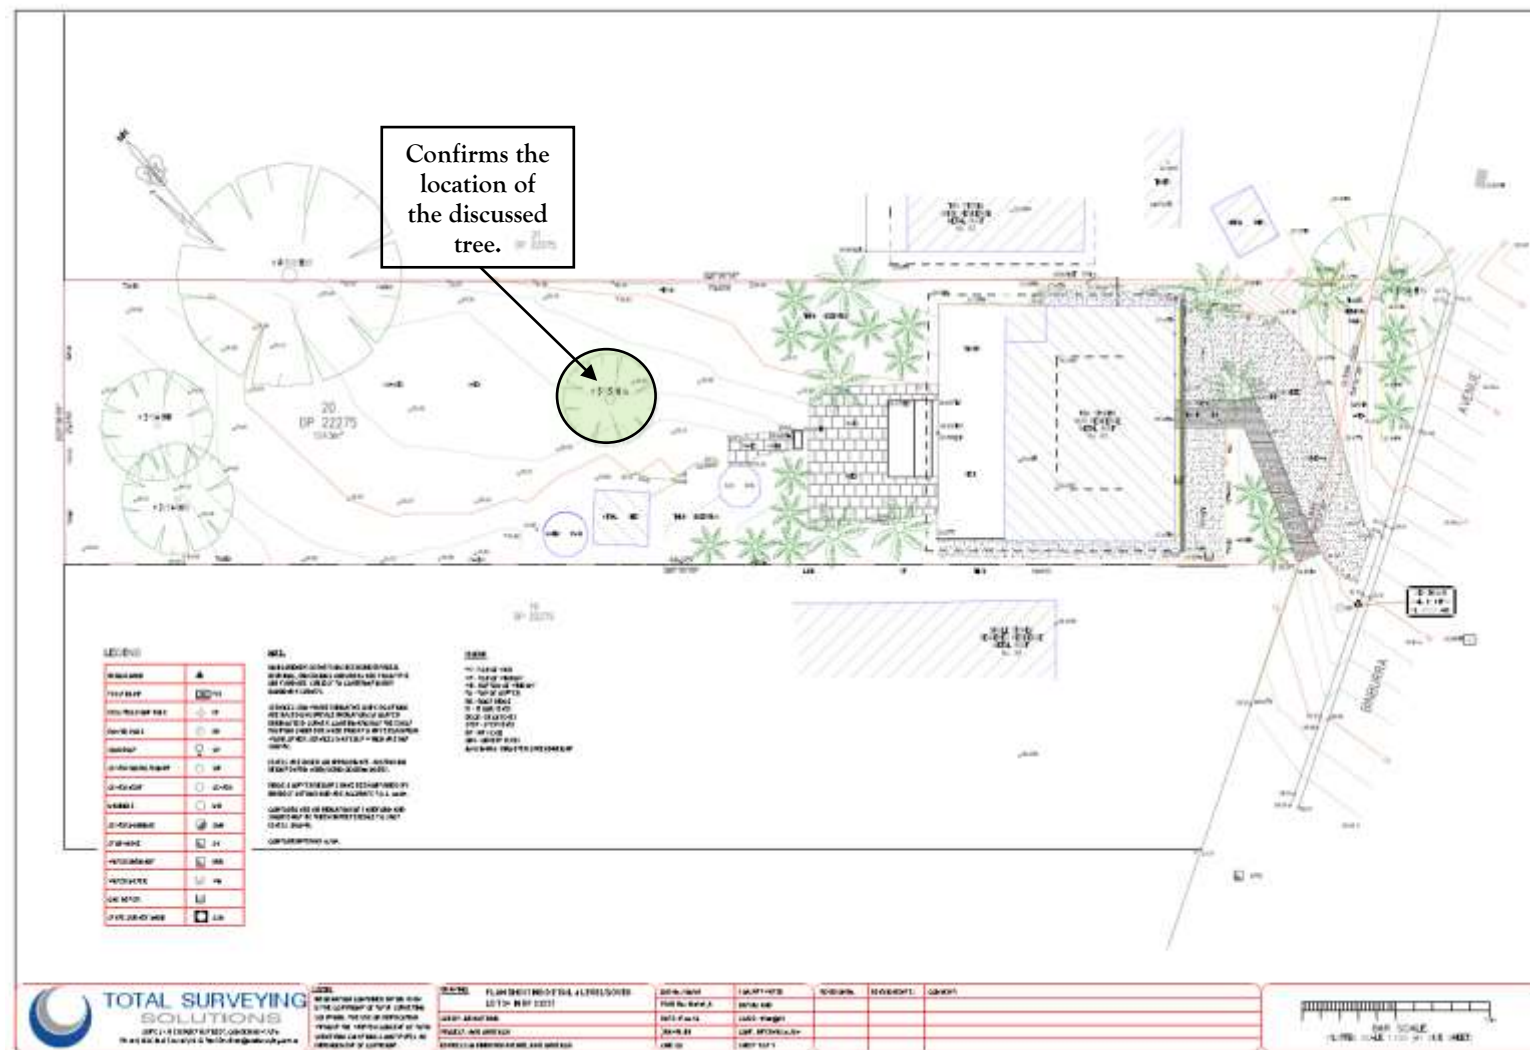
Figure 3: Illustrates portion of Site Survey with discussed tree is marked with a “green circle”. Trees marked within Yellow Boxes are not impacted upon by the DA proposal. Trees within Red Boxes are largely proposed to be removed/replaced.

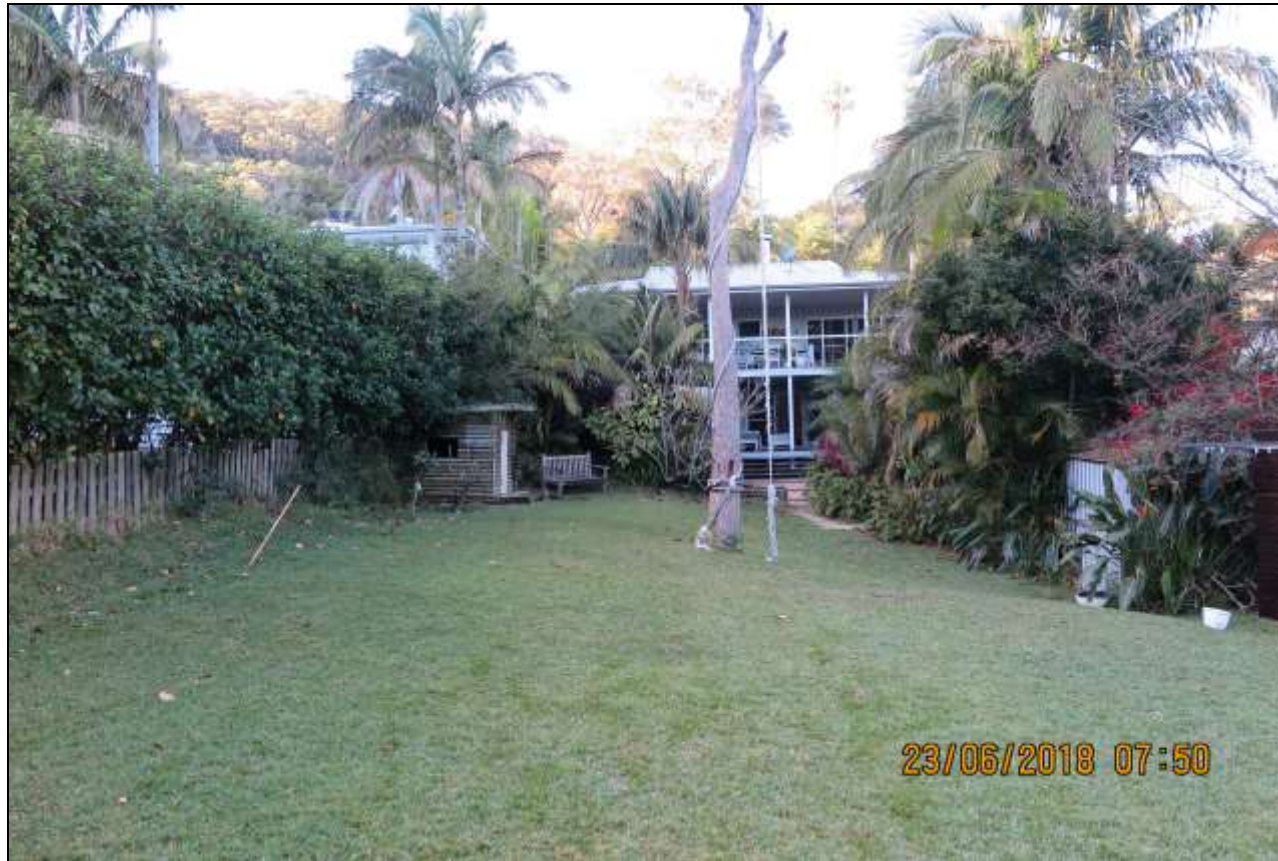
Figure 5: Illustrates east & west sides of rear yard trees mostly proposed to be removed/replaced. Centre of photograph illustrates location of the only identified as protected tree species discussed.

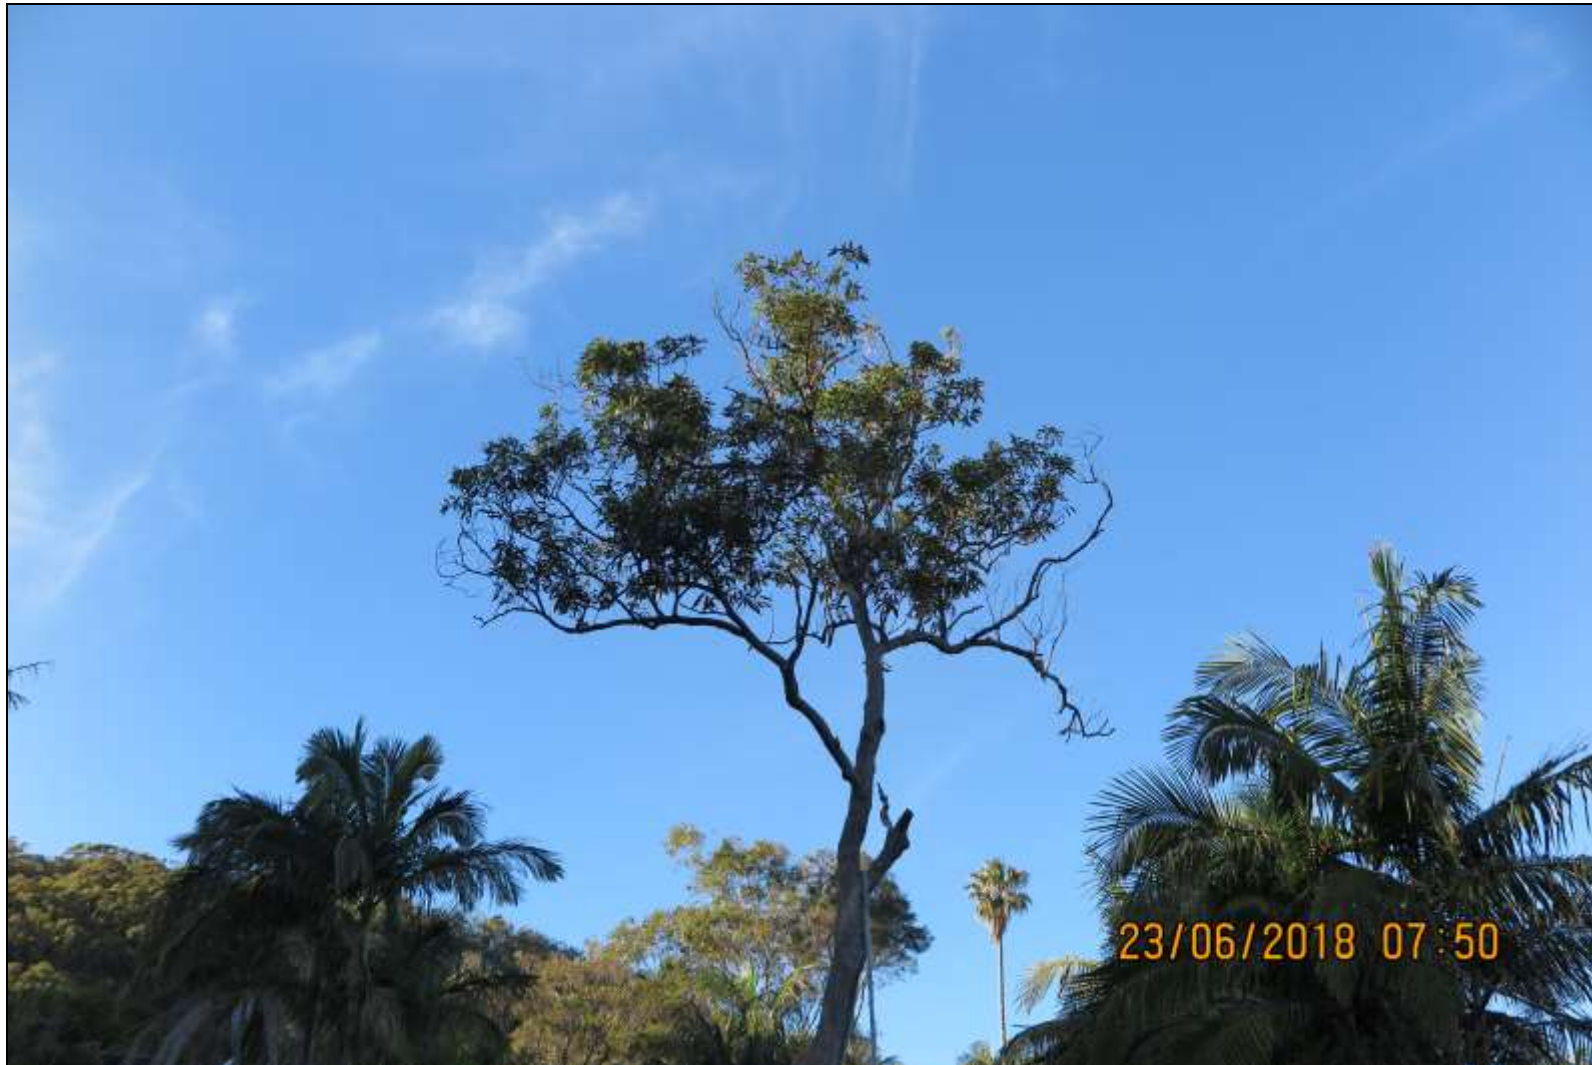
Figure 6: Illustrates tree condition as viewed on 23 June 2018.

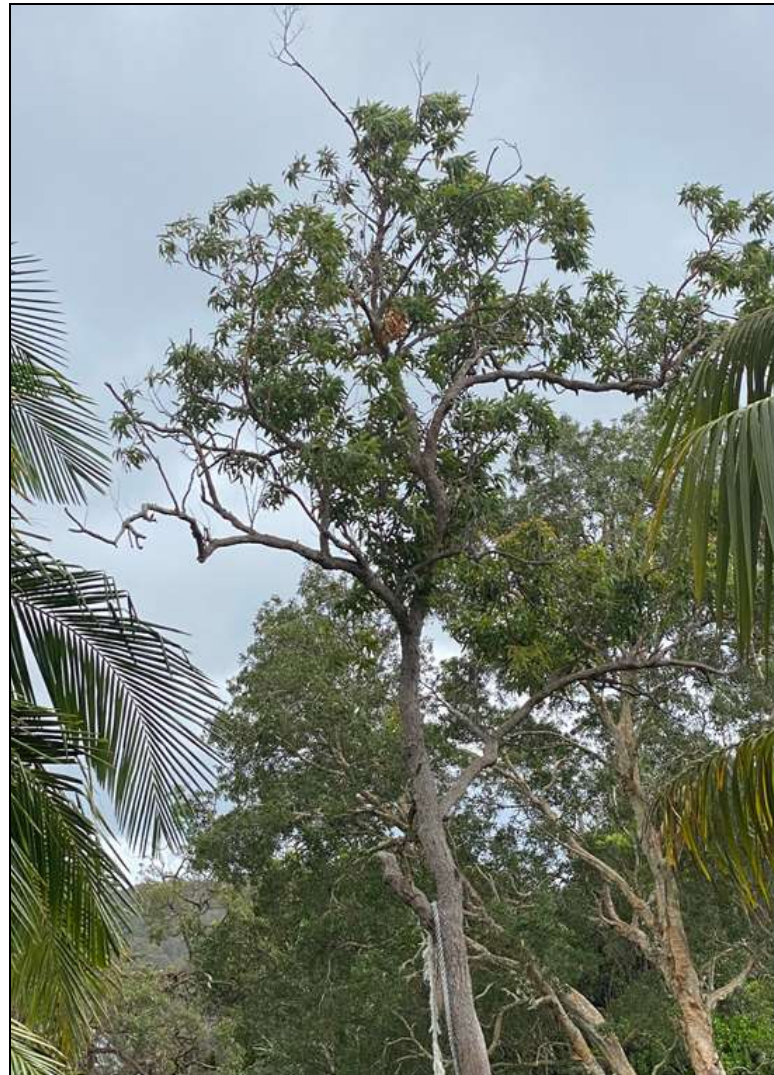
The discussed tree is confirmed to have declined in Health & Vigour since originally assessed in June 2018 to the present, (March 2020).

Figure 7: Confirms 'canopy condition decline' between June 2018 & March 2020. (Photograph provided by the property owner, 23 March 2020).

As a direct consequence of the 'change of natural environment' soil levels Tree #1 displays classic indicators of 'tree root dysfunction'. They include 'branch tip dieback' as well as the death of larger diameter dead branches.

Tree #1 by location is technically able to be retained but by virtue of its 'advanced state of decline' is supported to be removed & replaced by a minimum of at least one (1) new same species tree. Reason being, it a locally indigenous species.

Tree #1: Remove & Replace

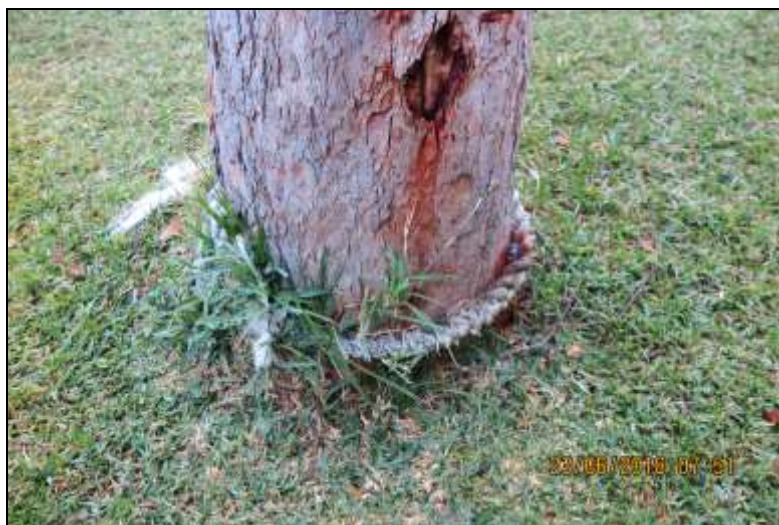
Figure 8: Illustrates the 'change of natural soil levels' Tree #1 has been subjected too.

One (1) tree, (Tree #1) noted on the Site Survey to be a dead tree is actually not dead but in a 'state of advanced decline'. It is confirmed to be a locally indigenous tree species. Its 'state of advanced decline' is easily explained. Previous subject site owners (not the as proposed DA benefactors) in an effort to create a near level outdoor (grassed) playing area have changed natural soil levels. Simply, natural soil levels have been raised. The evidence being side of rearyard battered/grassed edges parallel to adjoining long common boundary properties & 'NO EXPOSED Tree #1 base of tree trunk flare, (a classic give-away). See page 17 photograph.

No one can accurately estimate how long it will take for Tree #1 to actually die. However, it will never recover to be a healthy example of its species.
