1 June 2023

RE: GEOTECHNICAL SITE INSPECTION - 147 MCCARRS ROAD, CHURCH POINT, NSW

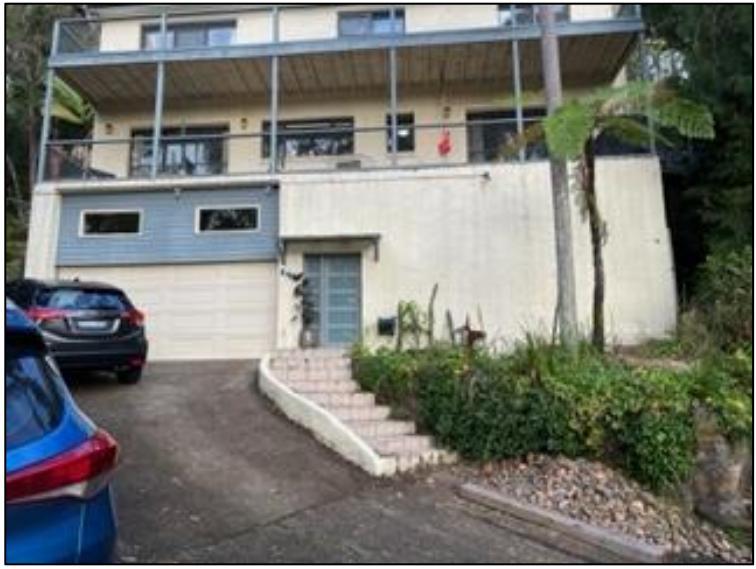
We understand from provided information and following the site visit, that the existing property is located on a steeply sloping site comprising an approximately 40 year old double brick building with a sloping concrete driveway providing access to the garage on the northwest side of the buildings ground floor, with stair access to the front door adjacent to the driveway and a short retaining wall supporting some backfill placed in front of a rock out crop, for levelling purposes (see Attachment A, Photo 1). Observations indicate the building is likely constructed on the shallow rock.

Photo 1: House frontage - concrete driveway and access stairs

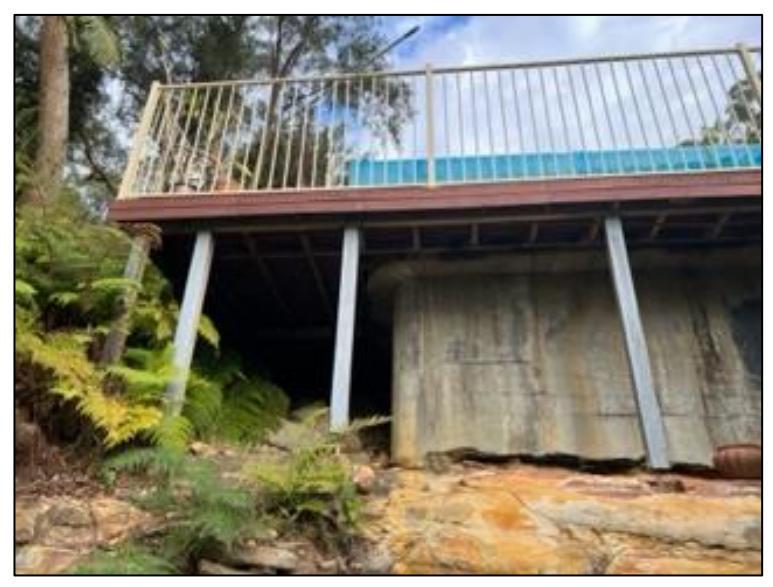
The sloping ground generally falls towards the north at varying grades, exposing rock outcrops particularly in areas of cut. The swimming pool is located at the top of the site in an area of cut which appears to have been shotcreted on the cut side and supported by steel posts bolted into the bedrock on the downside (see Attachment A, Photo 2 and Photo 3). No signs of significant instability were observed and the building / pool structure appears to be in good condition.

Photo 2: Steel posts supporting the pool

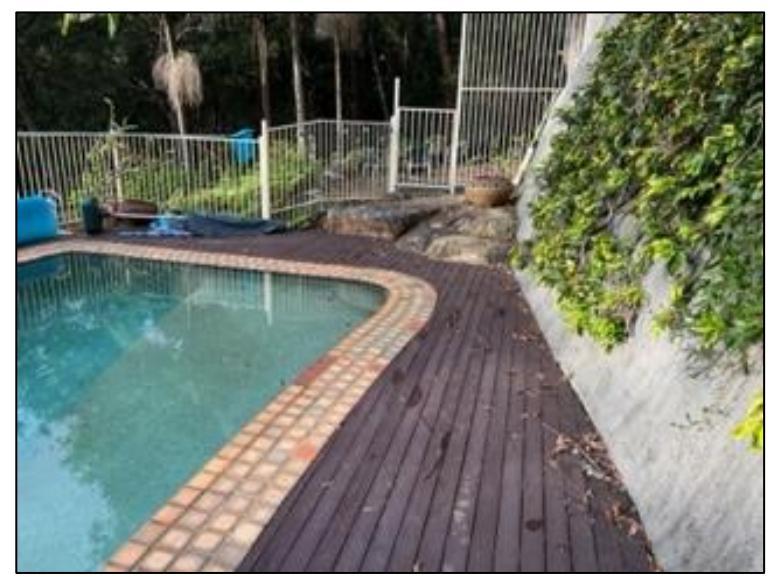
Photo 3: Shotcrete on cut face of pool

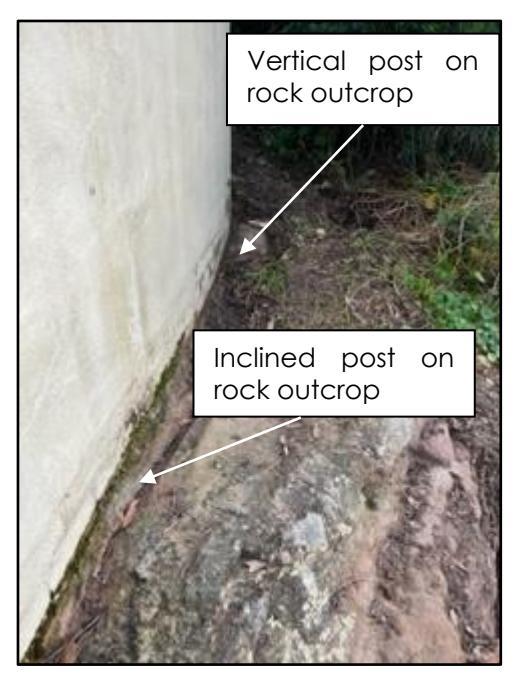
Site observations and review of provided information, indicate that the footings for the proposed supporting posts will comprise a baseplate bolted into rock or a concrete plinth, immediately adjacent to the existing building. Exposed rock outcrop was observed at two of these locations (see Attachment A, Photo 4) and concrete was observed at other locations (see Attachment A, Photo 5 and Photo 6).

Photo 4: Footings on rock - right side of house frontage

MA considers the proposed foundation arrangements to be acceptable subject to exposed rock being present for baseplate attachment or where any soil is present, this should be removed down to the level of bedrock and the baseplate attached or a concrete plinth fixed for attachment of the baseplate. It is recommended that all beams and supporting posts, as well as plates and fixings, be designed by a structural engineer.

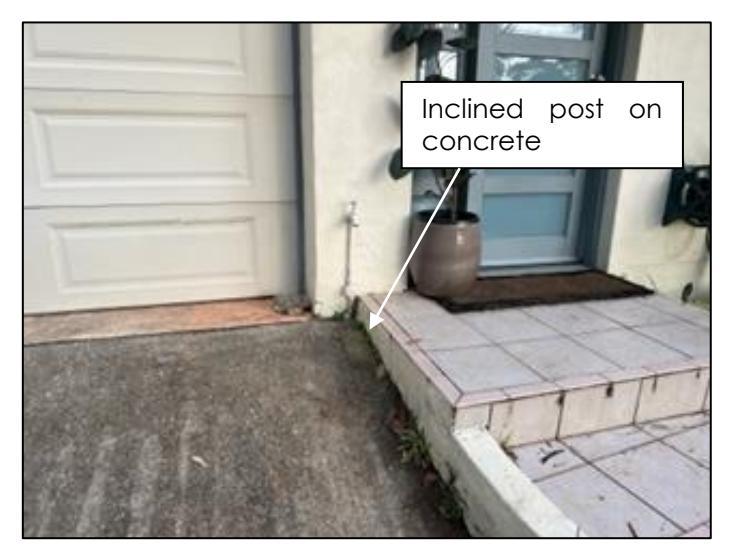
Photo 5: Footings on concrete - top of driveway / stairs

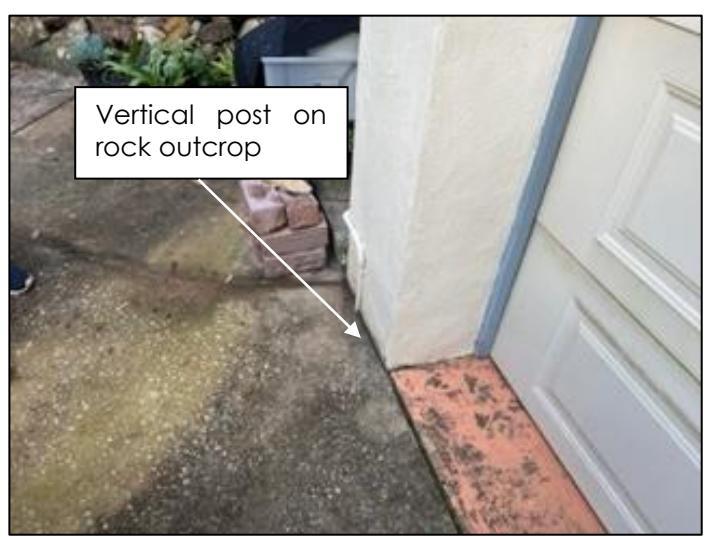
Photo 6: Footing on concrete – top of driveway (left side of house frontage)
