**Re: Development Consent No. N0641/04
Construction Certificate No. 2006/1245**

Determination of a Final Occupation Certificate Application

Final Occupation Certificate No: 2006/1245

Address: 41 Attunga Road, Newport

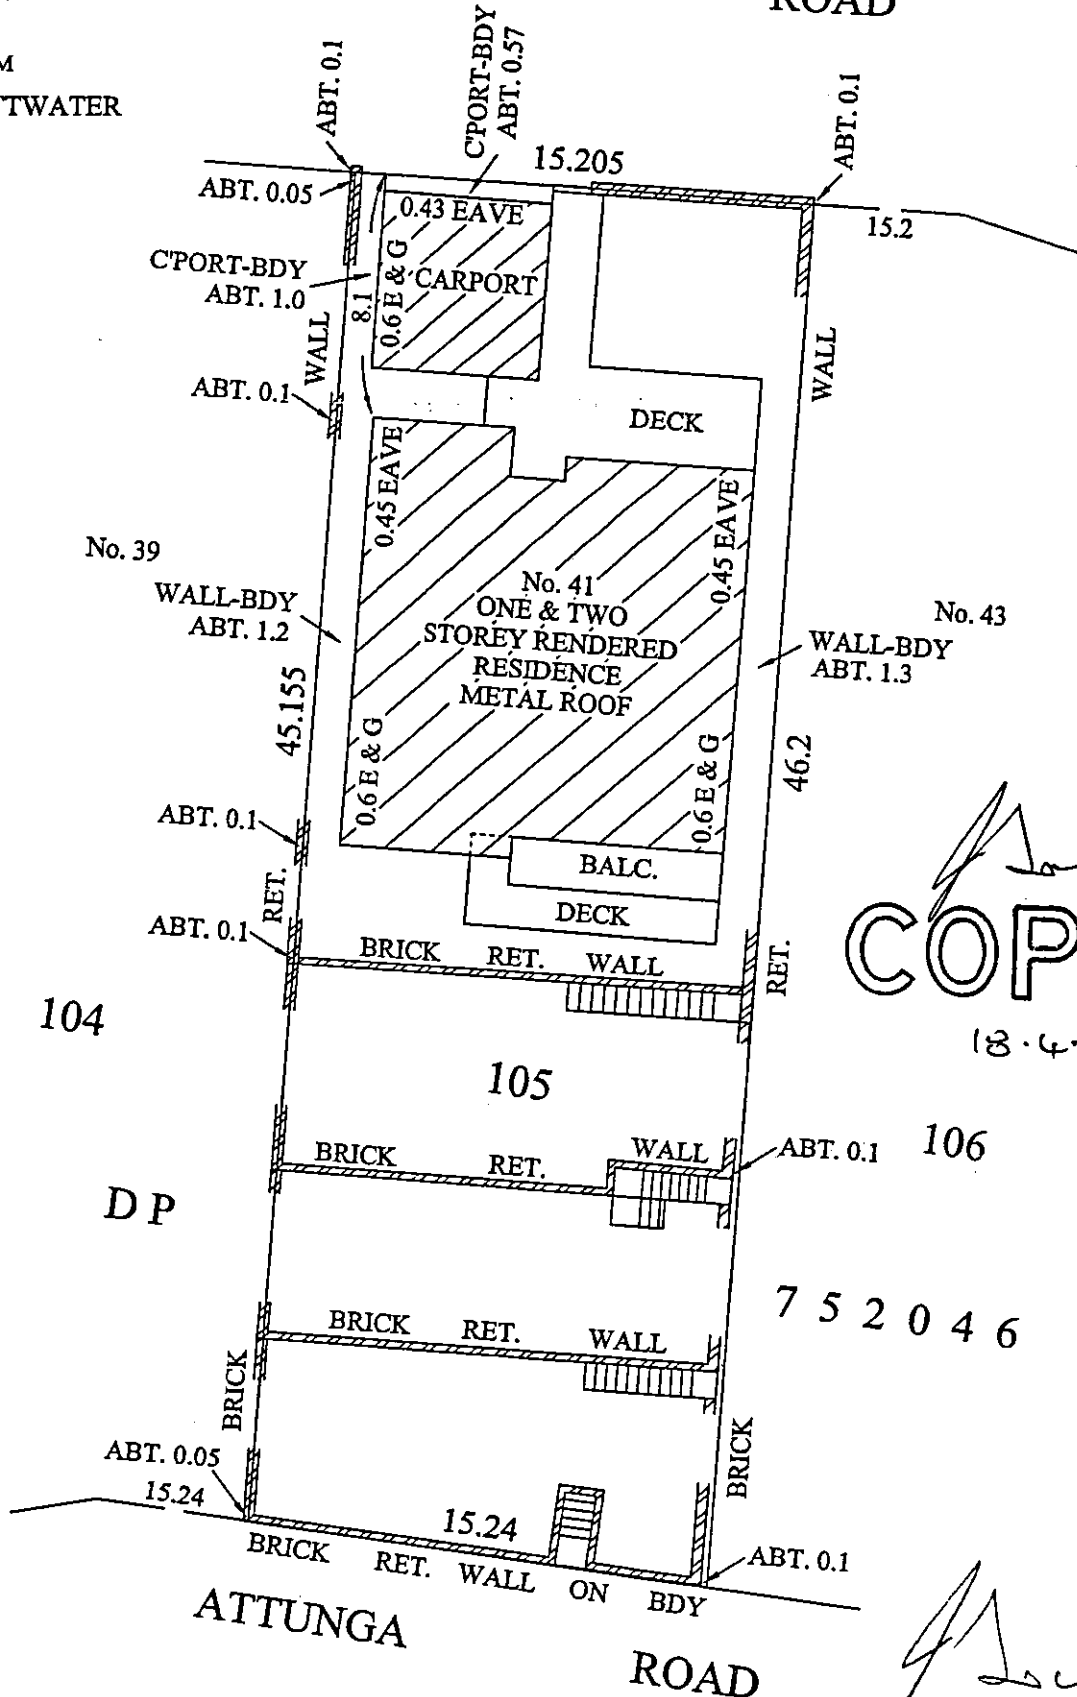
SKETCH

1. Upon the land and wholly within the boundaries, stands a 1 and 2 storey brick rendered residence with a tile roof, known as No.41 Attunga Road, Newport.
2. The residence and improvements stand in relation to the boundaries of the land by distances as shown on the attached sketch plan.
3. The land is fenced by brick retaining walls which stand in relation to the boundaries of the land by distances shown on the attached sketch plan.

Apart from minor brick retaining wall clearances from the boundaries, there are no other visible encroachments by or upon the said land.
