Arboricultural Impact Assessment Report Revision A

<u>Client Name</u>: Sydney Water

Site Address: 4 Bellara Avenue, North Narrabeen, NSW

<u>Phone:</u> 0426 836 701 <u>Date Prepared:</u> 12th October 2022

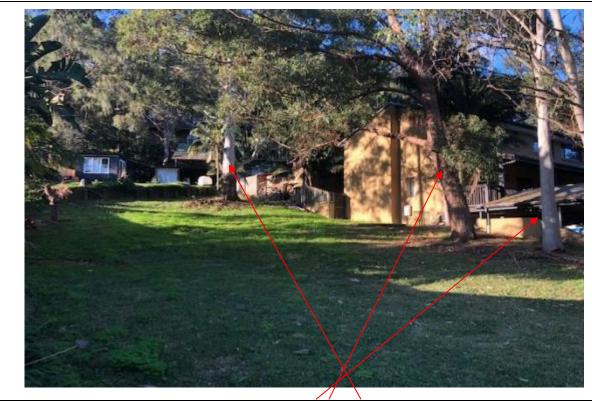
Photo a: Looking north up the subject site and trees 3, 4 and 5.

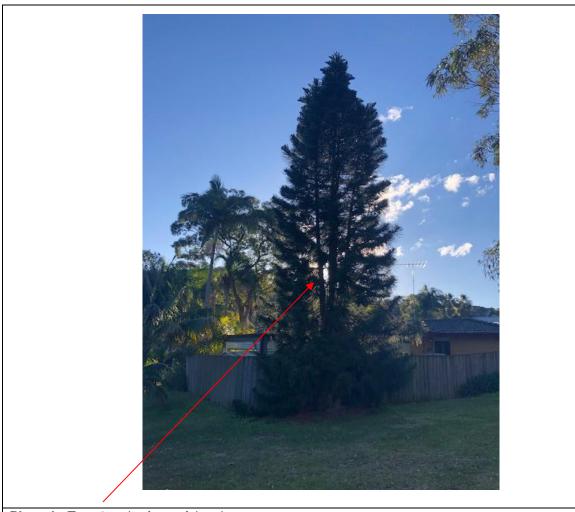
Tree ID	Species	Retention value	TPZ radius (m)	SRZ radius (m)	TPZ encroachment	Discussion/ Conclusion	Recommendation
1	Cook Island Pine	A1	4.9	2.4	Major	The proposed driveway will encroach into the Tree Protection Zone and the Structural Root Zone by up to 40%. This is a major encroachment that has the potential to impact the health and stability of the tree. If the tree is to be retained in a viable condition root mapping should be carried out to determine the location of significant roots that may be impacted. Alternatively design modifications to mirror the proposed driveway to allow a greater setback from the tree and avoid encroachment into the SRZ area and reduce the level of impact. See the recommendations section for further detail.	Root mapping or design amendments required.
2	Sydney Blue Gum	A2	5.8	2.8	Minor	The proposed structures will encroach into the Tree Protection Zone by less than 10% which is of low impact.	Retain and protect

Photo b: Tree 1 at the front of the site.

- 11.2 The proposed works will require the removal of three category A trees.
- 11.3 One category A tree (T1) that is proposed to be retained will be subject to major encroachment that is likely to cause the tree to decline in health. To ensure the tree is not adversely impacted by the construction, either of the two following points should be implemented to reduce the level of impact.

- 11.3.2 Root investigations: Where major TPZ encroachments require demonstrating the viability of trees the following method for root investigations is to be used. Non-destructive excavations are to be carried out along the outer edge of proposed or existing structures within the TPZ (excavation methods include the use of pneumatic and hydraulic tools, high-pressure air or a combination of high-pressure water and a vacuum device). Excavations generally consist of a trench to a depth dictated by the location of significant roots, bedrock, unfavourable conditions for root growth, or the required depth for footings up to 1 metre. The investigation is to be carried out by AQF5 consulting Arborist who is to record all roots greater than 30 millimetres in diameter and produce a report discussing the significance of the findings. No roots 30 millimetres in diameter are to be frayed or damaged during excavation and the trench is to be backfilled as soon as possible to reduce the risk of roots drying out. In the event roots must be left exposed, they are to be wrapped in hessian sack and regularly irrigated for the duration of exposure.
