rain Tree consulting

13 June 2021

1-1a NARRABEEN PARK PARADE – NORTH NARRABEEN, NSW SECTION 4.55 MODIFICATION, ARBORICULTURAL ASSESSMENT REPORT Ref No: 5821 issue 2

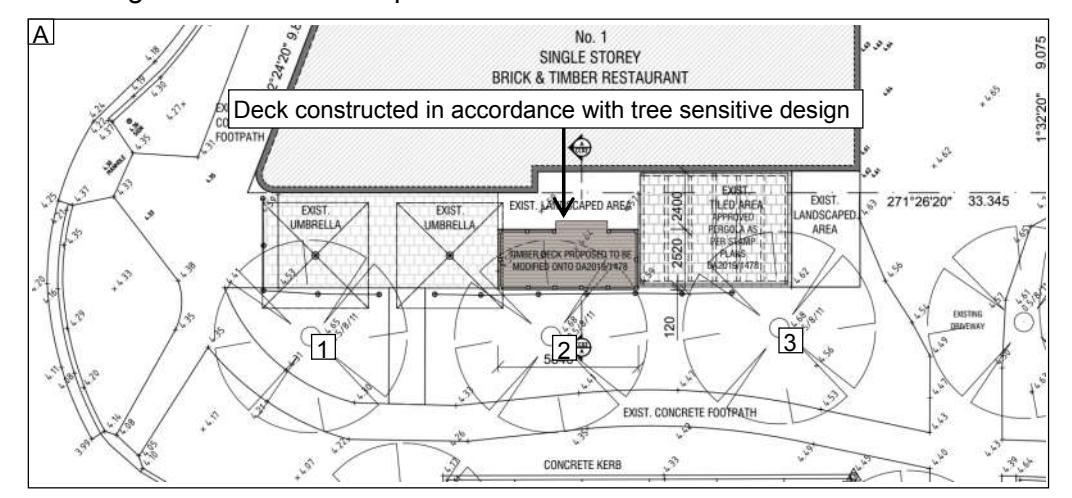
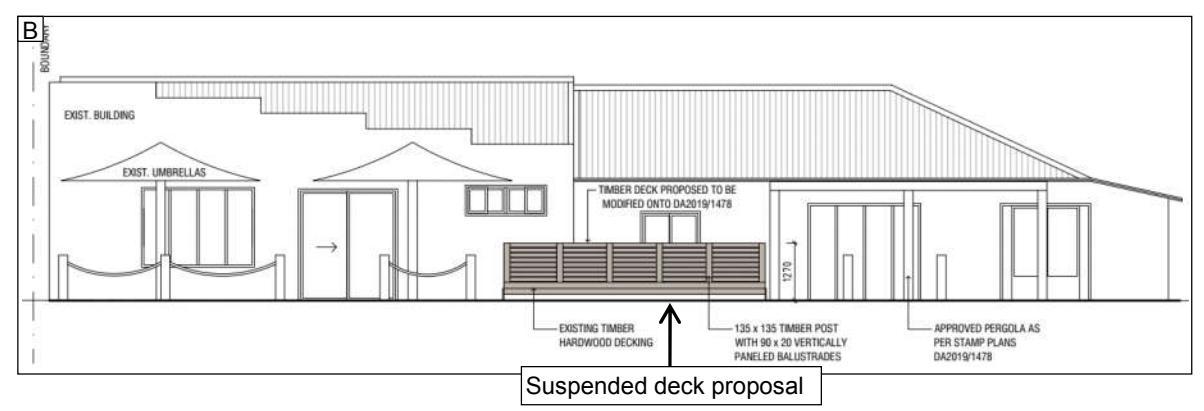
1. Construction of a new timber deck adjacent tree T2 has been conducted in accordance with tree sensitive construction measures by suspending the deck above ground level. This mitigates the impact of development encroachment & impact within the trees 10.8m Tree Protection Zone (TPZ) radius as noted within AS4970-2009 Section 3.3.4 (h) *design factors*.

Visually the timber deck is near 120mm above ground level and is supported by single isolated pier footings. The deck clears ground level at 1.1m from the base of the tree.

The overall TPZ coverage and impact is considered negligible (<10%) TPZ occupancy with the decking permitting precipitation and irrigation through timber gaps to contact natural ground.

Figure 1: showing tree location & suspended deck area

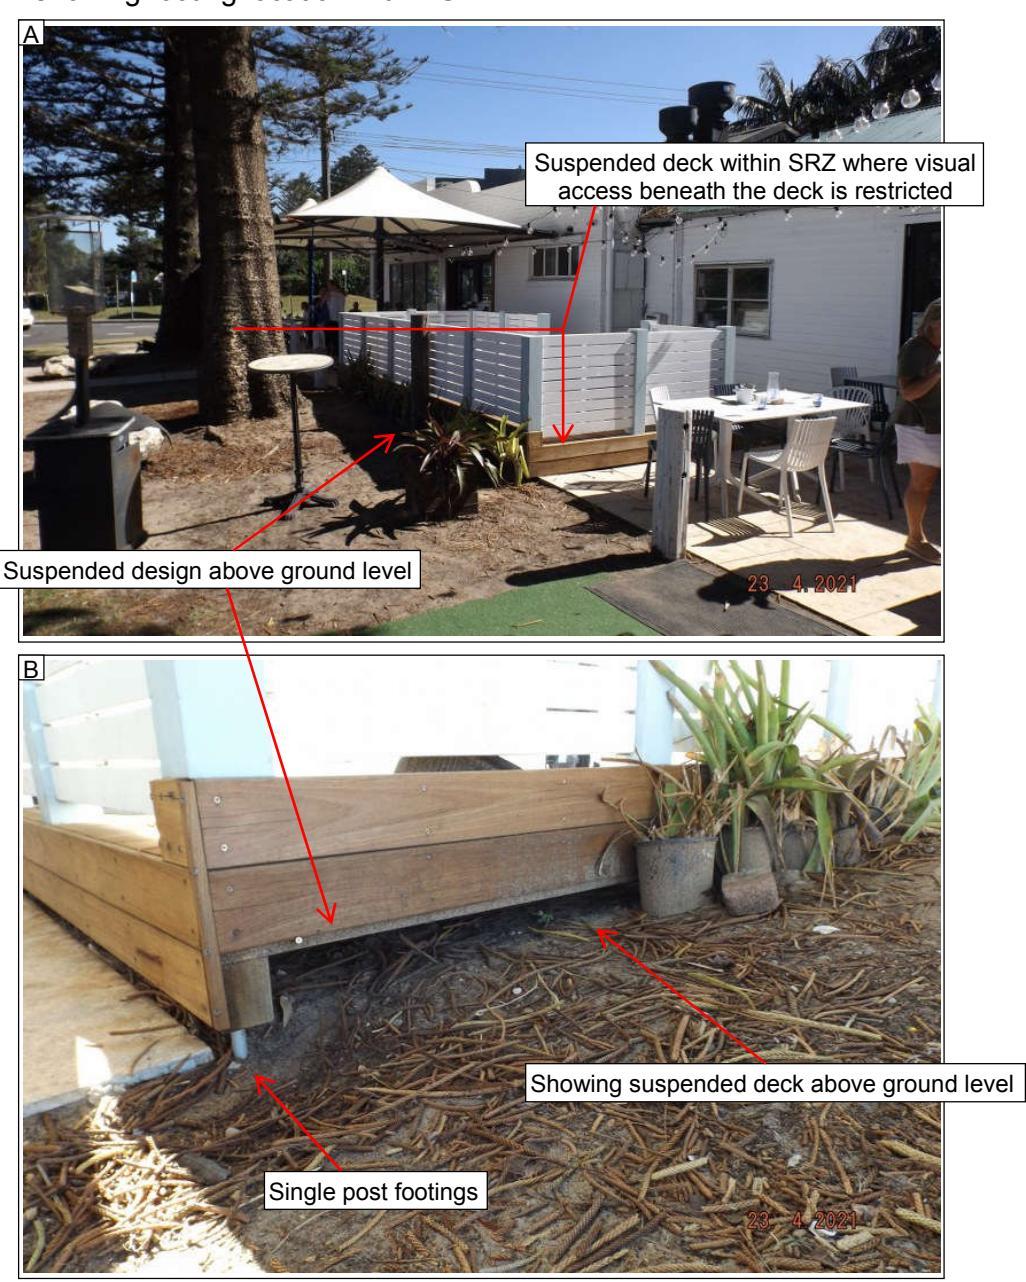
Footings are located within the trees critical 3.2m Structural Root Zone (SRZ) radius where it is unclear if root severing occurred to accommodate footing pad placement. Having isolated pot hole excavation for pier footings it is unlikely, however still possible, critical roots have been disturbed by works.
Impacts to the tree would be based on the amount, size and loss of critical roots encountered or disrupted during excavation for footing placement of which the amount of disruption is unknown.

As shown within Figure 2, it is unclear if such roots have been disturbed with the suspended deck compliant with tree sensitive design.

Figure 2: showing footing location within SRZ

- 8. To ensure the trees are appropriately managed there should be no additional excavation within tree protection zone setbacks without prior arborist advice.

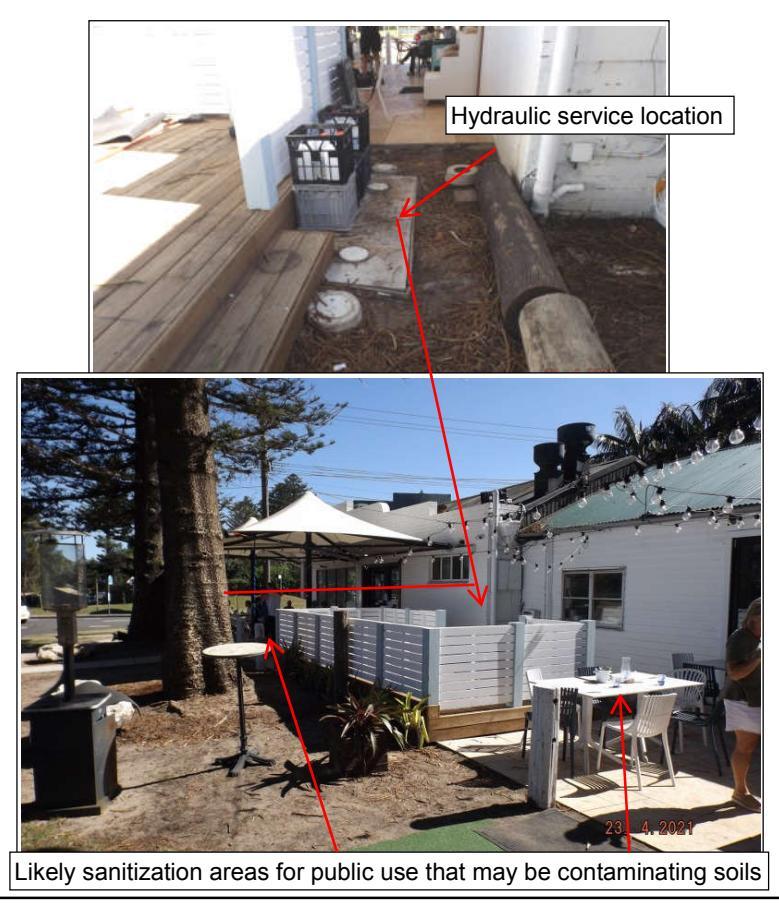
- 6. The cause of decline in tree vigour is unknown and may be partly associated with root zone disturbance by construction activities. It may also be associated with poor site and soil conditions, disturbances caused by hydraulic line maintenance or associated contaminants (cleaning agents) used to sanitize public use facilities within a Café environment for COVID compliance.

Figure 3: showing hydraulic services & likely required COVID sanitization area

- 7. Providing deep natural tree mulch within exposed soil and garden bed areas with regular irrigation would likely mitigate environmental stress and increase tree vitality. Restricting sanitization of outdoor public use areas would also be beneficial where maintaining significant tree vitality is a requirement.
