16.12.2021

COUNCIL REFERENCE: EPA2021/0292. ARBORIST INSPECTION AND ASSESSMENT OF TREES ADJOINING CONSTRUCTED TIMBER RETAINING WALL AT 3 THOMPSON STREET, SCOTLAND ISLAND.

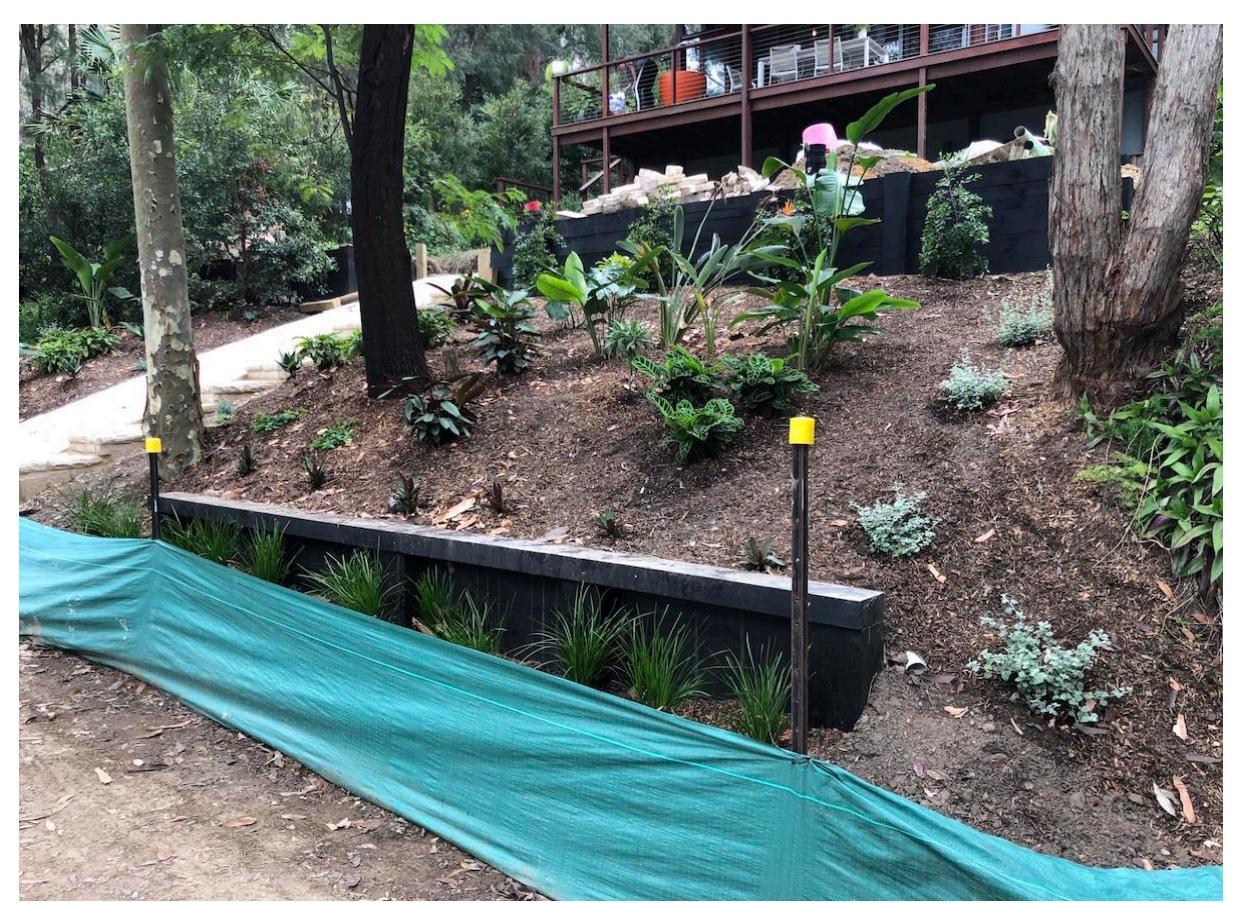
As per photos attached the constructed timber retaining wall is located in front of the considered street embankment alignment, thus ensuring minimal impacts to these trees.

The retaining wall has been constructed clear of the informal roadway of Florence Terrace, and in a location to have the least environmental impact to adjoining trees individual SRZ. I am informed that minor sandstone rock floaters were removed as part of these works, which exposed minor surface feeding roots ranging from 10mm to 30mm in diameter, which were pruned and in line with current best arboricultural practice and *AS* 4970-2009 Protection of trees on development sites.

Figure 1 Shows the existing constructed timber retaining wall.

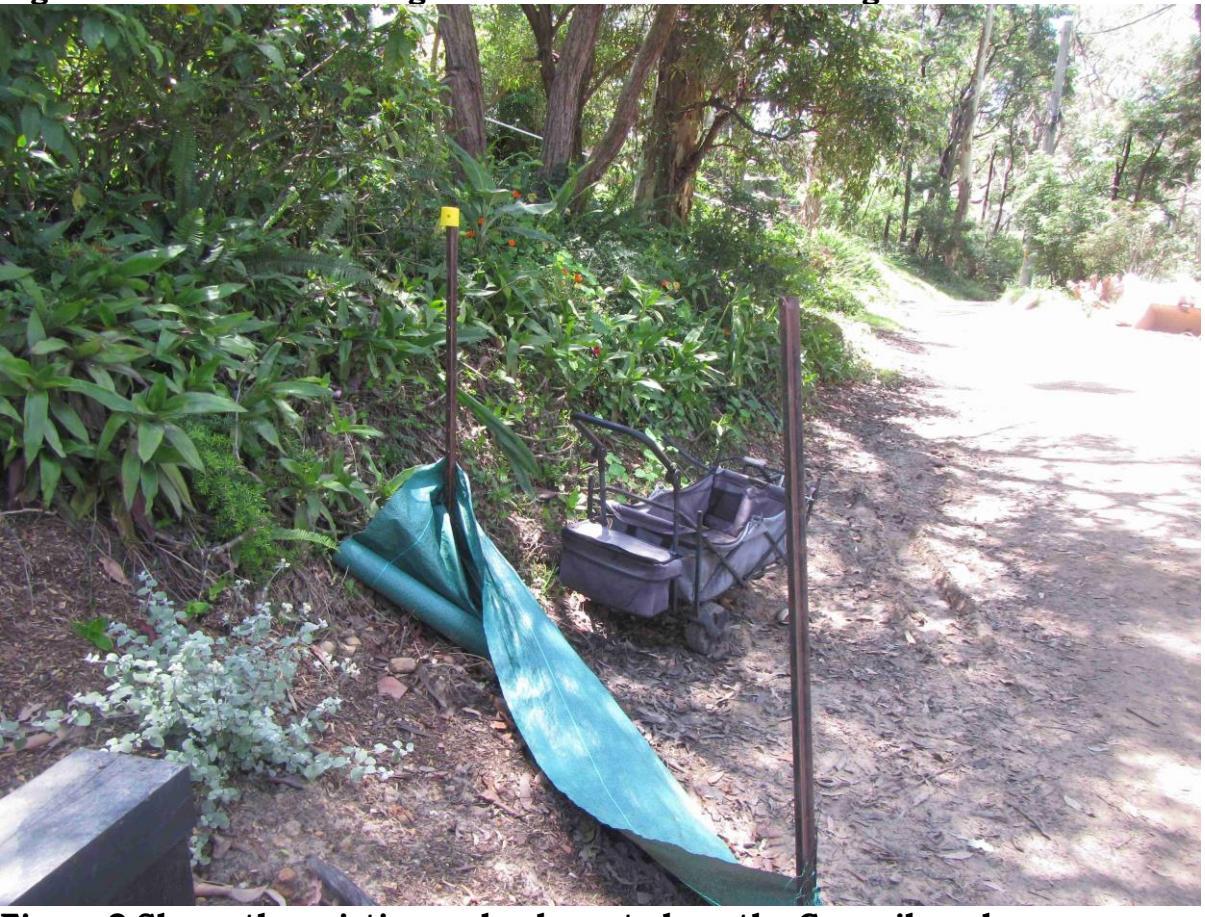
The adjoining embankment along Council's Road Reserve, to Florence Terrace, consisted of an excavated cut-off with typical weed infestation and observations of erosion from surface run-off from storm events.

Figure 2 Shows the existing embankment along the Council road reserve.

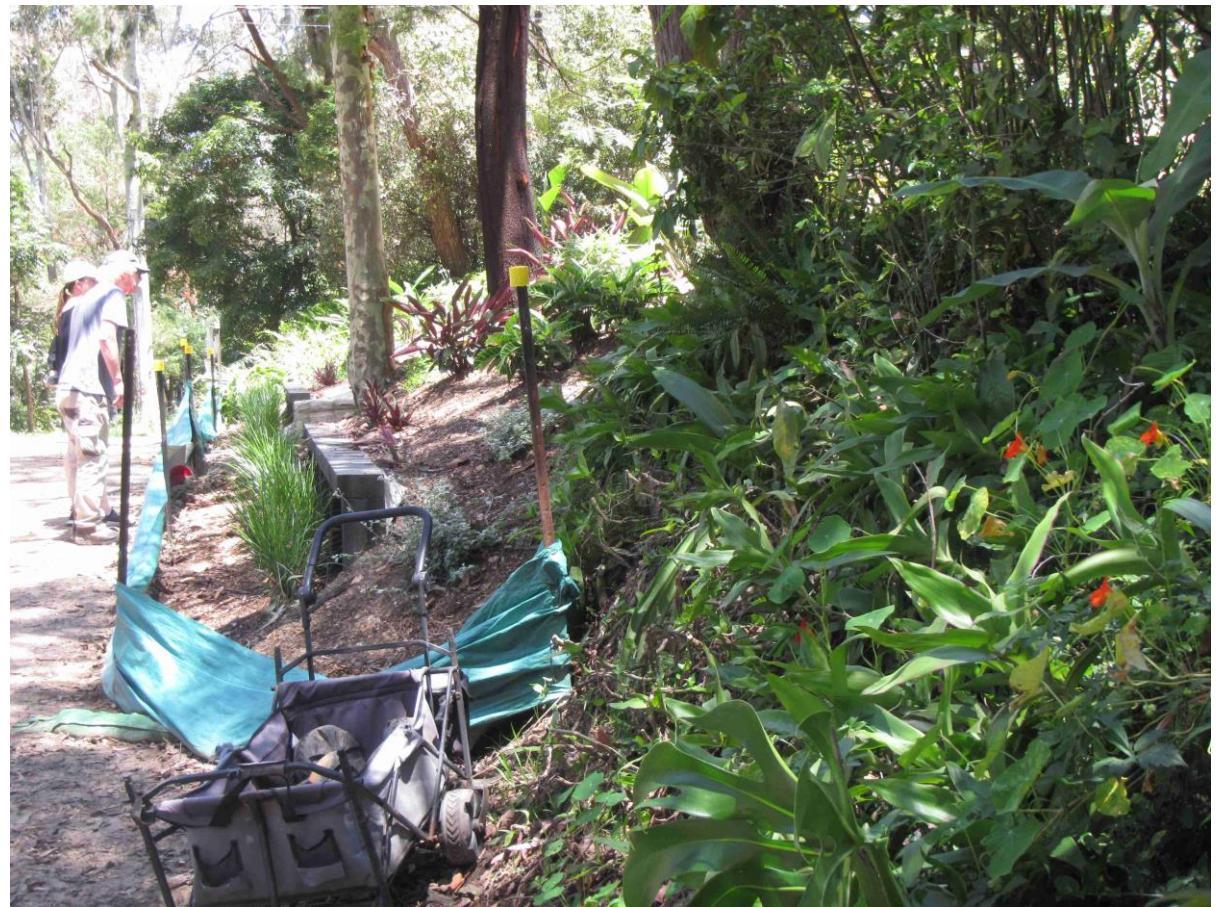
Figure 3 Shows again the embankment and timber wall alignment.

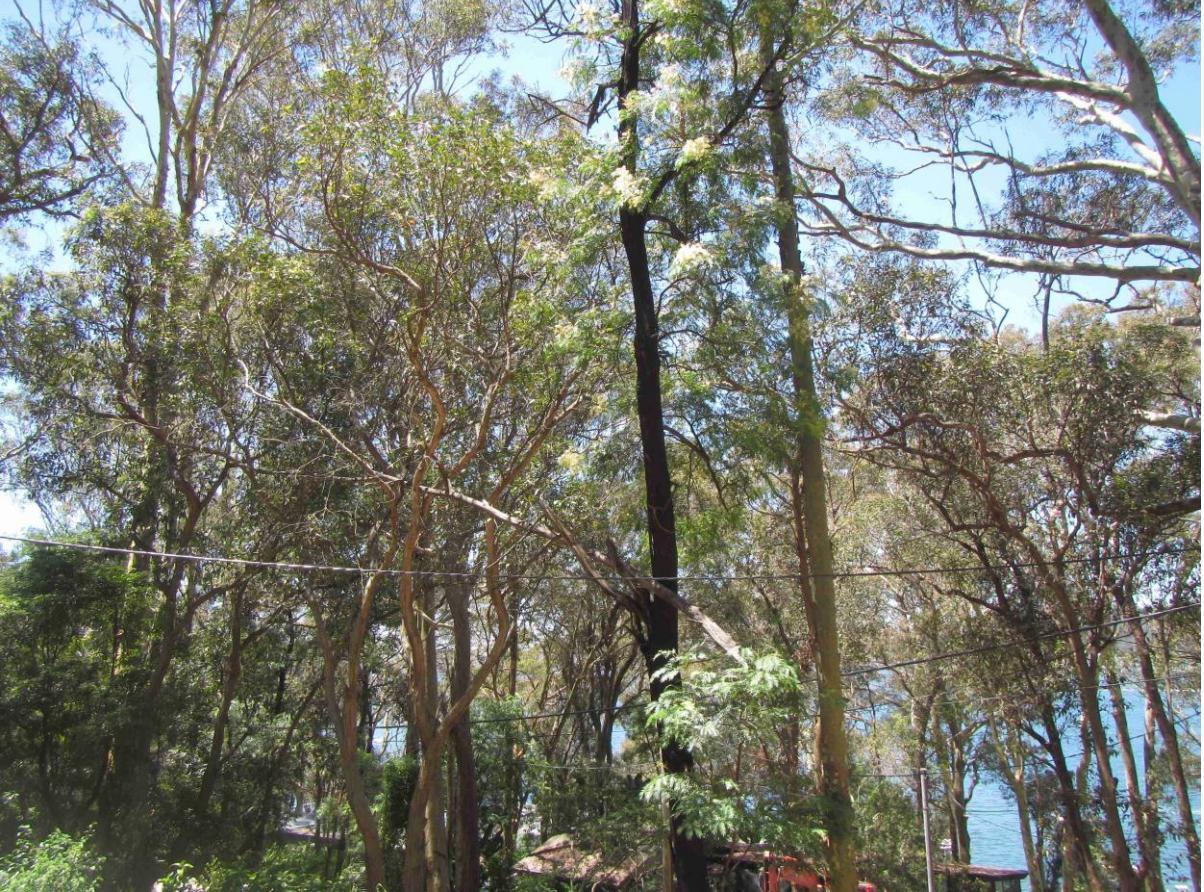
Tree 2, Mountain C edar W attle is in good health, however, it is in advanced decline, with the upper canopy being dead and structural branches dead and or failed over a period of time.

I observed the condition of this tree has been in decline over a period of time and is not a result of these works.

Figure 4 Shows Trees 1, 2 and 3 from a distance with noted dead hanger in Tree 2.

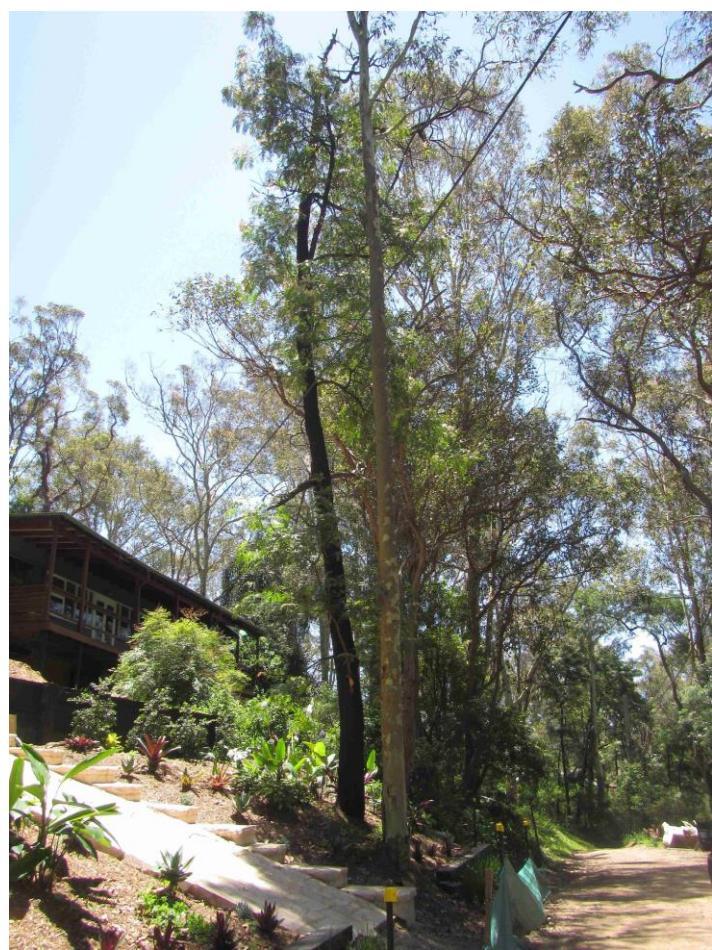
I am also informed that the sandstone rock steps, and entry pathway location did not encounter any existing roots. The finished level of the entry pathway appears to be consistent with that advice. In circumstances where no tree roots have been impacted, identified and or removed as part of these works, I am satisfied that the adjoining trees will be safely retained.

Figure 5 Shows Trees 1, 2 and 3 along the Roadway, with new steps and entry pathway adjoining.

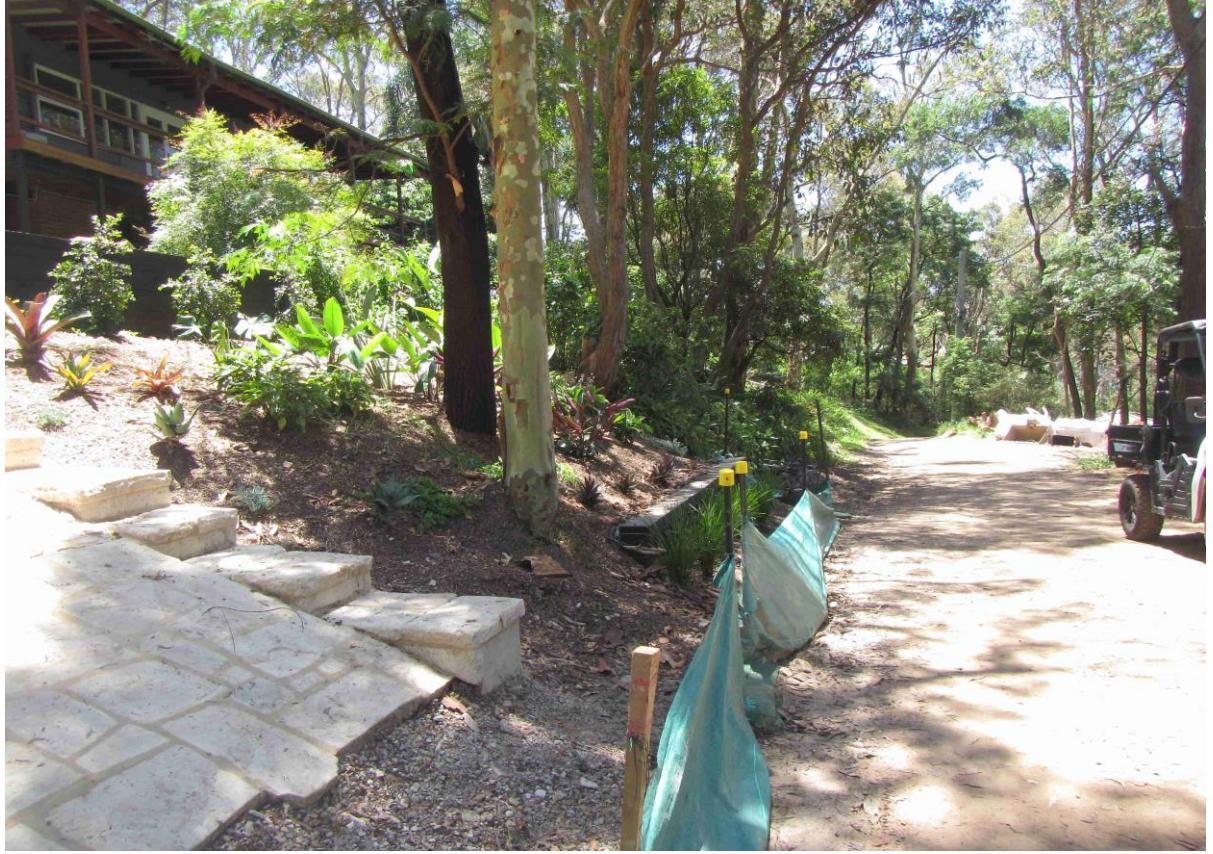
Figure 6 Shows the trees with typical embankment.

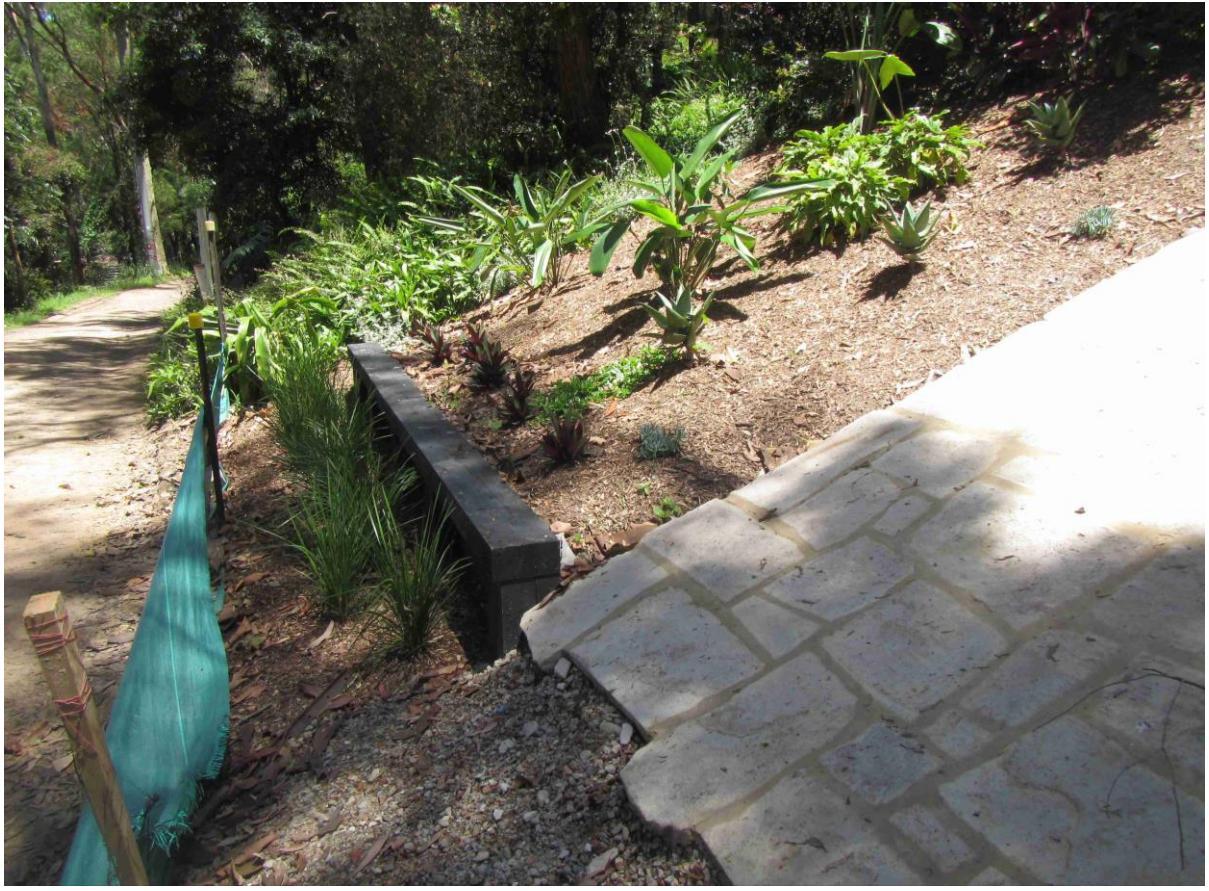
Figure 7 Shows the retaining wall continued on the other side of the entry pathway.

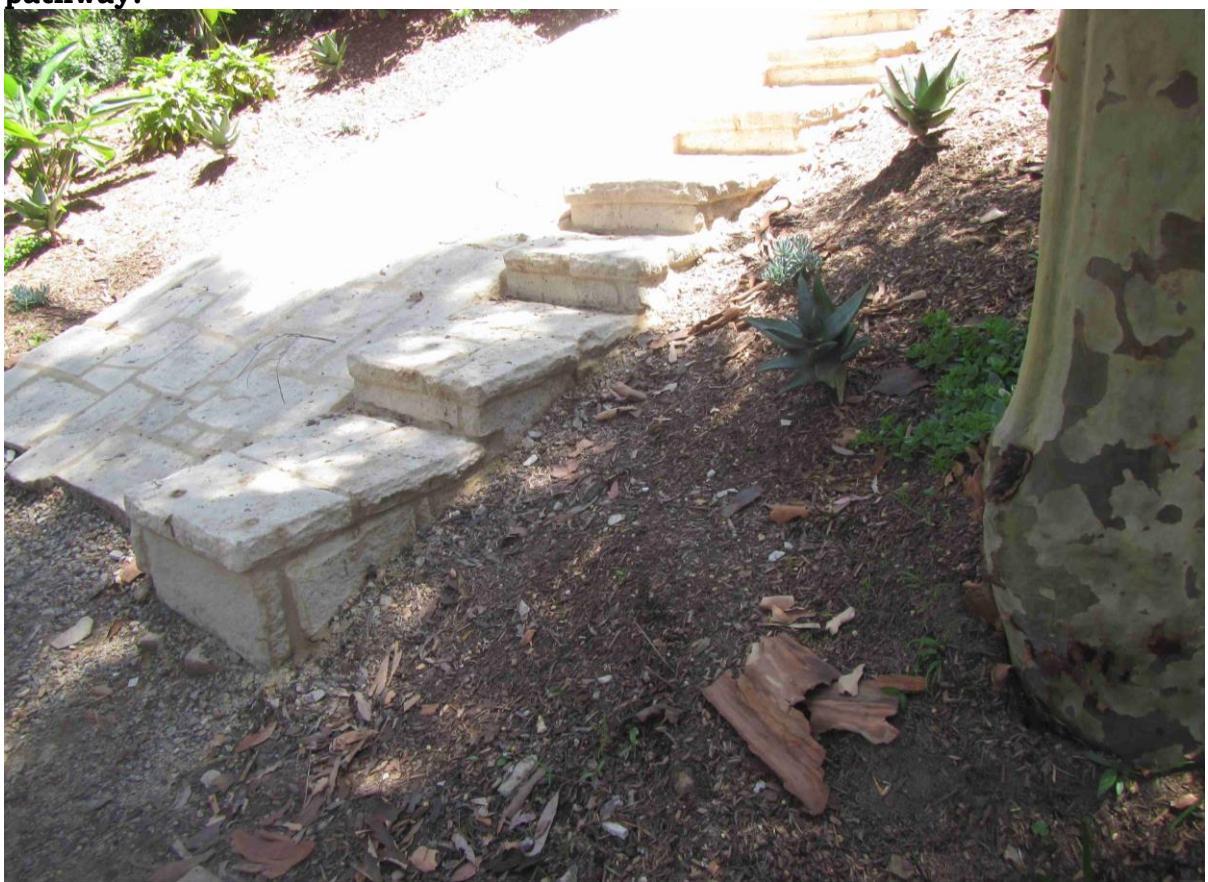
Tree 1, Spotted Gum is in good health, density, and structural condition and able to be safely retained and managed as per current practices.

Figure 8 Shows the rock steps cut into the existing topography to ensure no impacts to surface or anchorage roots of Tree 1.
