J4193. 20th April, 2022. Page 1.

GEOTECHNICAL INVESTIGATION:

New Garage and Deck at 82 Binburra Avenue, Avalon

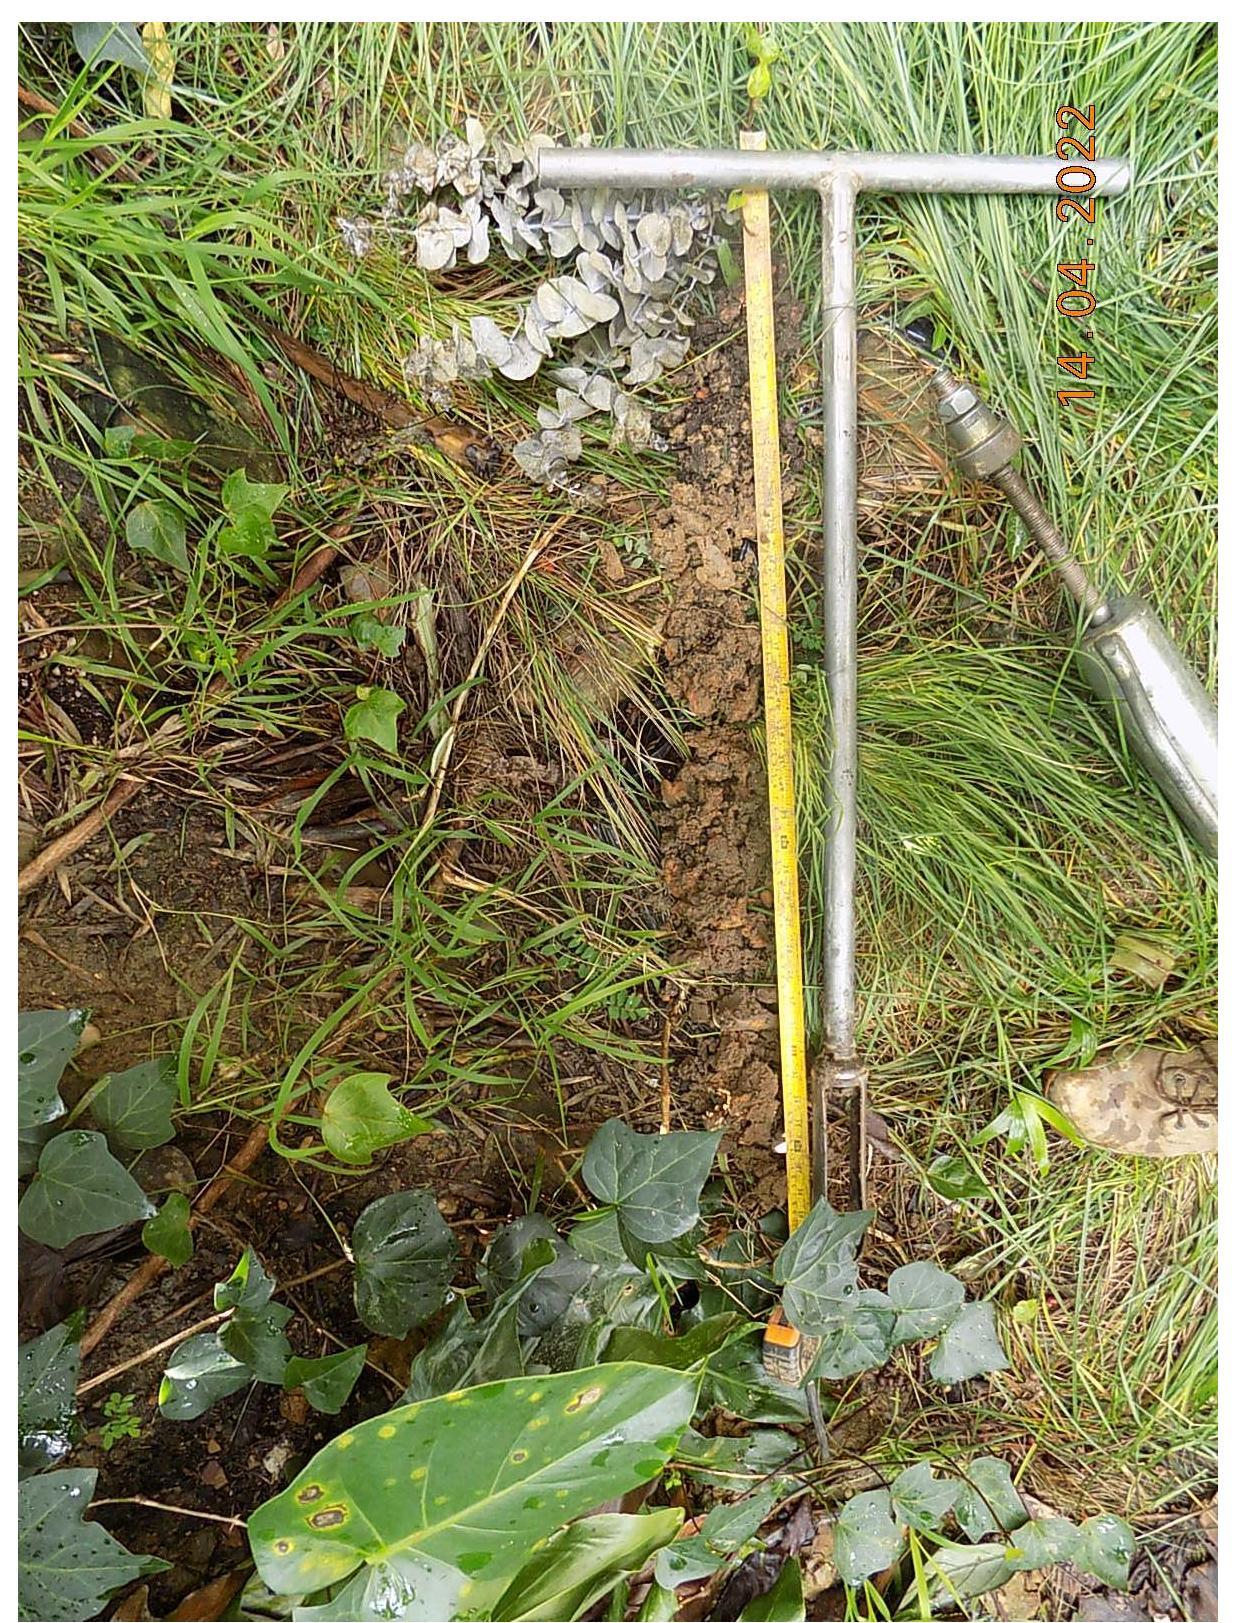
Photo 8 (Top to bottom)

AUGER HOLE 1 (~RL58.8) - AH1 (Photo 8)

Depth (m)	Material Encountered
0.0 to 0.2	FILL, dark brown clayey soil and orange sand, medium grained, fine trace of organic matter, dry.
0.2 to 0.4	FILL , mottled orange, yellow, sandy clay, fine to medium grained, fine trace of organic matter, dry.
0.4 to 0.8	CLAY , brown and orange, sandy, fine to medium grained, dry.

End of test @ 0.8m. No water table encountered.
