## Arboricultural Impact Assessment

**Client Name:** Brett Jeffries  
**Site Address:** 9-10 Taminga Street, Bayview, NSW  
**Authors Details:** Jack Williams  
**Date Prepared:** 7 March 2025  
**Email:** [hugh@hughtheArborist.com.au](mailto:hugh@hughtheArborist.com.au)  
**Phone:** 0426 836 701

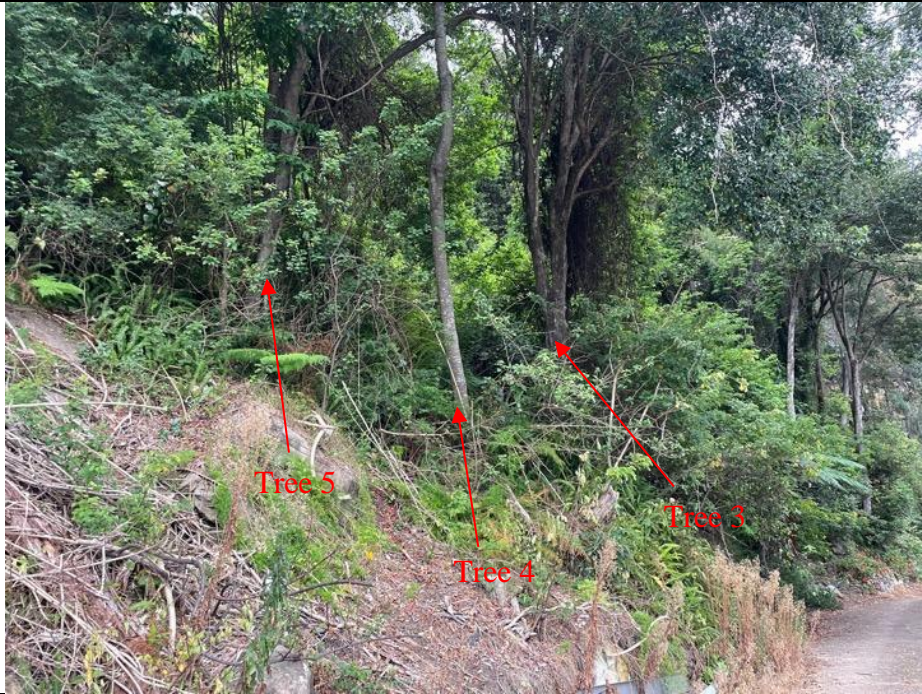
Showing the location of tree 3, 4 and 5.

Tree ID	Species	Retention value	TPZ radius (m)	SRZ radius (m)	TPZ encroachment	Discussion/ Conclusion	Recommendation
5	<i>Glochidion ferdinandi</i>	A1	4.3	2.5	None	The tree is located on the slope on the upper side/South of the driveway and has not been identified on the site plans provided. Based on the trees estimated location the tree will not be impacted.	Retain and protect
6	<i>Brachychiton acerifolius</i>	Z3	2.0	1.6	Minor	The tree is located on the slope on the upper side/South of the driveway and has not been identified on the site plans provided. Based on the trees estimated location the tree will not be impacted.	Retain and protect
7	<i>Glochidion ferdinandi</i>	Z1	2.6	1.9	Major	The tree is located on the slope on the upper side/South of the driveway and has not been identified on the site plans provided. Modifications are proposed to the driveway in the TPZ and SRZ, however there is a large existing sandstone retaining wall and significant change in level between the trunk and these works, the tree will therefore not be impacted.	Retain and protect

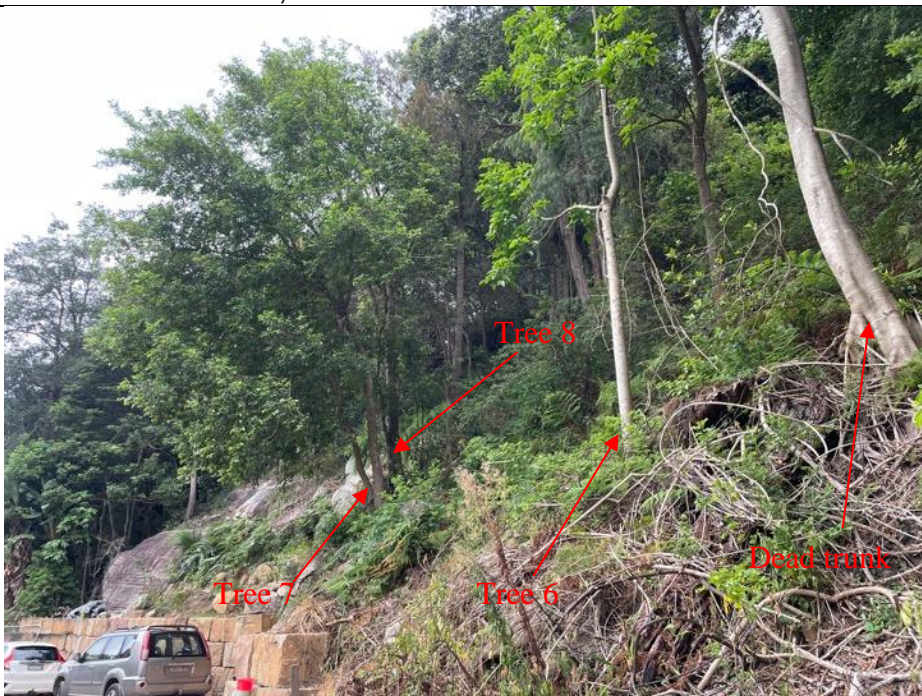
Showing the location of tree 6, 7 and 8.

8	<i>Glochidion ferdinandi</i>	A1	3.7	2.1	Major	The tree is located on the slope on the upper side/South of the driveway and has not been identified on the site plans provided. Modifications are proposed to the driveway in the TPZ, however there is a large existing sandstone retaining wall and significant change in level between the trunk and these works, the tree will therefore not be impacted.	Retain and protect
