LOT CLASSIFICATION REPORT

Prepared for: Wincrest Homes - Wincrest Group P/L
Site Address: Lot 1 (98) Elimatta Road, MONA VALE

Revision:**Site Test:** 25/01/2019**Lab Test:** 01/02/2019**Customer Job:** 17271/080/X02**Ideal Job:** 37822**Technician:** JK

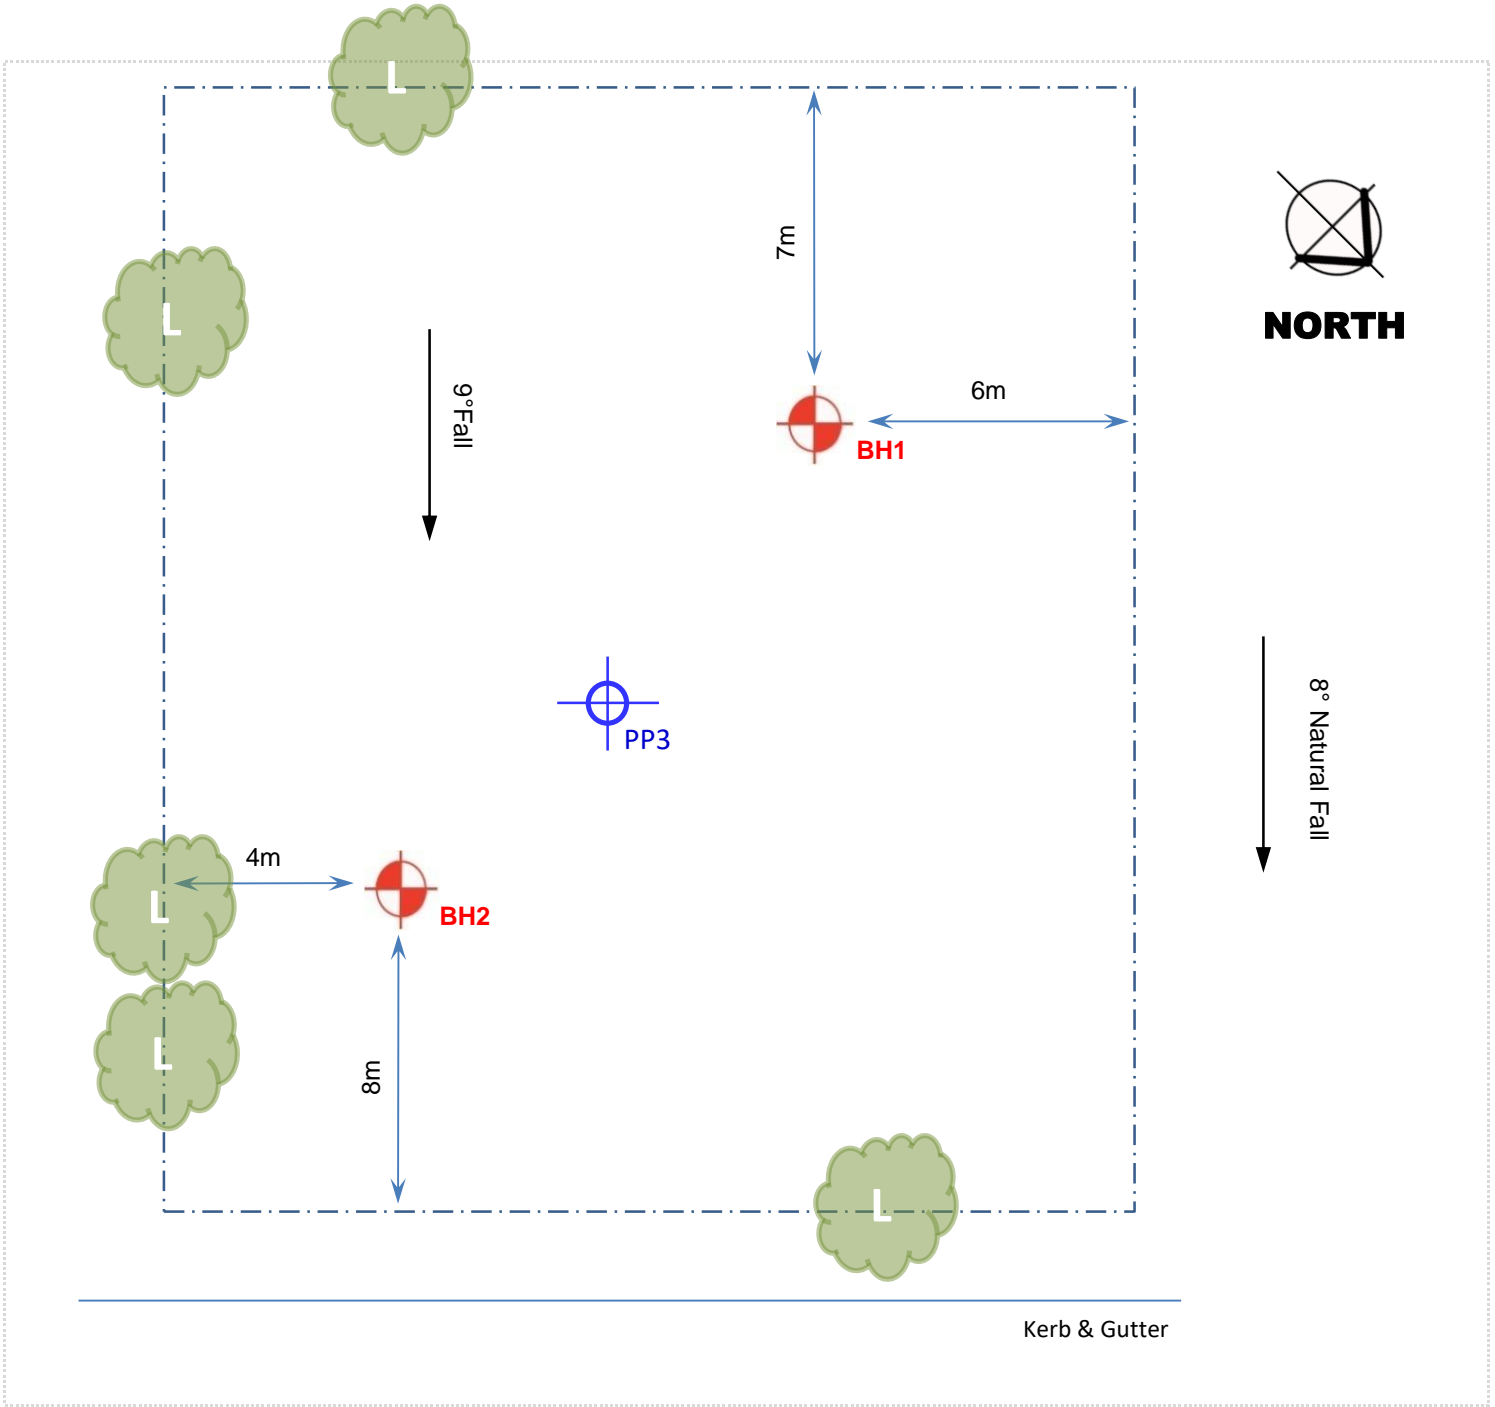
6.0 LOCATION SKETCH

| 2.6* | Are there any trees (or removed trees) on site or adjoining site? If Yes show locations at 6.0 | Yes |
